**Final Report of the Investigation into the incident
that occurred on 5 September 2002
at North Point Station of the Tseung Kwan O Line**

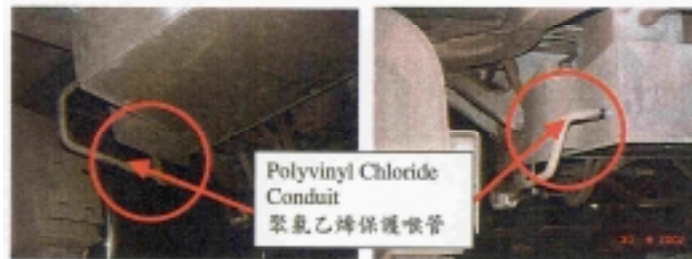
Photo 3 - Polyvinyl Chloride Conduit Arrangement (Before Modification)
相片三 - 聚氯乙烯保護喉管安裝(修改前)

21. The train had not divided and this was a false alarm. The wires to the train divided trip-switch, run in a special heavy-duty polyvinyl chloride conduit under the train, were entering the trip-switch box close to the wheels of the train. This switch and associated conduit were installed on the fleet between 1998-2001. The conduit to this trip-switch on this train was found broken and damaged at the junction with the trip-switch box. This allowed the conduit to drop by approximate 20 mm and caused the wires inside to rub against the trip-switch box, eventually causing a short-circuit and tripping the Train Line circuit Breaker (TLB) which could not be reset.

23. The Technical Investigation Team concluded that the conduit was broken either by vibration of the conduit relative to the more rigid trip-switch box, or by being struck by an external object thrown up by the wheels of the train. As the damage to the conduit was significant, not just a simple fracture, and there were other marks on the underside of the train, the Technical Investigation Team concluded it was most likely that the damage was caused by an external object, probably thrown up by the wheels of the train.

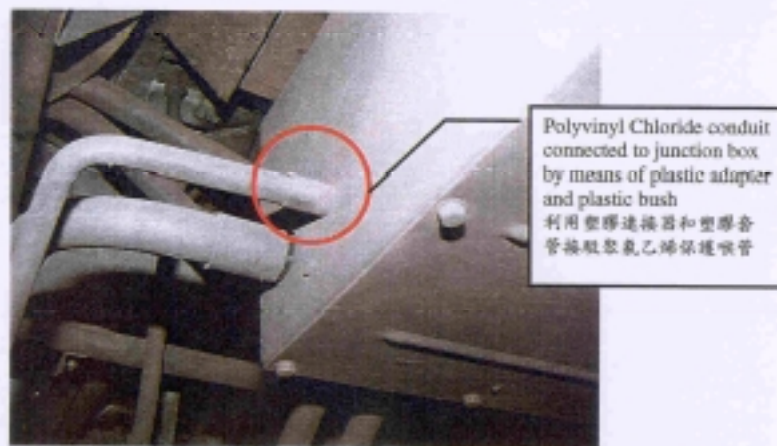
Photo 1 – TDI wiring connection (before modification)

18. Immediately after the incident, an examination of the defective train at siding 2 confirmed that a device used to monitor the coupling between train cars had short-circuited, generated a false alarm, causing the train to stall and unable to move under its own power. Initial investigation showed that the protective tubing connecting to the switch had fractured.
