**Legislative Council Panel on Transport  
Subcommittee on matters relating to railways**

**Light Rail service and the incident on 18 December 2002**

## **Final Report of the Investigation into the Light Rail Vehicle Derailment Incident that Occurred on 18 December 2002 at Siu Hong Stop**

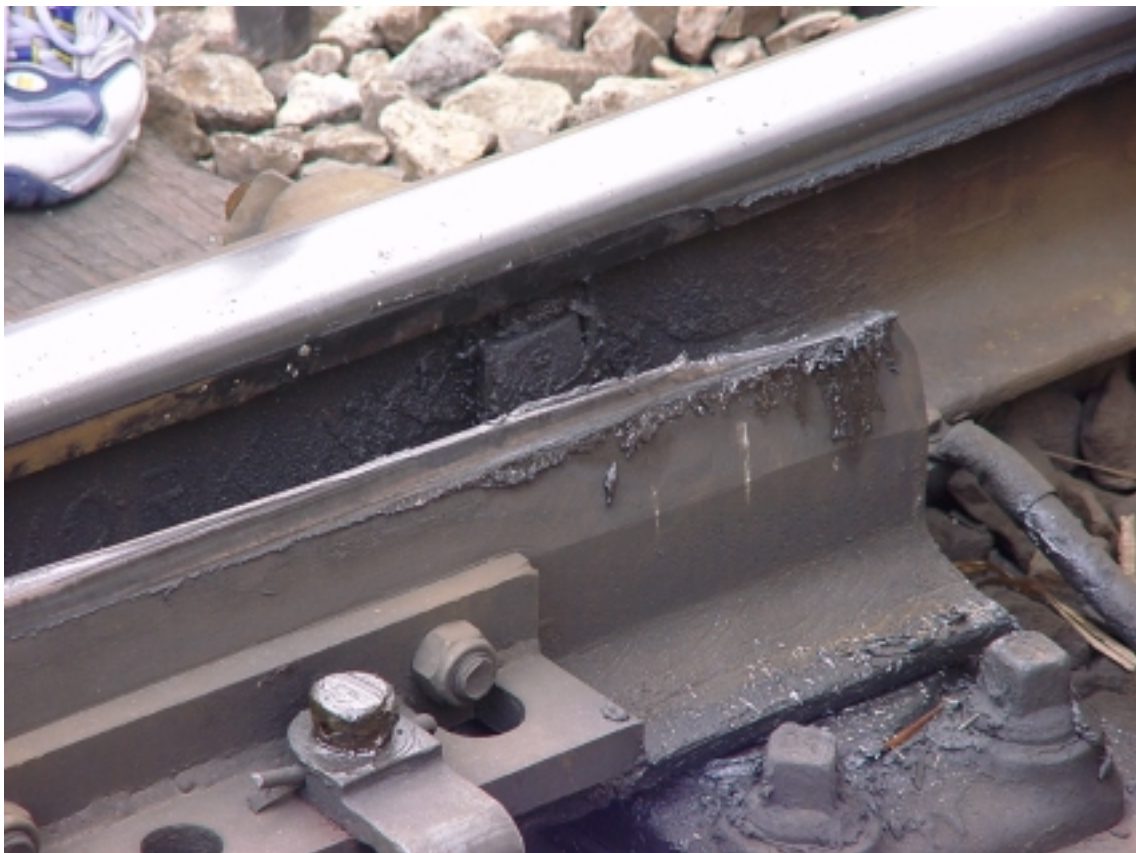
**Condition of Tongue Blade Immediately After Removal of LRV**

- (g) the tongue blade of the right hand side switch rail of W401 had signs of severe wear and the top edge was slightly broken over a length of approximately 70 mm, commencing 50 mm from the tongue tip – this is shown in the photograph at Annex 5. The breakage appeared to have taken place immediately before or at the time of the derailment;

# Photograph showing the exposure of the top edge of the tongue blade

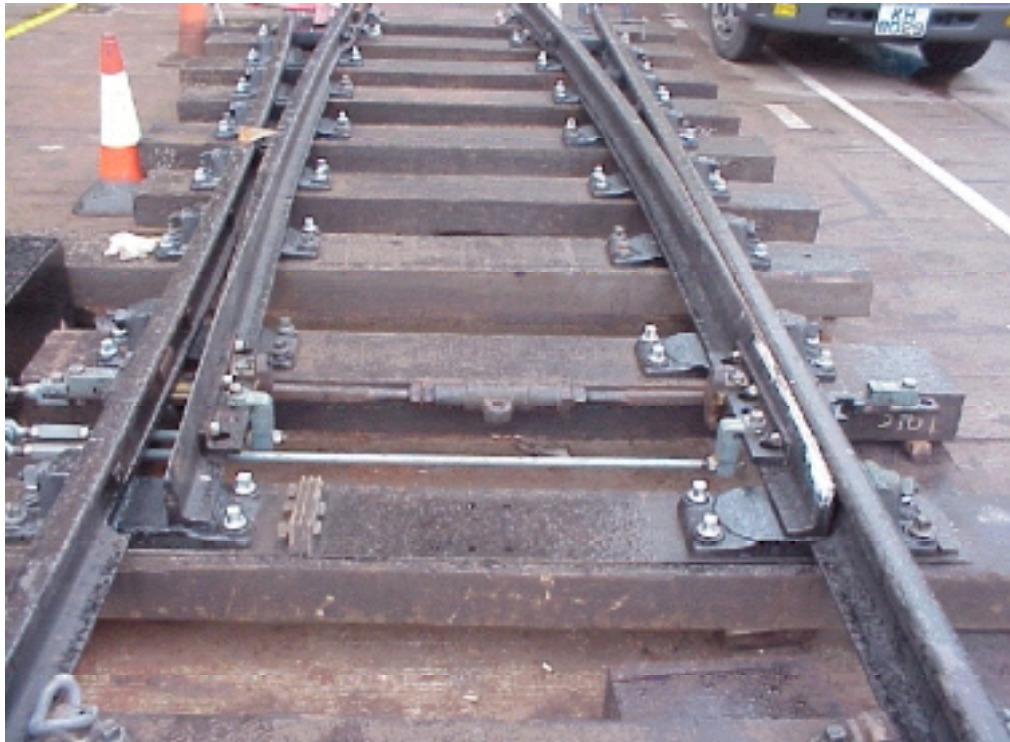
Point switched to right

- (i) the manufacturer's design of the turnout was such that the tongue tip of the right hand side switch rail was not fully accommodated by the recess of the right hand side stock rail. As a result the whole top edge of the tongue blade could be seen in plan view – see

photograph at Annex 6. This contributed to the accelerated wear of the tongue blade during the increased frequency of service over the turnout during the preceding weeks;

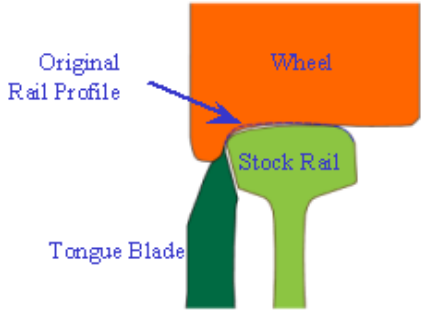
Figure 1  
At 50mm from the Toe of Tongue Rail

- (h) a Point Monitoring Report revealed that the width of the tongue blade of the right hand side switch rail, measured 50 mm from the tongue tip had reduced from 3.4 mm, when measured on 12 June 2002, to 2 mm when measured again on 26 October 2002. The thickness of the tongue blade at this point had thus reduced by 1.4 mm in four months, whereas the wear recorded over the previous six months had been only 0.2 mm. While a fast rate of localized wear had been noted, which triggered a special inspection on 9 November 2002, the Senior Supervisor involved considered the condition of the turnout to be acceptable. He so advised his superior, the Maintenance Officer, when the latter was made aware of the high level of wear. This was based on the fact that one of the maintenance standards laid down that the tongue blade should not require repair or replacement until the thickness fell to 1.5 mm. He did not anticipate any problem and no special follow up action was called for. The routine daily inspection by patrolmen continued without any special emphasis being made on the need to inspect the tip of this tongue blade much more carefully. The next scheduled measurement of the tongue blade thickness was in fact not due until two days after the incident took place;

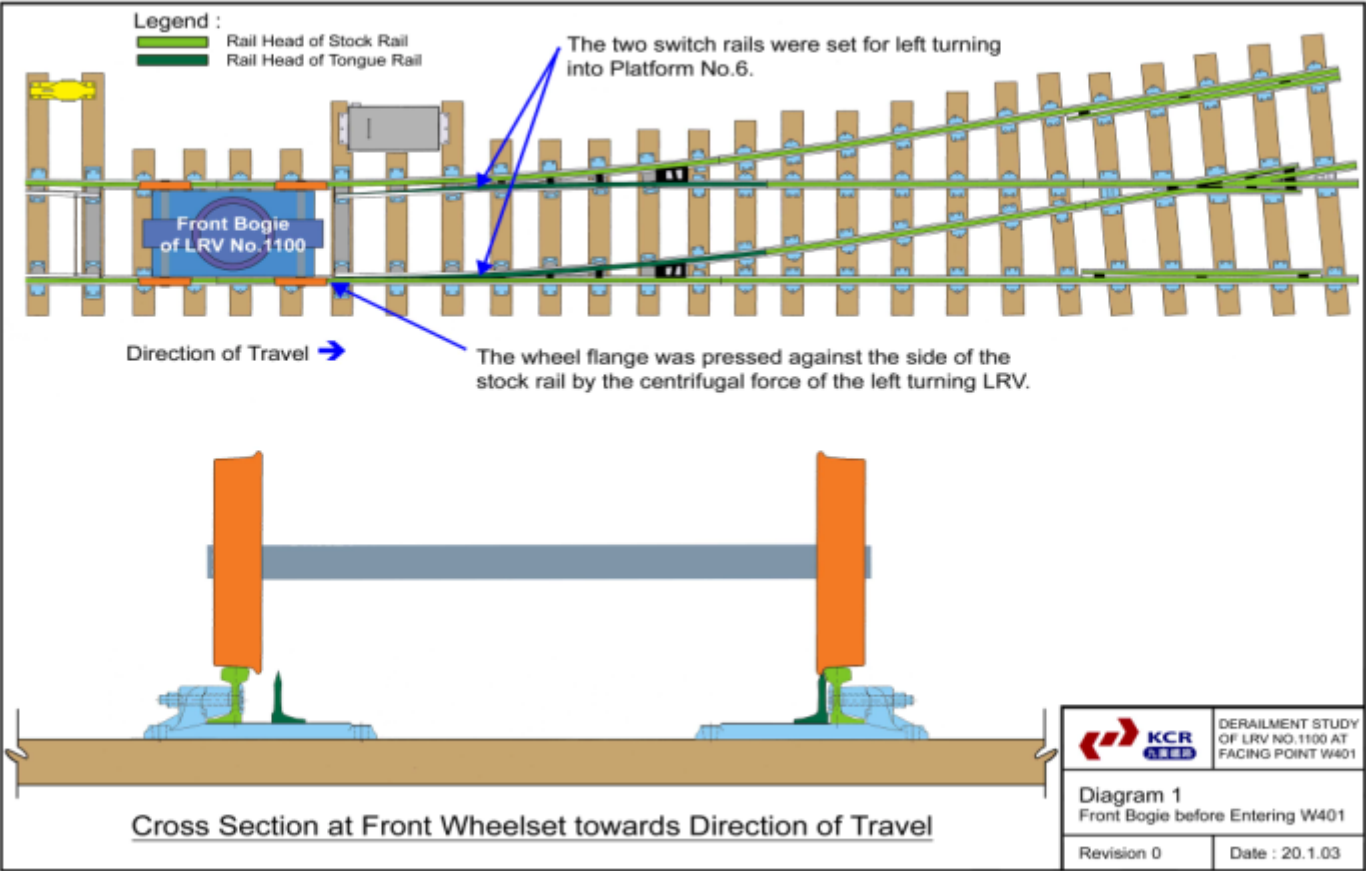
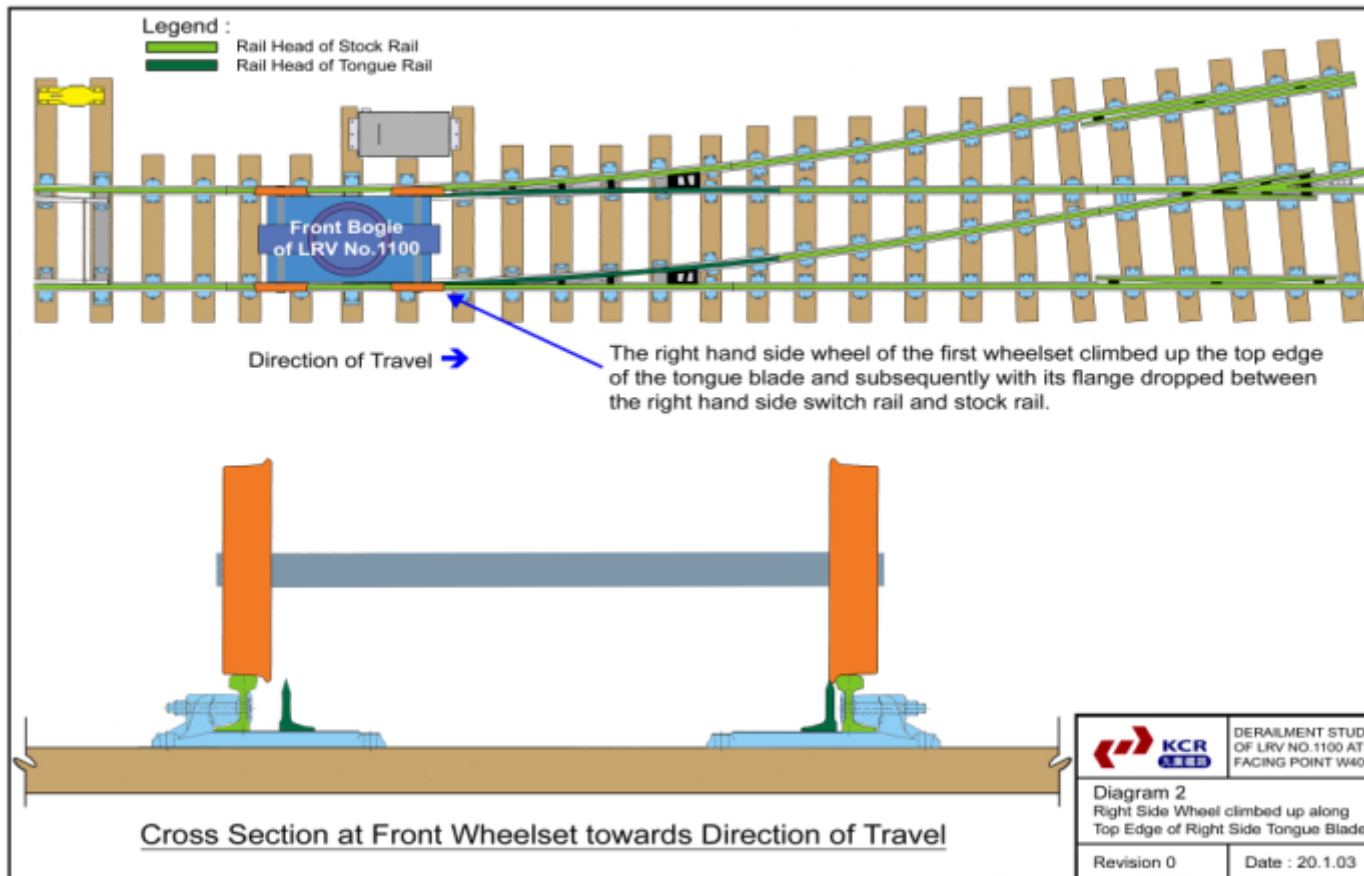
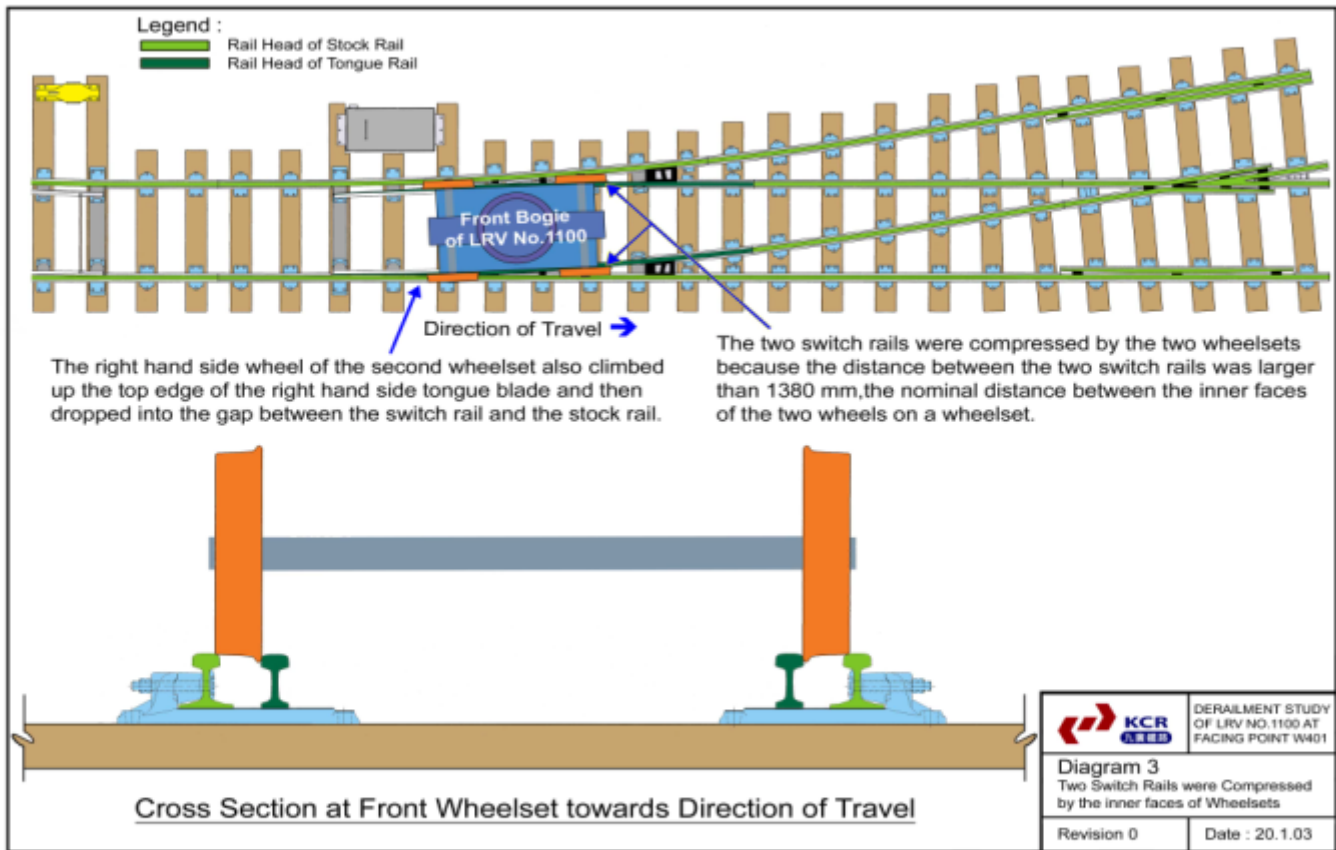
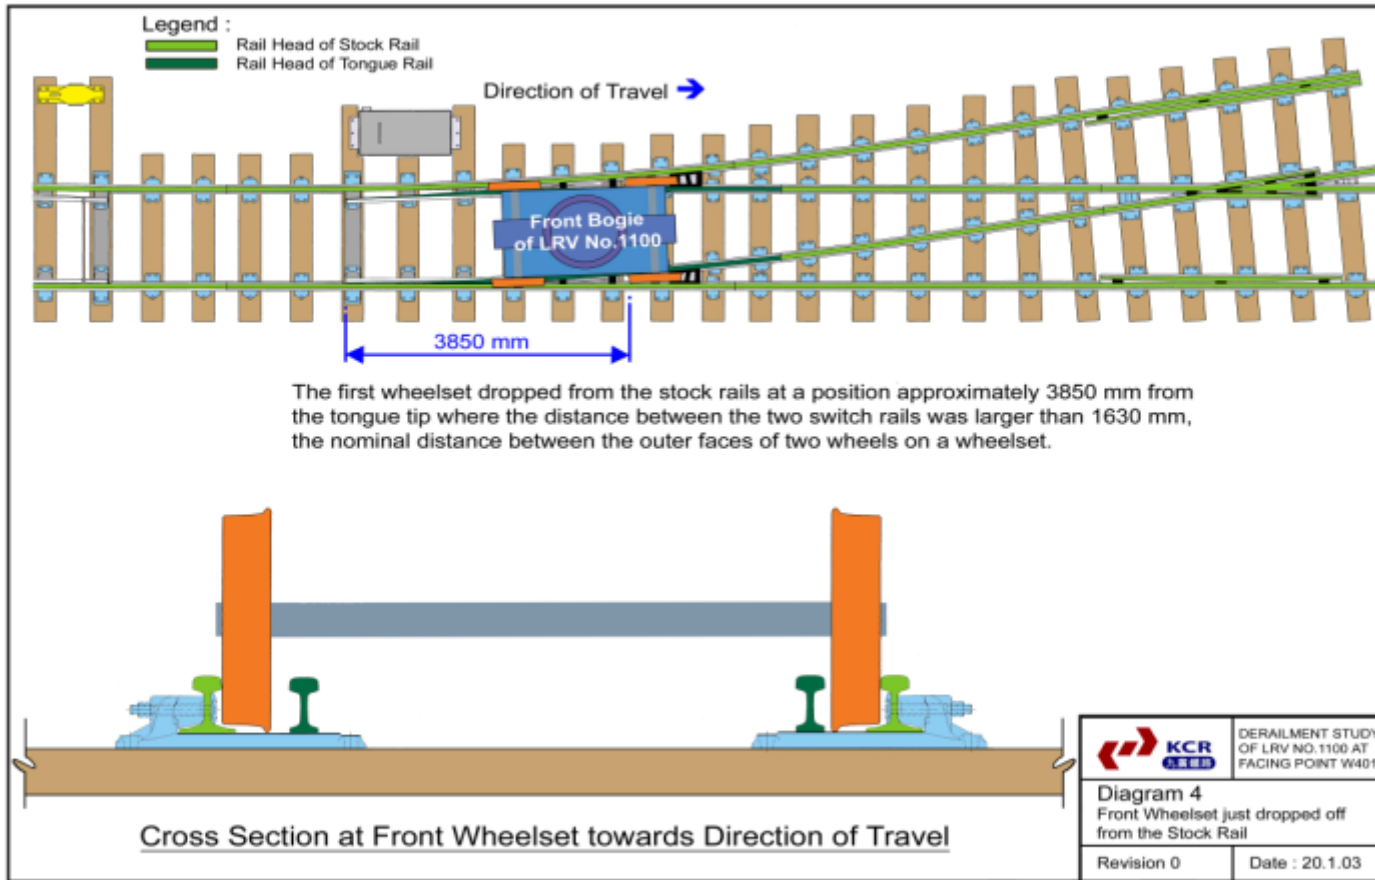
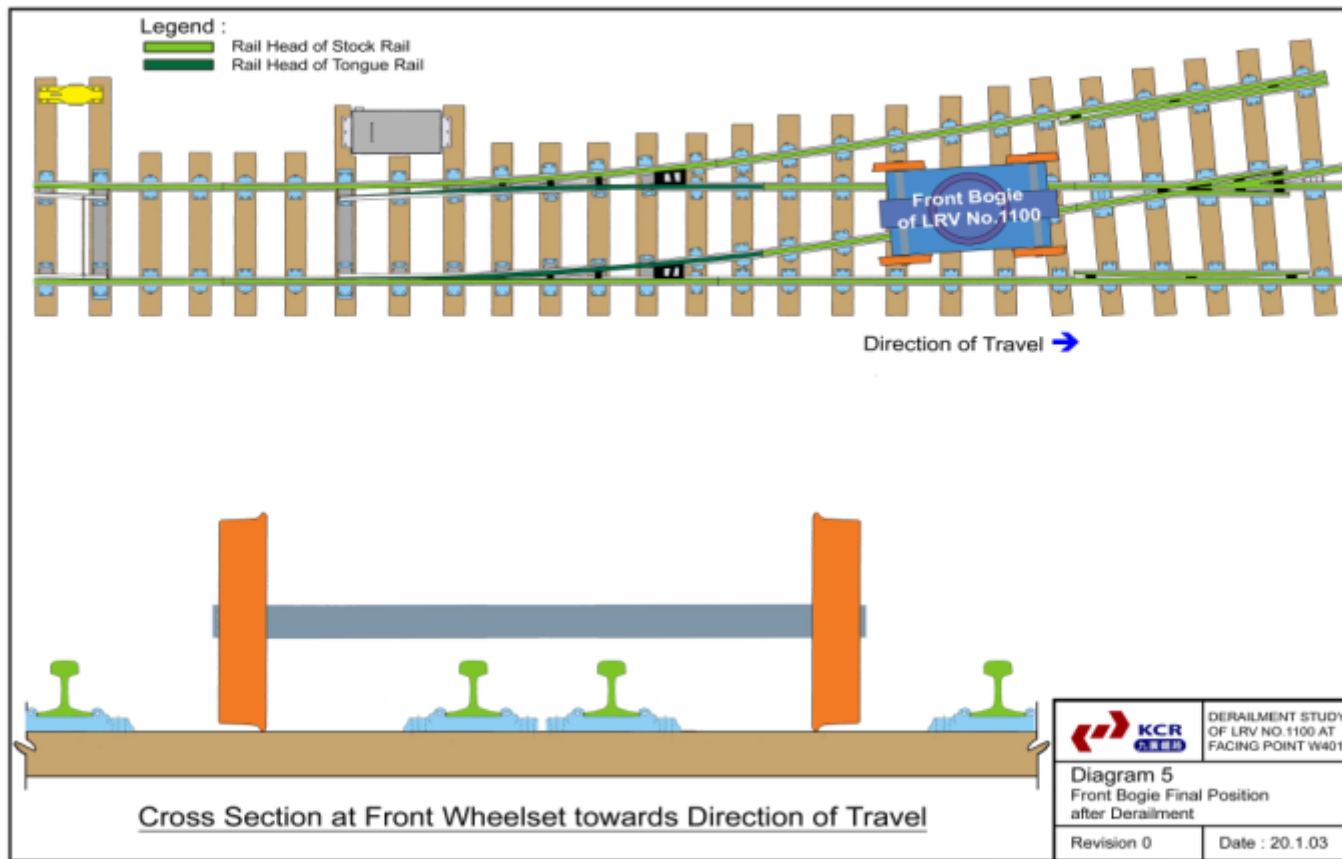
### How Derailment Occurred

16. These factors, it is believed, led to the eventual breakage of the top edge of the tongue blade by the right hand side wheels of the first bogie of LRV 1100, which was heavily laden at the time, thus derailing the vehicle.

17. The Committee concluded that, most probably, immediately prior to the derailment, the right hand side (when viewed in the direction of traffic) tongue blade of the W401 turnout was broken at the thin top edge over a length of approximately 70 mm commencing 50 mm from the tip of the tongue blade by the first right hand side wheel of LRV 1100 (see Annex 7). Then the wheel, under the centrifugal force of the left turning LRV, rolled over the worn-out groove and rough broken top edge of the tongue blade and derailed between the tongue blade and the stock rail of W401. The LRV then continued forward until the gear box of the first axle was trapped by the convergent roots of the left and right tongues of W401 (see Annex 8).
