立法會經濟事務委員會

昂坪纜車車廂墜下事件調查報告

Report from the Expert Panel
on the
Cabin Falling Incident
occurred on 11 June 2007
at the
Ngong Ping Ropeway

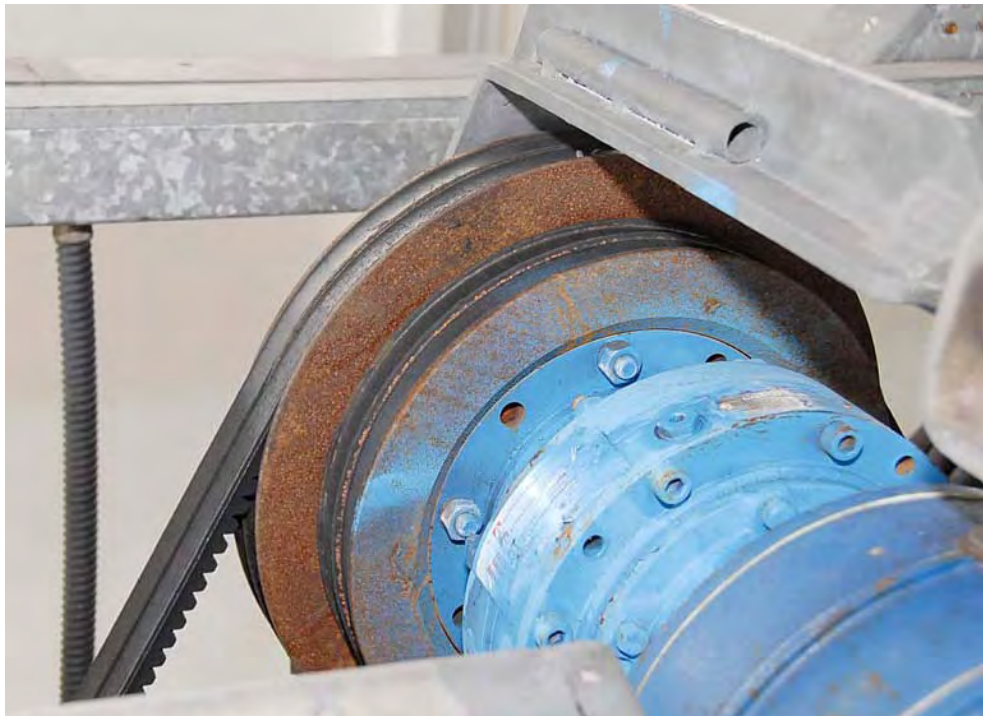
32. On the other hand, the Expert Panel noted that certain components of the ropeway system, including v-belt pulleys in stations, track ropes, and connection pins between hangers and the cabins showed signs of rusting which would not be expected for a system that was put into service for one year (figures 17, 18 and 19). Signs of rusting also existed on the spare parts inside the cabin storage area. Those components should be treated for corrosion protection, or replaced with better quality ones that are suitable for the humid environment of Hong Kong, especially in the north Lantau area.

Figure 17 – Close up view on the rusty v-belt pulley

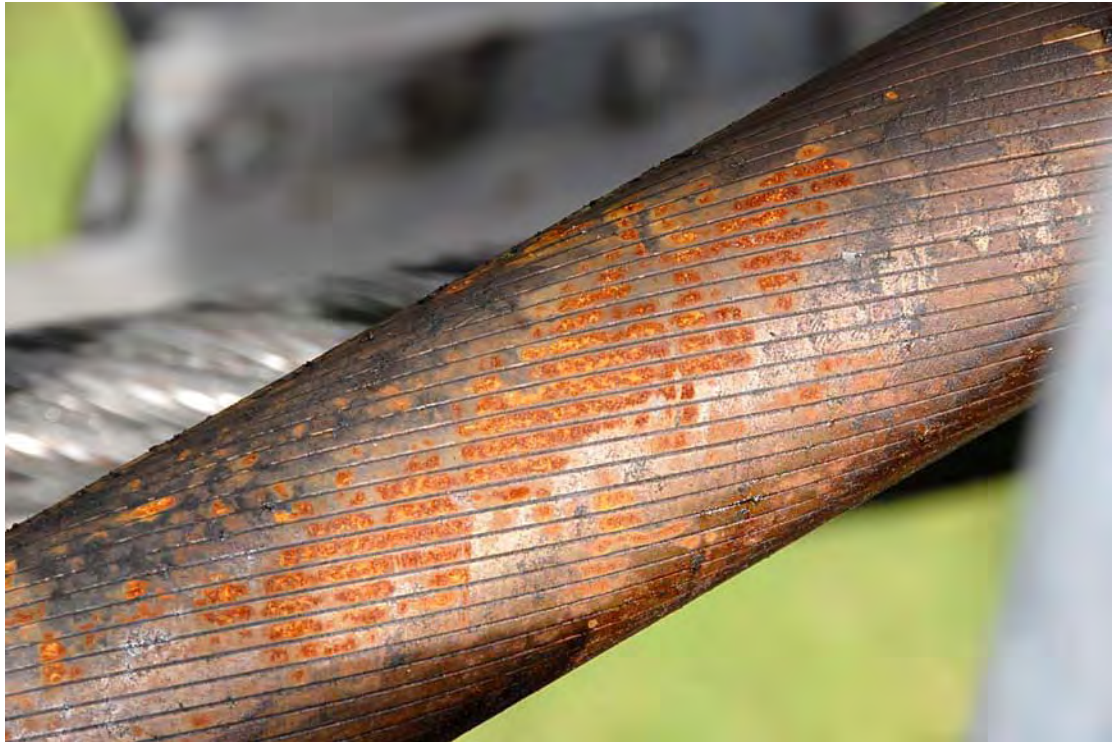
Figure 18 – Close up view on the track rope with rust

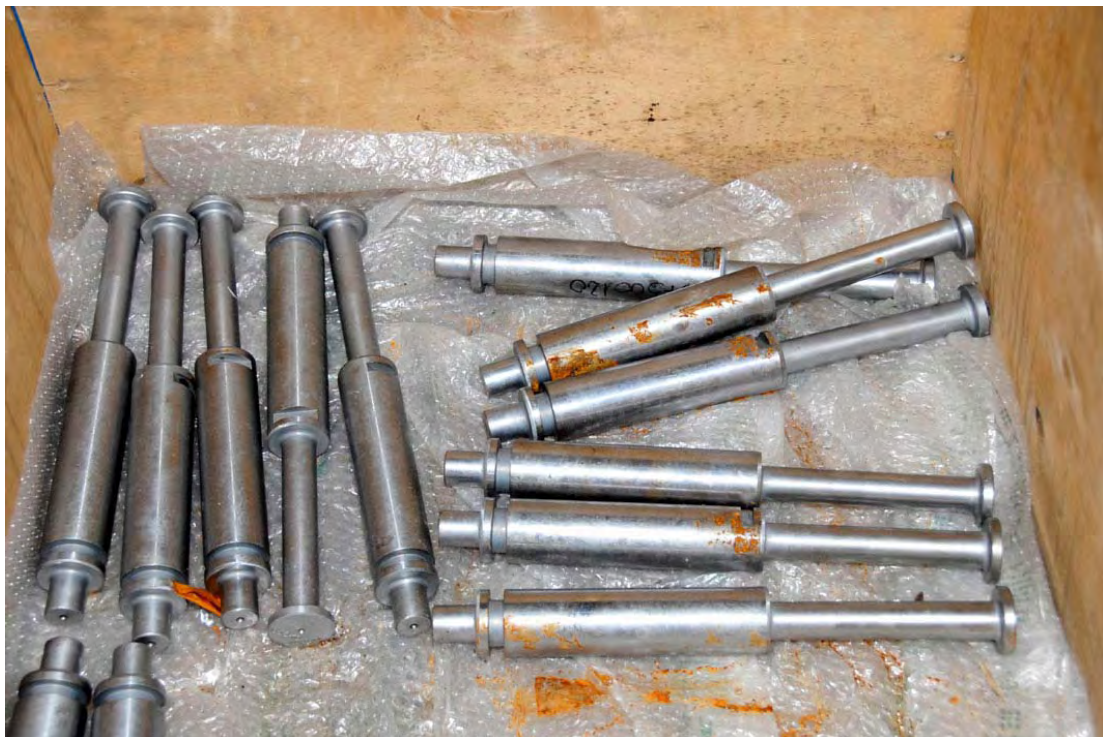
Figure 19 – Spare parts stored inside cabin storage area with sign of rust

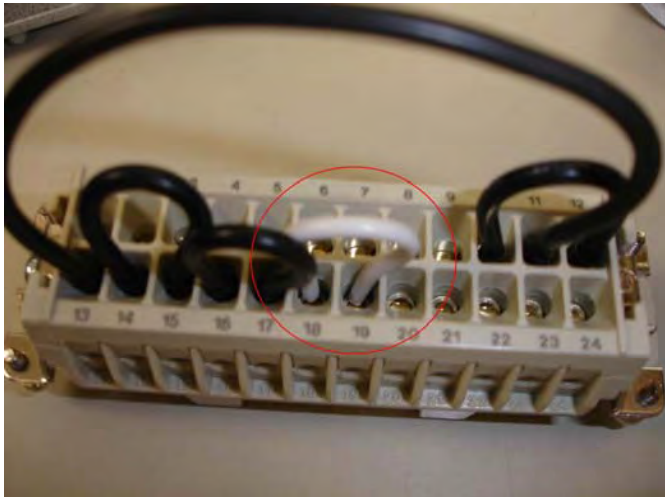
Ref. No.	Date & Duration of Service Disruption	Brief Description
OM1	30.9.06 51 minutes	<p>An incorrect control function plug was used at Tung Chung Terminal, leading to improper functioning of the control system which subsequently tripped the system operation.</p>

<p>Figure 20 - A jumper (in red circle) was found missing from the plug</p>
OM2	15.10.06 59 minutes	<p>The maintenance work conducted at night caused improper cabin spacing resulting in the ropeway system not ready for operation on time in the morning of 15.10.06.</p>

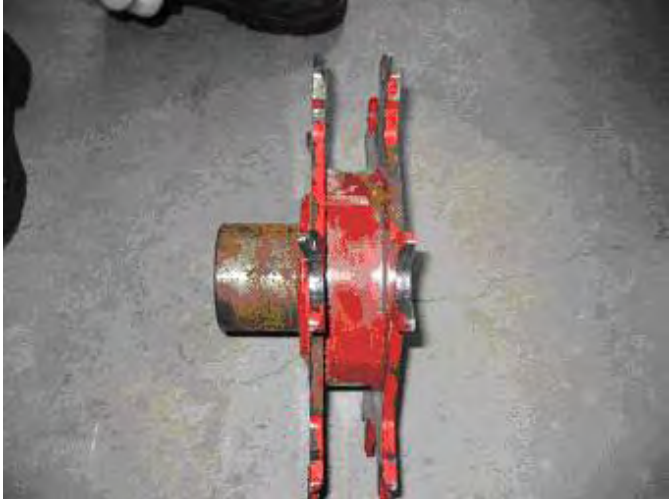
OM3	27.10.06 4 hours 20 minutes	<p>A drive sprocket in the cabin storage area was jammed and one of the teeth was damaged. There was no spare sprocket in stock, and therefore requiring repair of the damaged sprocket, leading to service interruption for over 4 hours.</p>

<p>Figure 21 - Drive sprocket with one of the teeth damaged</p>
OM4	28.11.06 23 minutes	<p>One of the friction belts was found loosen, causing improper cabins separation and resulting in tripping of the system. Frequency of checking and adjustment of belt tension was considered inadequate.</p>
OM5	1.1.07 1 hour 12 minutes	<p>A friction tyre deflated during operation, resulting in tripping of the system. Frequency of checking and maintaining the tyre pressure was considered inadequate.</p>

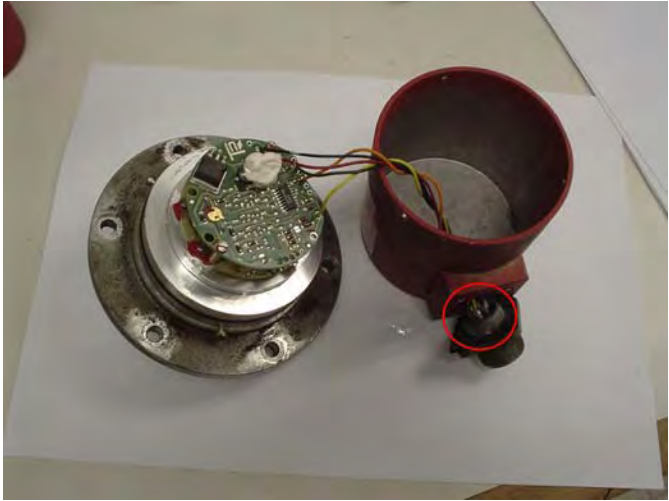
OM6	3.1.07 1 hour 18 minutes	<p>Water ingressed into an electronic encoder at Airport Island Angle Station, causing tripping of the system. Encoder electronics parts are not well insulated from moisture and dirt.</p>

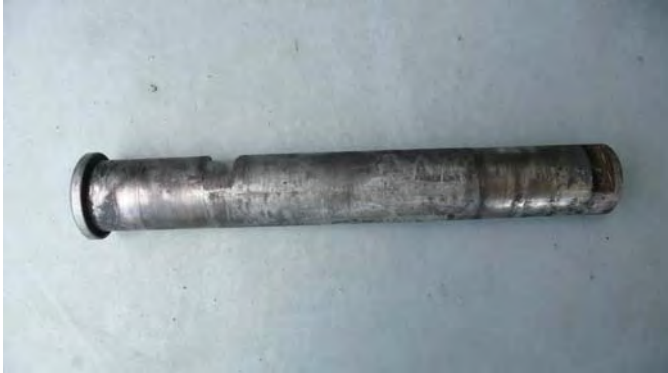
OM10	11.5.07 2 hours	<p>A spring-loaded damping roller was damaged during operation, resulting in tripping of the system. The shaft of the damping roller showed heavy surface abrasion, a sign of inadequate routine checks and maintenance.</p>

<p>Figure 23 - Close up view on the shaft with heavy surface abrasion</p>
OM11	11.6.07 from 19:52, 11.6.07 onwards

OM10	11.5.07	<ul style="list-style-type: none"> ● Check alignment and working condition of all spring-loaded damping rollers. * ● Ensure availability of enough stock for spring-loaded damping rollers. ● Regular apply lubrication and conduct inspection on the moving parts of the spring-loaded damping roller and other similar mechanisms.

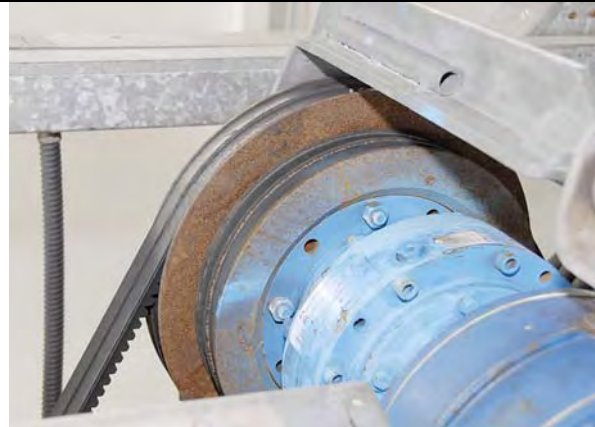
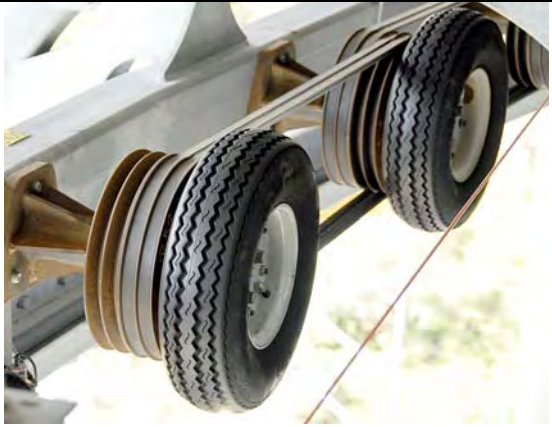
2.1 In the course of the survey it turned out that many construction units show indications of rust, which one does not expect with a so recent installation. Figures 1 to 11 show such construction units.

Fig. 1: Rusty V-belt pulleys at the driving motor of the conveyer systems	Fig. 2: Rusty V-belt pulleys at the conveyer systems

3.1 Rust protection should be generally improved.

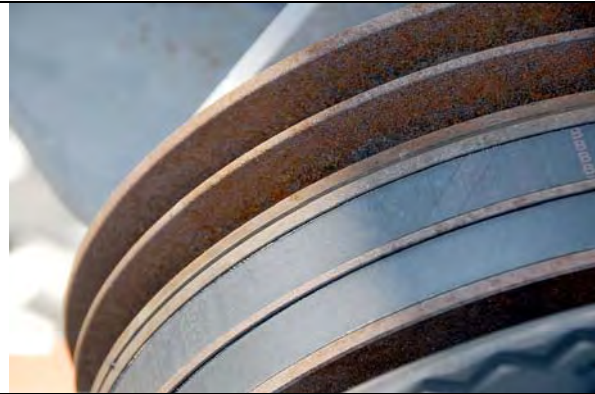
Fig. 3: Rusty V-belt pulleys at the conveyer systems (detail)

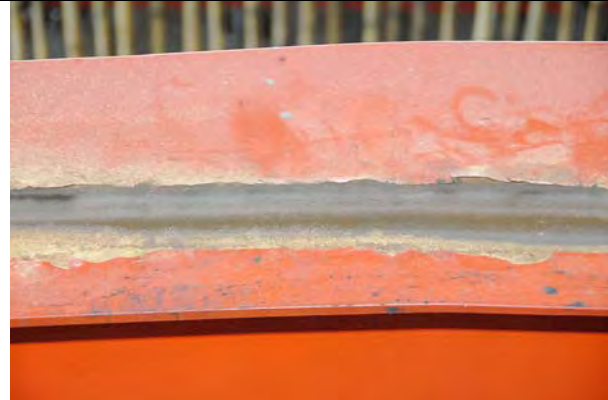
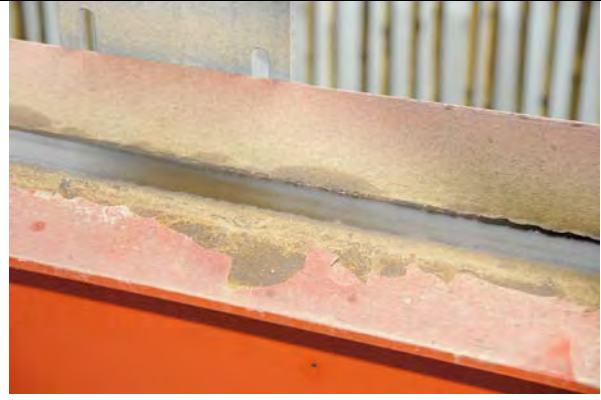
Fig. 4: Rust and peeling coat of paint at the coupling rails

Fig. 5: likewise

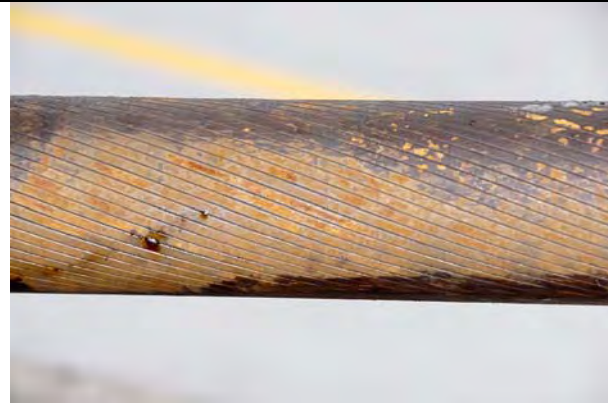
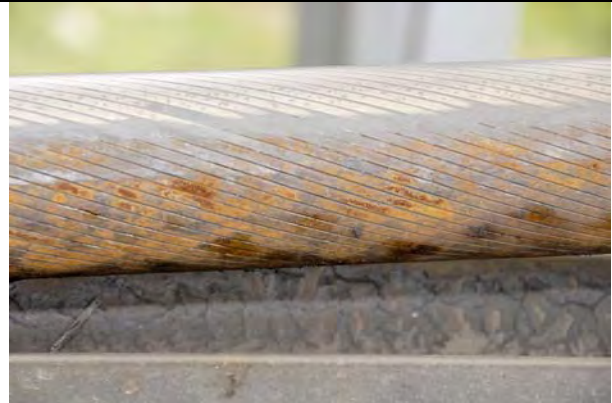
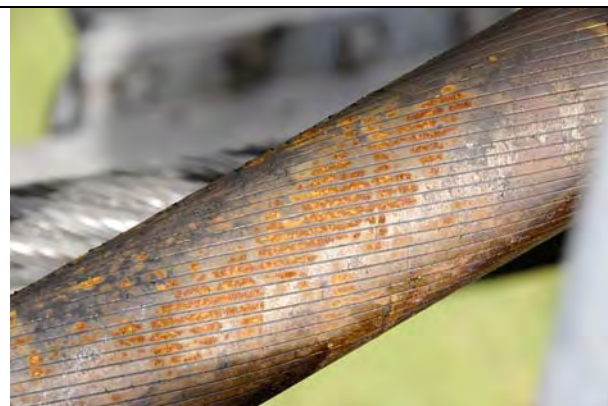
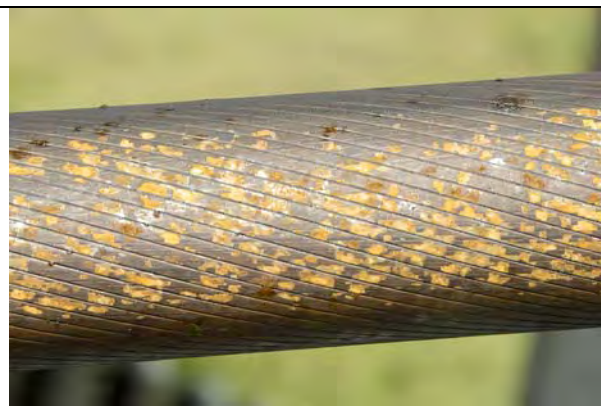
Fig. 6: Rust at the carrying rope within the range of Nei Lak Shan Angle Station

Fig. 7: likewise

Fig. 8: likewise

Fig. 9: likewise

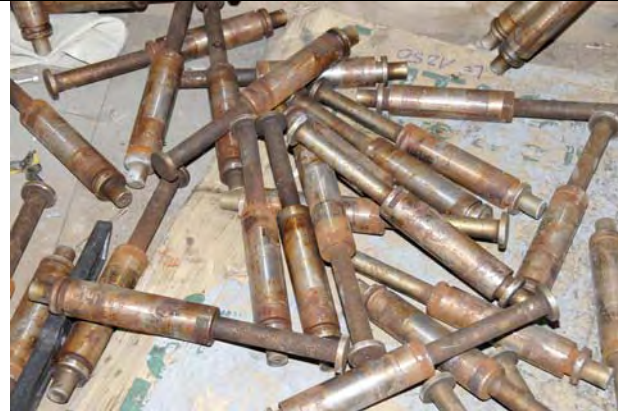
Fig. 10: Rusty axles of the connection of suspension and cabin

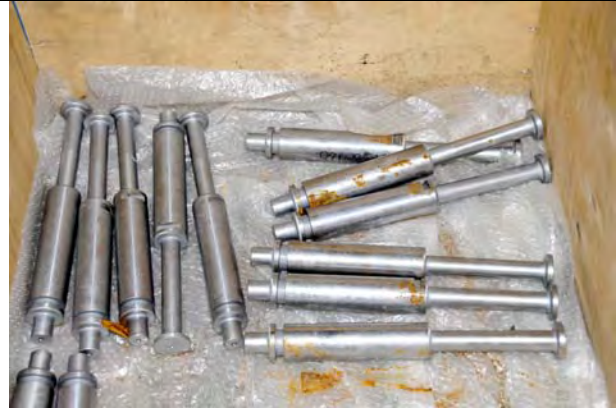
Fig. 11: Even the new axles of the connection of suspension and cabin show traces of rust.

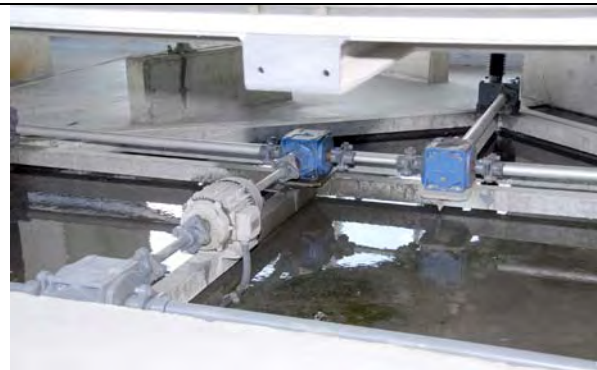
2.2 Within the range underneath the mobile platform in Tung Chung Terminal and Ngong Ping Terminal water was found, which can damage the drive of the mobile platform (electrical and mechanical parts under water). Figures 12 and 13 show that range underneath the platforms.

Fig. 12: Water within the range underneath the movable platform in Tung Chung Terminal

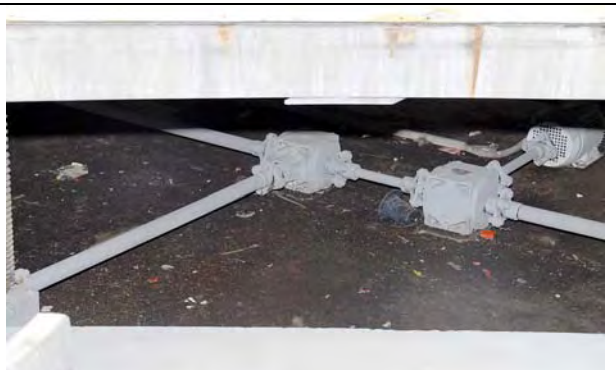
Fig. 13: Water within the range underneath the movable platform in Ngong Ping Terminal

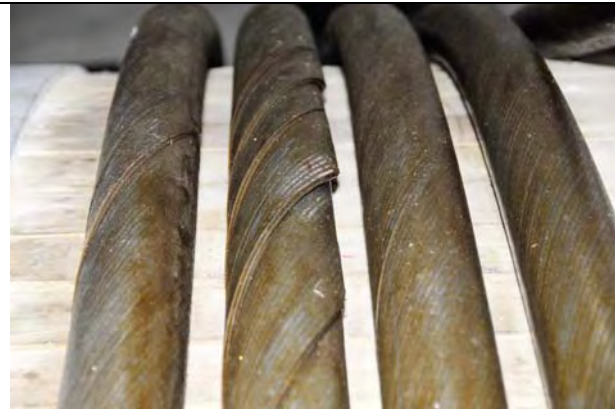
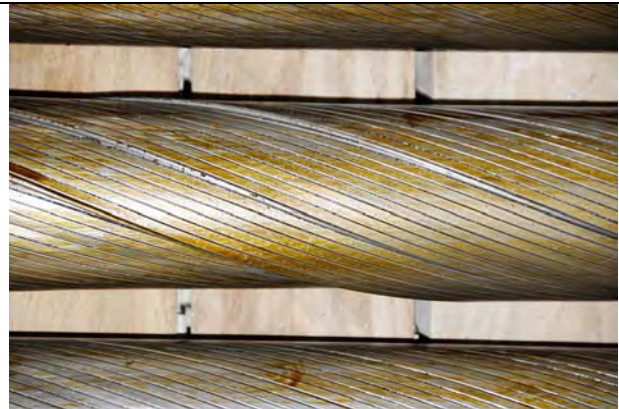
2.3 At some anchor drums the outer layer of z-wires of the carrying rope show structural problems (e. g. Fig. 14 and 15). As Prof. Oplatka has told me Fatzer (manufacturer of the ropes) already took care of the problem.

Fig. 14: Structural problems of the carrying ropes in the outer layer of z-wires

Fig. 15: likewise

3.3 It should be clarified whether the structural problems of the carrying ropes on some of the anchor drums may cause problems in the future (e. g. at the time of relocation of the carrying ropes).
