正常易辦事付款流程

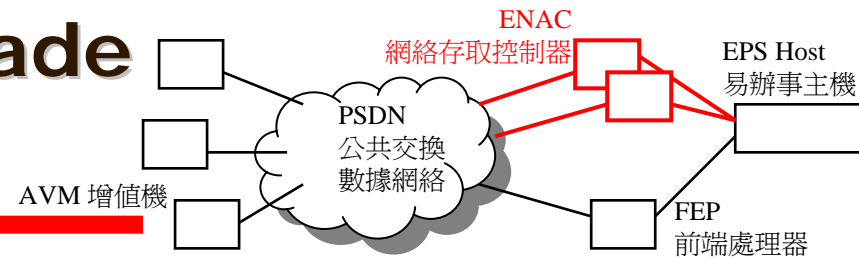
於2006年12月4日凌晨2點至5點期間進行更新。

純屬更換連接易辦事主機系統至公共交換數據網絡的設備。同時，網絡設備的實際擺放位置亦有更改。

是次網絡更新並未涉及地鐵及九鐵站八達通增值機的任何軟件或硬件更新。
