Legislative Council Panel on Economic Services

Report on Ngong Ping Skyrail Cabin Dislodgement Incident

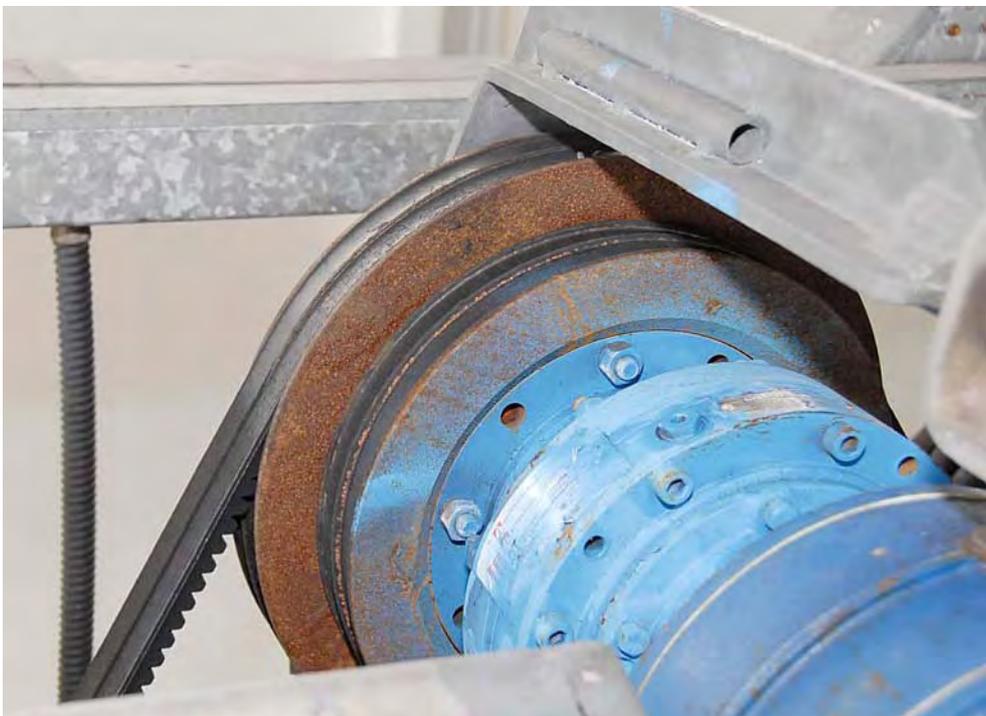
32. On the other hand, the Expert Panel noted that certain components of the ropeway system, including v-belt pulleys in stations, track ropes, and connection pins between hangers and the cabins showed signs of rusting which would not be expected for a system that was put into service for one year (figures 17, 18 and 19). Signs of rusting also existed on the spare parts inside the cabin storage area. Those components should be treated for corrosion protection, or replaced with better quality ones that are suitable for the humid environment of Hong Kong, especially in the north Lantau area.

Figure 17 – Close up view on the rusty v-belt pulley

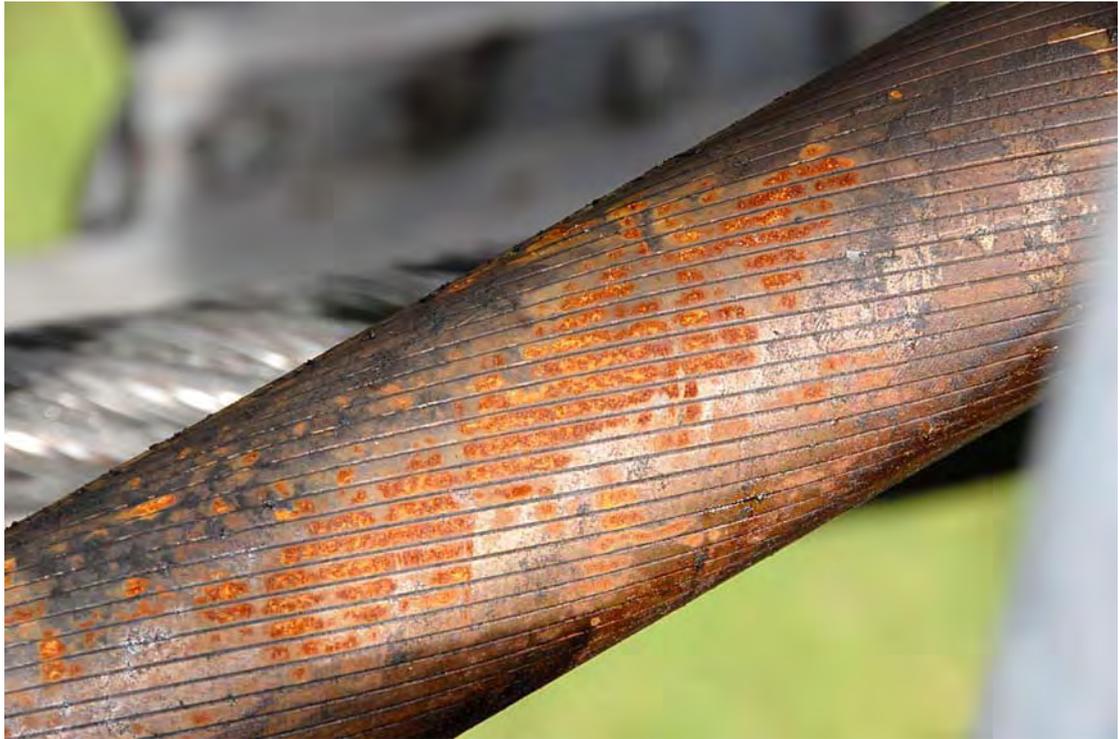
Figure 18 – Close up view on the track rope with rust

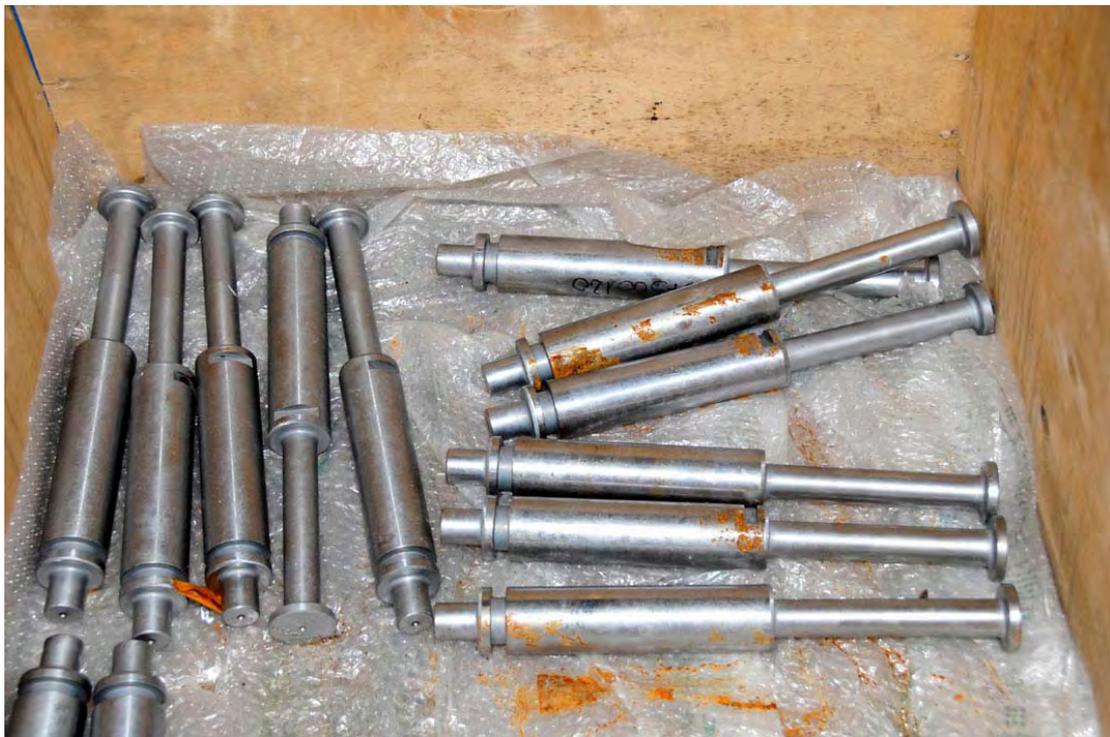
Figure 19 – Spare parts stored inside cabin storage area with sign of rust

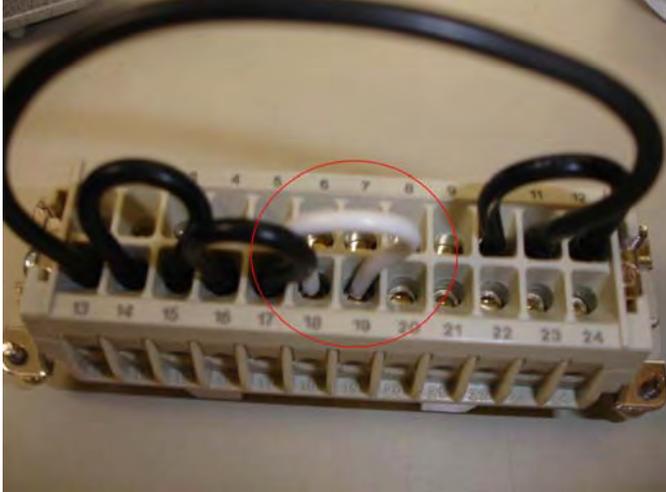
Ref. No.	Date & Duration of Service Disruption	Brief Description
OM1	30.9.06 51 minutes	<p data-bbox="639 779 1331 909">An incorrect control function plug was used at Tung Chung Terminal, leading to improper functioning of the control system which subsequently tripped the system operation.</p>

<p data-bbox="639 1496 1331 1576">Figure 20 - A jumper (in red circle) was found missing from the plug</p>
OM2	15.10.06 59 minutes	<p data-bbox="639 1641 1331 1771">The maintenance work conducted at night caused improper cabin spacing resulting in the ropeway system not ready for operation on time in the morning of 15.10.06.</p>

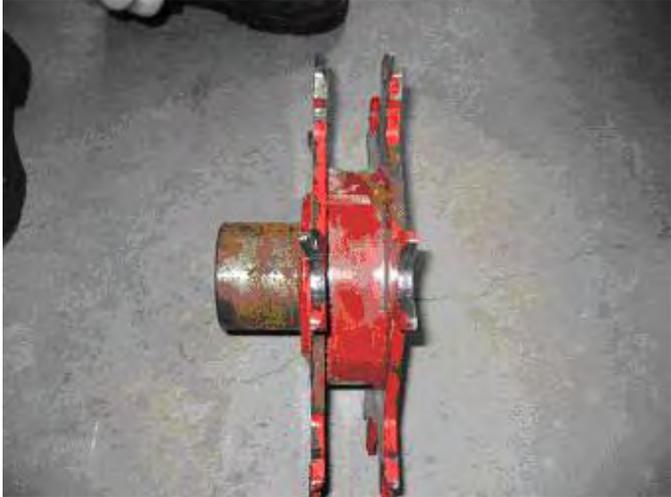
OM3	27.10.06 4 hours 20 minutes	<p>A drive sprocket in the cabin storage area was jammed and one of the teeth was damaged. There was no spare sprocket in stock, and therefore requiring repair of the damaged sprocket, leading to service interruption for over 4 hours.</p>

<p>Figure 21 - Drive sprocket with one of the teeth damaged</p>
OM4	28.11.06 23 minutes	<p>One of the friction belts was found loosen, causing improper cabins separation and resulting in tripping of the system. Frequency of checking and adjustment of belt tension was considered inadequate.</p>
OM5	1.1.07 1 hour 12 minutes	<p>A friction tyre deflated during operation, resulting in tripping of the system. Frequency of checking and maintaining the tyre pressure was considered inadequate.</p>

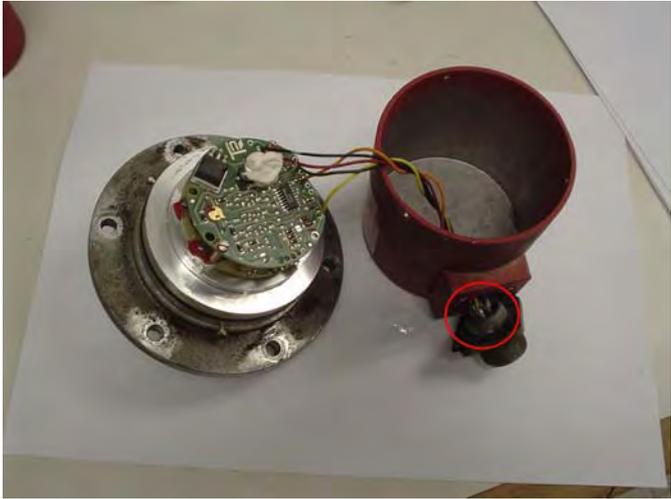
OM6	3.1.07 1 hour 18 minutes	<p>Water ingressed into an electronic encoder at Airport Island Angle Station, causing tripping of the system. Encoder electronics parts are not well insulated from moisture and dirt.</p>

<p>Figure 22 - Malfunctioned encoder with position where water and oil like dirt found was circled in red</p>
OM7	17.1.07 6 hours 20 minutes	<p>Dirty station rollers trapped moisture, resulting in “grounding fault” warning signal and tripping of the system. Checking and cleansing of station rollers was considered inadequate.</p>
OM8	7.2.07 26 minutes	<p>One of the friction belts was found loosen, causing slippage in the belt drive and resulting in tripping of the system. Frequency of checking and adjustment of belt tension was considered inadequate.</p>
OM9	9.4.07 51 minutes	<p>One of the friction belts was found loosen, causing slippage in the belt drive and resulting in tripping of the system. While adjusting the belt tension, the maintenance technicians over-tightened an adjustment bolt thus causing damage to the bolt threads. Subsequent replacement of the tensioning bolt caused extended service interruption.</p>

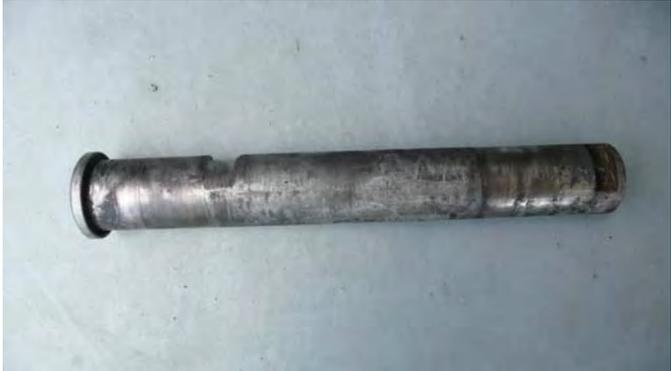
OM10	11.5.07 2 hours	<p>A spring-loaded damping roller was damaged during operation, resulting in tripping of the system. The shaft of the damping roller showed heavy surface abrasion, a sign of inadequate routine checks and maintenance.</p>

<p>Figure 23 - Close up view on the shaft with heavy surface abrasion</p>
OM11	11.6.07 from 19:52, 11.6.07 onwards

OM10	11.5.07	<ul style="list-style-type: none"> ● Check alignment and working condition of all spring-loaded damping rollers. * ● Ensure availability of enough stock for spring-loaded damping rollers. ● Regular apply lubrication and conduct inspection on the moving parts of the spring-loaded damping roller and other similar mechanisms.

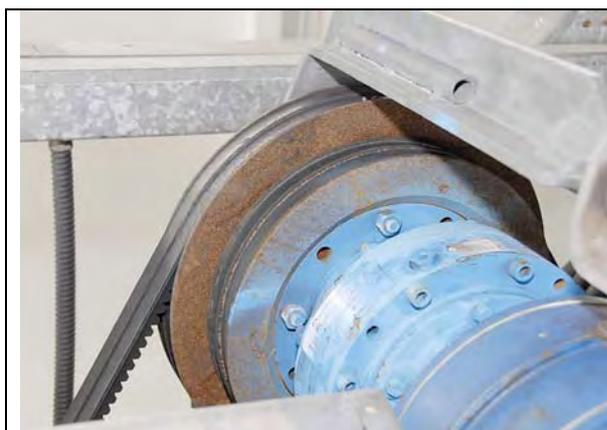
2.1 In the course of the survey it turned out that many construction units show indications of rust, which one does not expect with a so recent installation. Figures 1 to 11 show such construction units.

Fig. 1: Rusty V-belt pulleys at the driving motor of the conveyer systems

3.1 Rust protection should be generally improved.

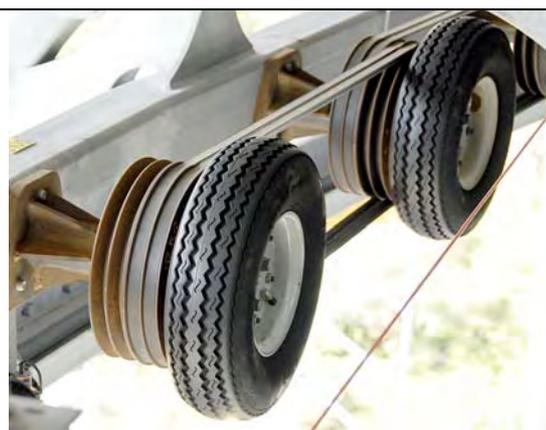
Fig. 2: Rusty V-belt pulleys at the conveyer systems

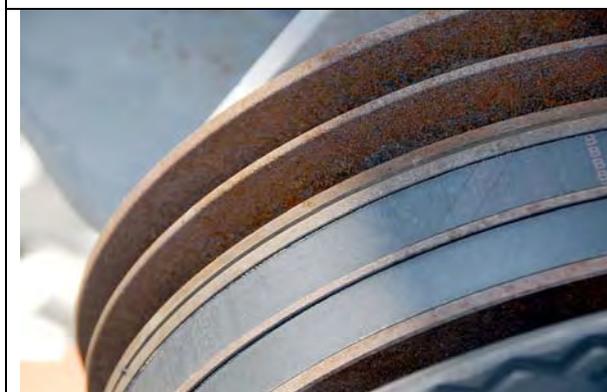
Fig. 3: Rusty V-belt pulleys at the conveyer systems (detail)

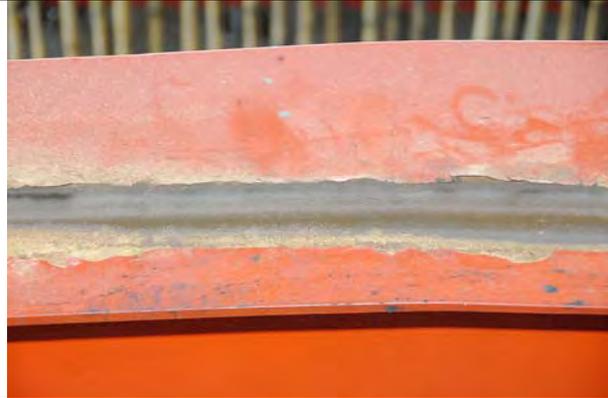
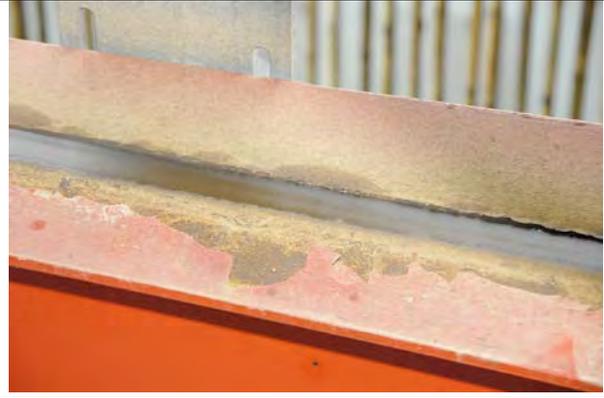
Fig. 4: Rust and peeling coat of paint at the coupling rails

Fig. 5: likewise

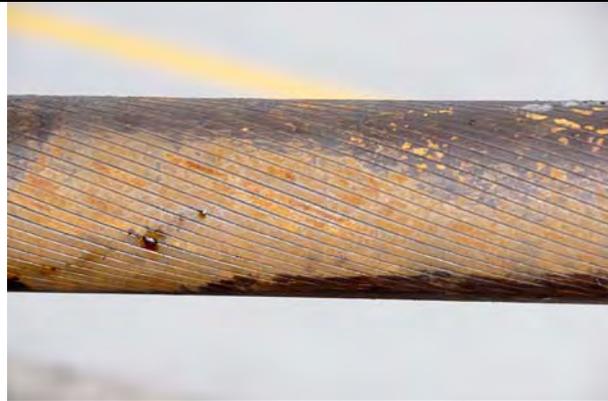
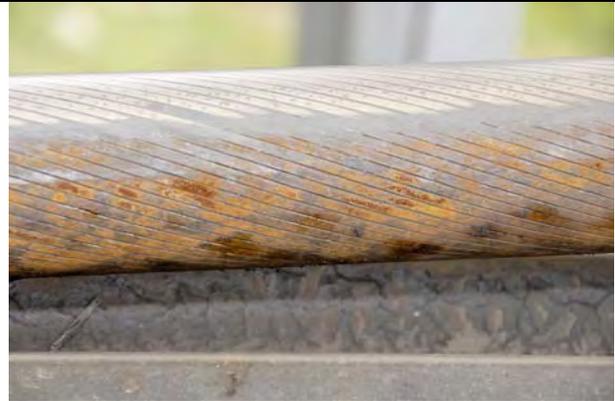
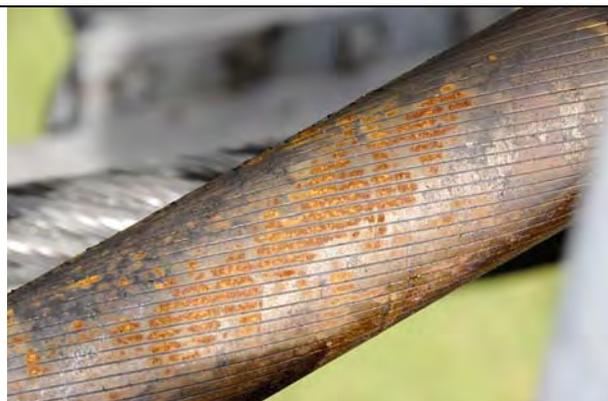
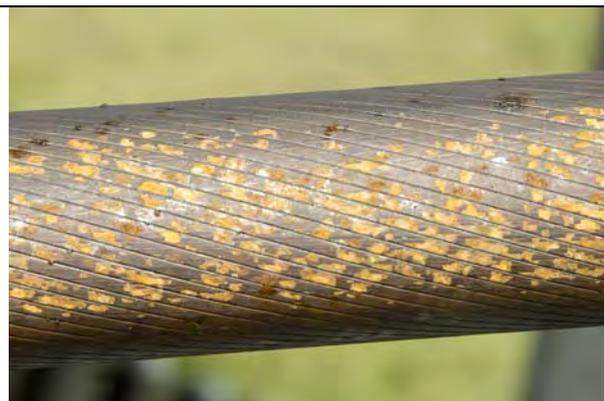
Fig. 6: Rust at the carrying rope within the range of Nei Lak Shan Angle Station

Fig. 7: likewise

Fig. 8: likewise

Fig. 9: likewise

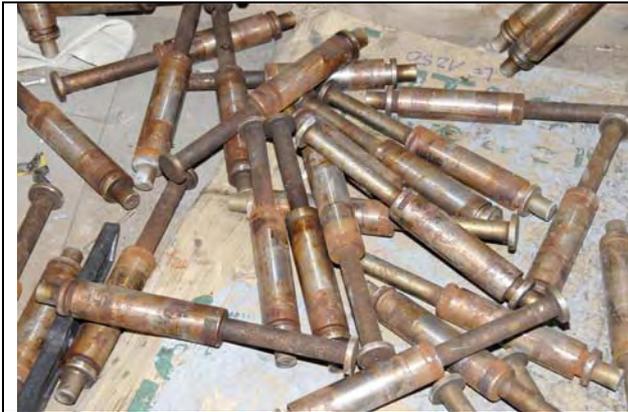
Fig. 10: Rusty axles of the connection of suspension and cabin

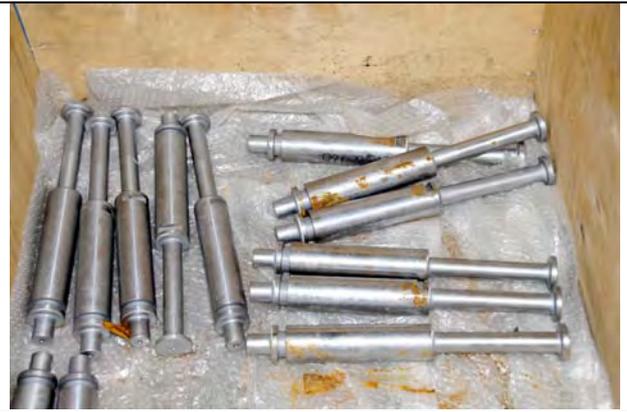
Fig. 11: Even the new axles of the connection of suspension and cabin show traces of rust.

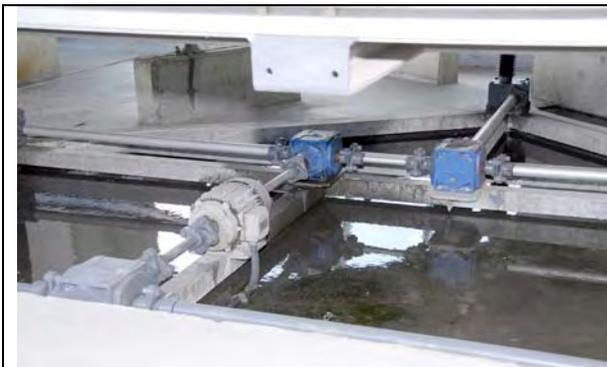
2.2 Within the range underneath the mobile platform in Tung Chung Terminal and Ngong Ping Terminal water was found, which can damage the drive of the mobile platform (electrical and mechanical parts under water). Figures 12 and 13 show that range underneath the platforms.

Fig. 12: Water within the range underneath the movable platform in Tung Chung Terminal

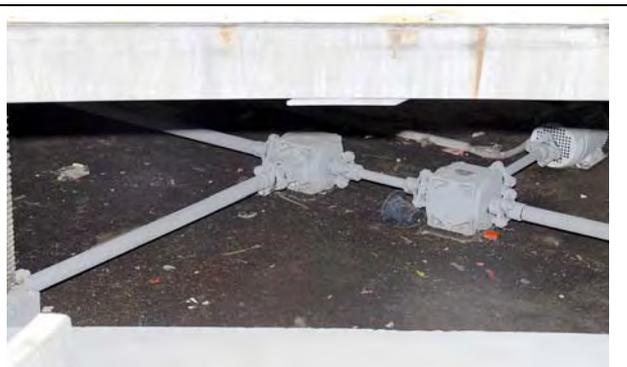
Fig. 13: Water within the range underneath the movable platform in Ngong Ping Terminal

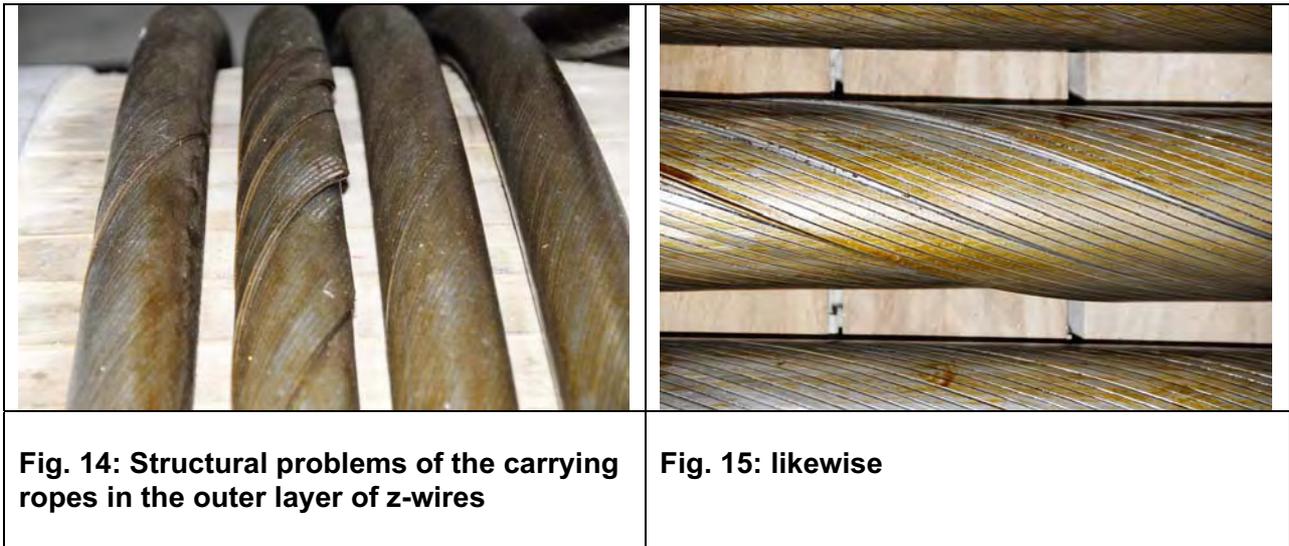
2.3 At some anchor drums the outer layer of z-wires of the carrying rope show structural problems (e. g. Fig. 14 and 15). As Prof. Oplatka has told me Fatzer (manufacturer of the ropes) already took care of the problem.

3.3 It should be clarified whether the structural problems of the carrying ropes on some of the anchor drums may cause problems in the future (e. g. at the time of relocation of the carrying ropes).
