**Legislative Council**

**Panel on Development**

**DEFORMATION OF ROAD SURFACES ON BRIDGES**

## Deformation of Road Surfaces on Bridges

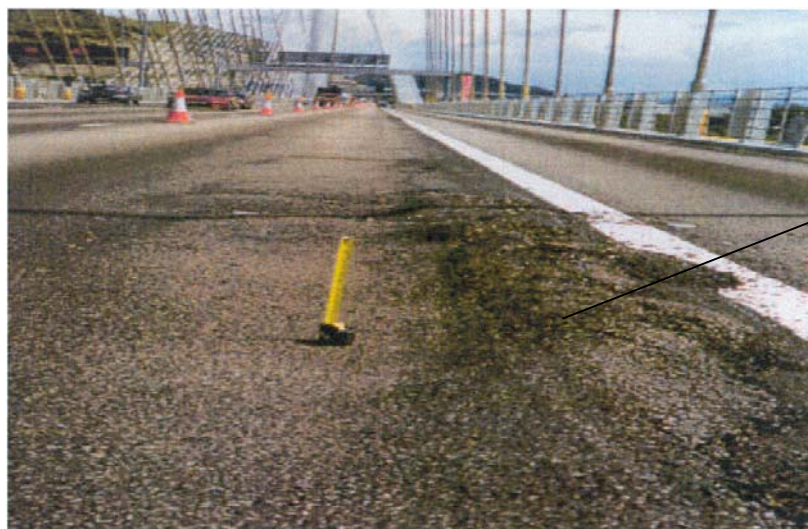
5. At the time when the above four bridges were designed, a liquid applied type of polymer waterproofing membrane was widely used in the United Kingdom and Europe. Compared with other types of waterproofing membrane, this type of membrane was considered to have better waterproofing ability. It was sprayed on the surface of the concrete deck after applying a layer of primer. A layer of tack coat was then applied to provide adhesion between the membrane and the asphalt surfacing above. The four bridges adopted this design. However, deformations at parts of the asphalt surfacing occurred shortly after the bridges were put to use. Figure 2 in the Appendix shows a typical premature deformation of asphalt surfacing at the TKB.

29. It is concluded that the predominant factor leading to premature deformation at the four bridges was local damage to the tack coat and loss of adhesion to the waterproofing membrane. The asphalt surfacing moved and cracked under traffic loading at these locations, and allowed water to seep through and accumulate in the asphalt surfacing to cause further deterioration. The situation was exacerbated at the TKB due to the heavy traffic loading and relatively thinner surfacing.

Premature deformation

Figure 2 – Premature deformation of asphalt surfacing at Ting Kau Bridge

exposed was inspected and loosened parts were replaced. In order to minimise the disruption to traffic and to re-open the traffic lanes as soon as possible, a bituminous waterproofing system that required a shorter construction period was adopted to replace the loosened waterproofing membrane. Where the membrane remained intact, a tack coat with improved adhesion properties was applied before resurfacing. Opportunity was also taken to increase the thickness of the TKB asphalt surfacing, taking into consideration the findings of the HKU study.

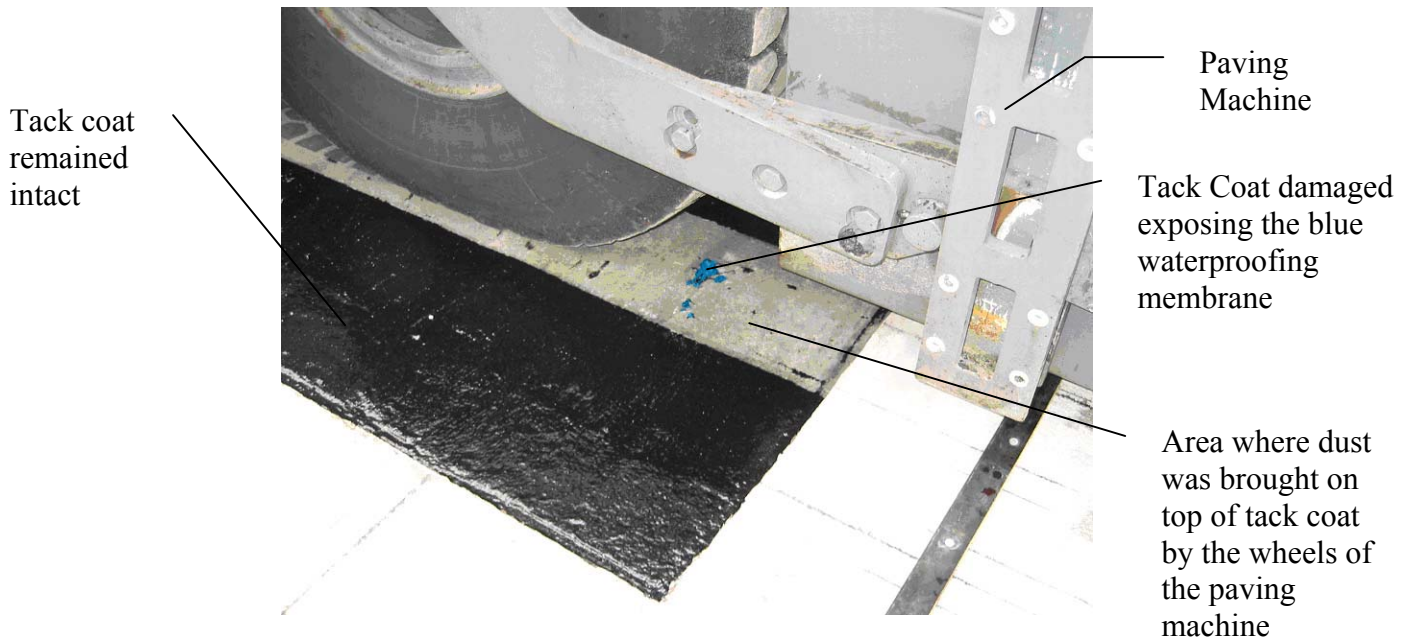
- e. Contamination and damage to the tack coat on top of the waterproofing membrane during the laying of asphalt surfacing for sample preparation was observed at some locations, and the damaged samples had extremely low adhesion strengths. Damage to the tack coat by construction plant is an inherent weakness in the traditional construction method used to lay the asphalt surfacing at the time. In comparison, for asphalt surfacing laid directly on top of concrete, the concrete surface is rougher and can absorb some asphalt, resulting in higher adhesion strengths even without a tack coat. Therefore similar damages to the tack coat will not cause premature failure of road surfacings on concrete bridge decks without waterproofing membranes. Figure 3 in the Appendix shows the damage on tack coat during sample preparation.

Figure 3 – Damage on tack coat during sample preparation for laboratory testing. The area under the wheel of the paving machine show that the tack coat had been contaminated by dust brought by the wheels of the paving machine. The blue spots show that the tack coat had been damaged and the blue waterproofing membrane was exposed.

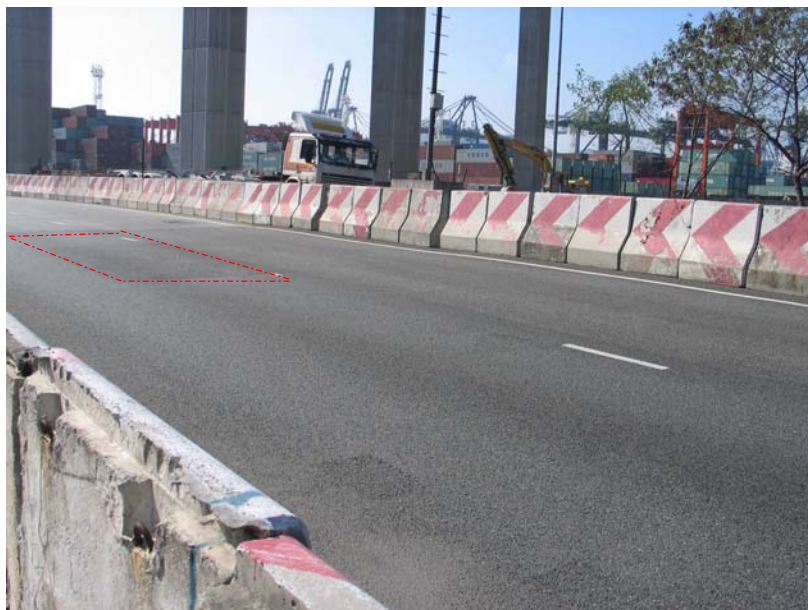
19. All the trial panels were monitored continuously for 12 months to assess their in-situ performance over seasonal weather variation. No deformation was observed during the period, except for one panel under the NSCV contract that had the thinnest asphalt surfacing of 50 mm, as shown in Figure 6 in the Appendix.

Figure 6 – Conditions of trial panels of waterproofing systems under the Ngong Shuen Chau Viaduct Contract. The red dotted line shows the repaired area of deformation that occurred at the thinnest panel of 50mm thick.
