Panel on Transport
Investigation Reports on the Bus Fire/Smoke Incidents
on 10 December 2008

Re: Bus Fire Incident of HB5201 (Fleet No.: 735) at Stubbs Road

Re: Investigation Report on The Fire Incident Involving MJ6852

Re: Bus Smoke Incident of GX8298 (Fleet No.: 924) at Cotton Road

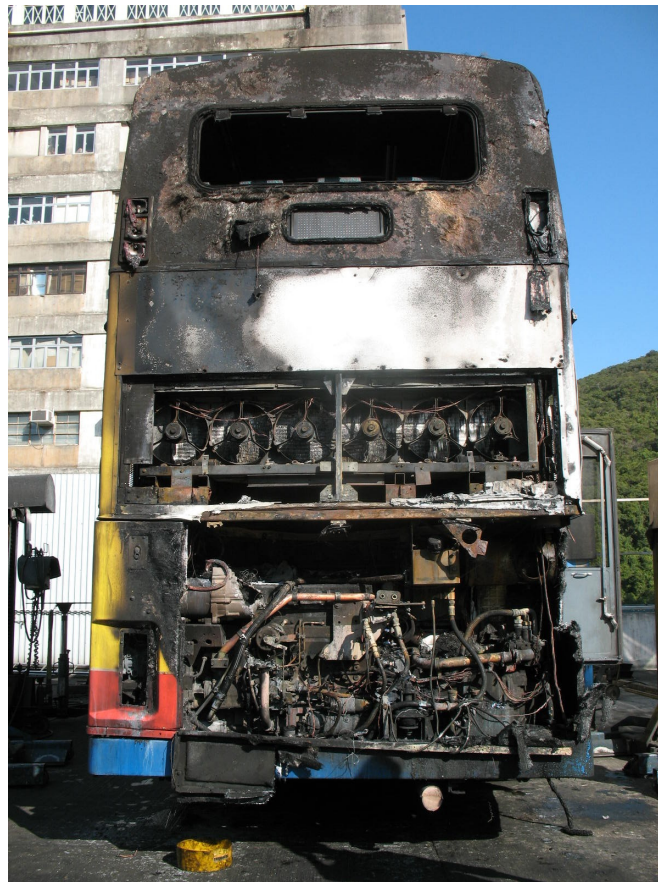
Physical Damage : The bus rear body was burnt by the fire. Some air conducts inside the bus compartment were also blackened and damaged. Most components inside the engine compartment were burnt seriously.

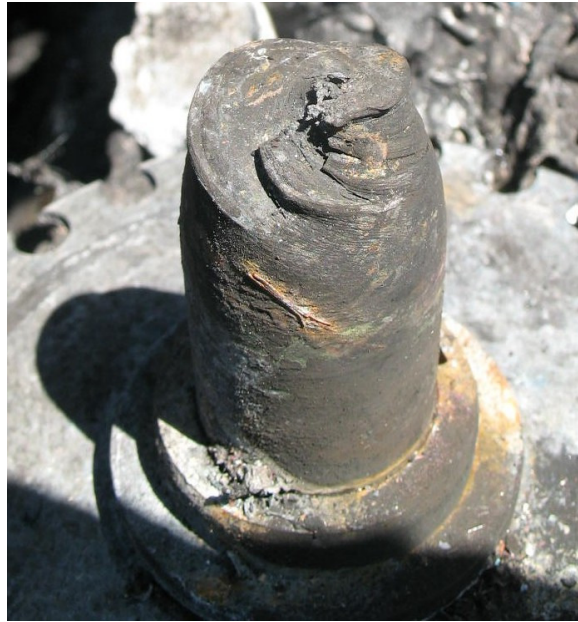
: The alternator of the Cummins L10 engine is first dismantled and every component is carefully examined. We note that the rotor shaft was twisted off in a ductile manner.

A steel shaft will only twist off in a ductile manner under extremely high temperature when the material is softened.

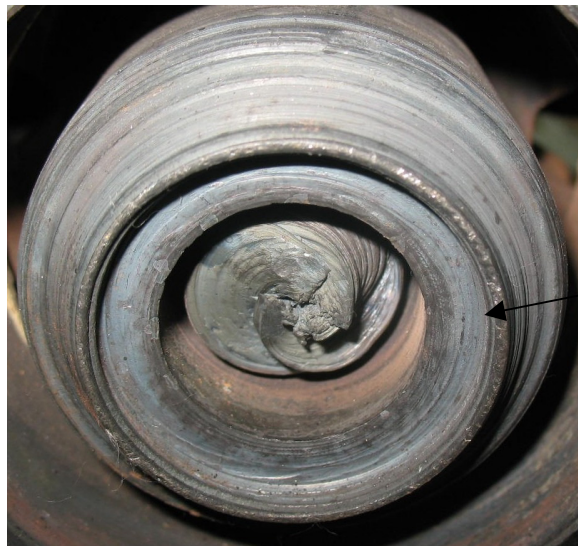
Circular surface

The other end of the twisted off shaft provides a clue of high temperature. The circular surface as indicated on the photo above is found with severe rubbing marks. For some reasons that will be elaborated below, we believe that the front-end bearing was running under uneven loading shortly before the incident. Metal particles were peeled off from the bearing cages and dropped in between the circular

surface and the bottom of the field coil. Normally, there is a clearance of a few millimetres between the two surfaces. Because of the rubbing with metal particles, intense temperature was developed.

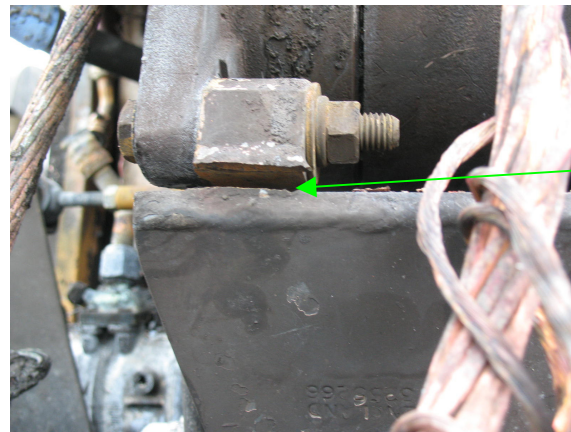
Support leg broken

The next question is why the front-end bearing of the alternator had been rotating with uneven loading. We examine the mounting bracket of the alternator and note that one of the two support legs is broken.

It is likely that sometime before the incident, the support leg had cracked apart. The alternator was misaligned slightly and the rotor thus ran under uneven loading, leading to the eventual twisting off of the rotor shaft.

- All alternator brackets of Cummins L10 engines of our fleet will be checked and the exercise will complete in one week the latest.
- All cracked brackets found will be repaired or replaced as necessary.

In the long term, we opine that the alternator bracket may be prone to cracks and will seek advice from the appropriate vehicle or equipment manufacture to modify the design to stronger supporting legs.

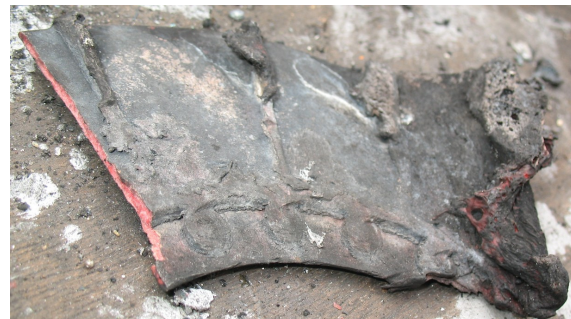
We suspect that the first fire flame is a result of tiny hot metal particles, i.e. sparks, flying out from the alternator through its cooling fan, descending on the surrounding wirings and oil hoses, and igniting them. Those sparks were produced from the severe rubbing mentioned above. This hypothesis is supported by the fact that many fan blades of the alternator's cooling fan were melted away and those remaining salvages are covered with terrible score marks.

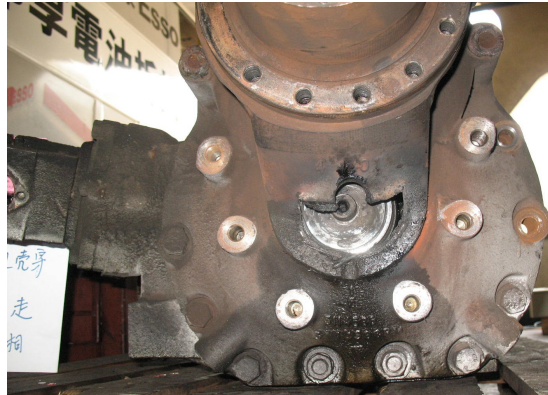
Physical Damage : The only physical damage is that the rear axle casing is broken.

Cause of Incident : It is suspected that the differential gears may have some teeth broken leading to consequential damage of the rear axle casing.

Oil mist was emitted through the broken casing hole and appeared like heavy white smoke.

Nevertheless, we will conduct a fleet check of all Volvo Olympian MKII buses and identify any oil leakage from the rear axle. All problematic rear axles will be repaired or replaced accordingly. It is expected that the exercise will complete in one week. Finally, all depots have been asked to reinforce inspection in this area during regular maintenance.
