Legislative Council Panel on Transport

Report on Traffic Accident on Mong Kok Road on 12 June 2009

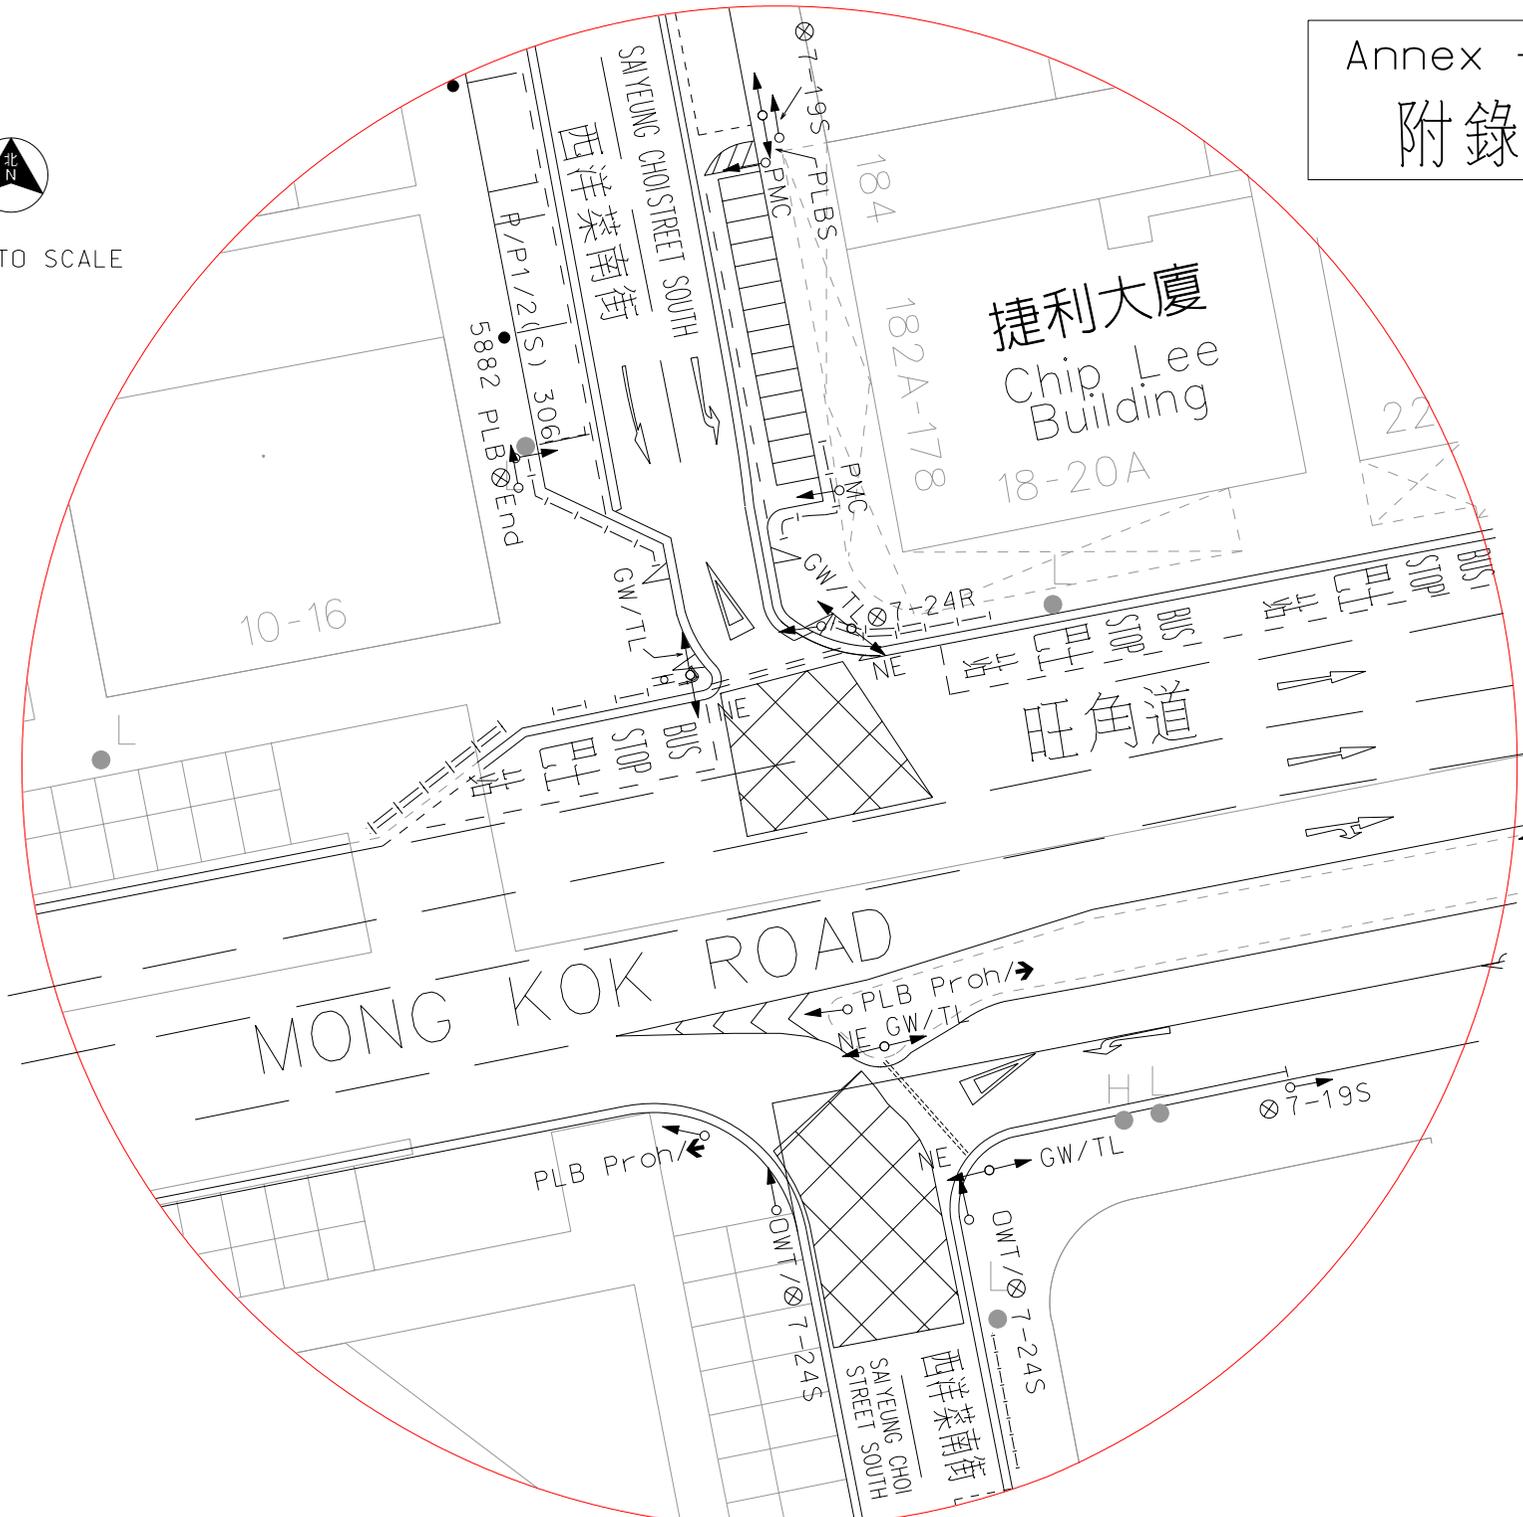
Annex - Junction Layout

2. At about 2340 hours on 12 June 2009, a GMB of Route 616S (Mong Kok – Lok Ma Chau) ran into a double deck bus of KMB Route 1A (Tsim Sha Tsui – Sau Mau Ming Central) when it made a left turn from Sai Yeung Choi Street South onto Mong Kok Road. As a result of the collision, the GMB ran onto the footpath of Mong Kok Road and knocked down a number of pedestrians, some of whom were waiting for bus services at the bus stops, along the same section of Mong Kok Road. 2 persons were killed and 8 injured / seriously injured. A plan showing the accident location is at the **Annex**.
