REPORT
ON THE COLLAPSE OF THE BUILDING
AT 45J MA TAU WAI ROAD
TO KWA WAN, KOWLOON - K.I.L. 8627
ON 29 JANUARY 2010

Buildings Department

April 2010

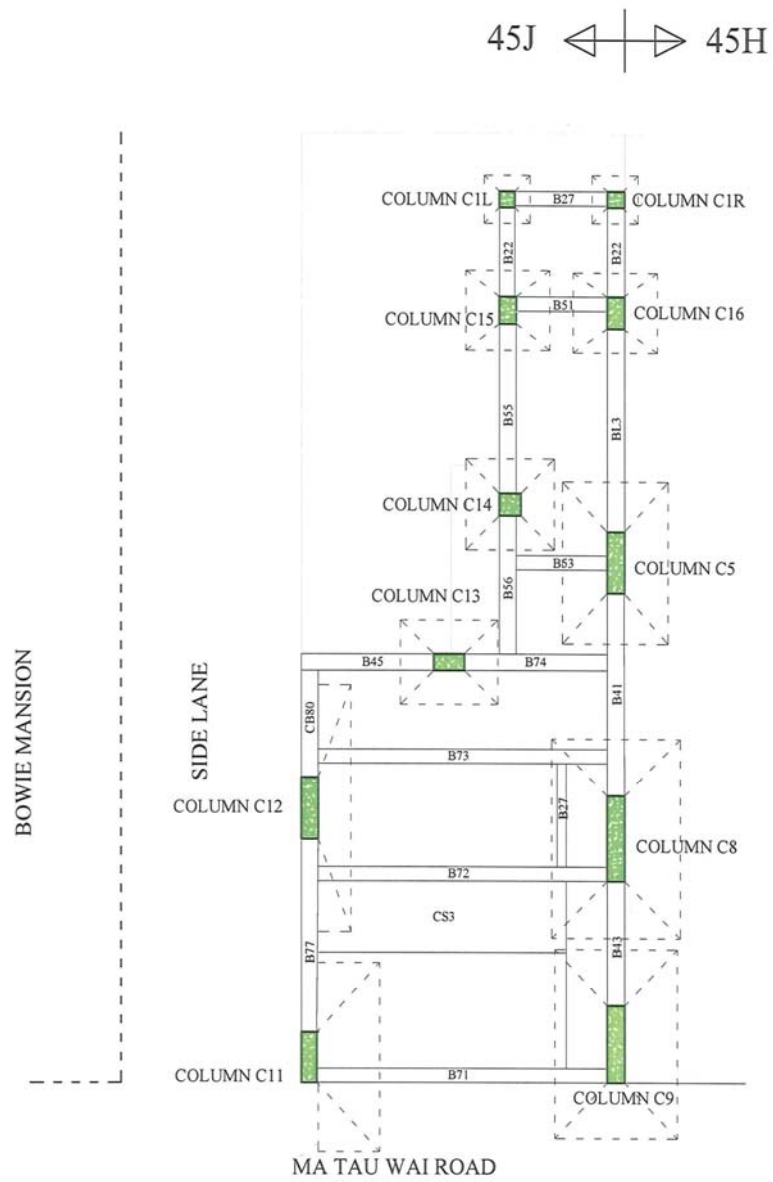
Column Layout Diagram-
No.45J Ma Tau Wai Road

- (a) Alterations in the form of sub-divided flats were noted on all upper floors.
- (b) Repair works and removal of unauthorized building works on G/F commenced on 23 January 2010 and were still in progress in the morning of 29 January 2010.
- (c) Three columns, namely C11, C12 and C13, collapsed in the incident. Remnants of the three columns were noted at ground level after the collapse. The column layout diagram is at Annex.

11. A further scenario assessment was conducted. When column C13 was further disturbed by some external forces, its loading capacity would be reduced. Without the provision of any precautionary measures such as steel I-props and bracing ties to share out the loading, the loading that column C13 had to bear would have exceeded its ultimate loading capacity and the destructive effect spread to the nearby columns C11 and C12, thereby increasing the loading on these two columns.

12. The asymmetrical arrangement of the 5 main supporting columns (i.e. C8, C9, C11, C12 and C13) formed a less rigid portal-framed integral structure (i.e. the collapsed portion of 45J). With the simple supported column-beam joint connections, there was no moment transfer between the column and beam. This type of structure would not be able to withstand any lateral loading when comparing to the symmetrical arrangement of columns of the remaining buildings at 45G and 45H. The symmetrical arrangement of the columns of 45G and 45H formed a more rigid multi-framed integral structure to withstand lateral movement.

13. Once the three structurally unbalanced columns C11, C12 and C13 reached their ultimate failure state, they would have crushed progressively within a very short period of time and failed to support the loading of the 5-storey building. This would have caused the lower portion, about two storeys, of the building to collapse first.
