**REPORT**  
**ON THE COLLAPSE OF THE BUILDING**  
**AT 45J MA TAU WAI ROAD**  
**TO KWA WAN, KOWLOON - K.I.L. 8627**  
**ON 29 JANUARY 2010**

**Buildings Department**

**April 2010**

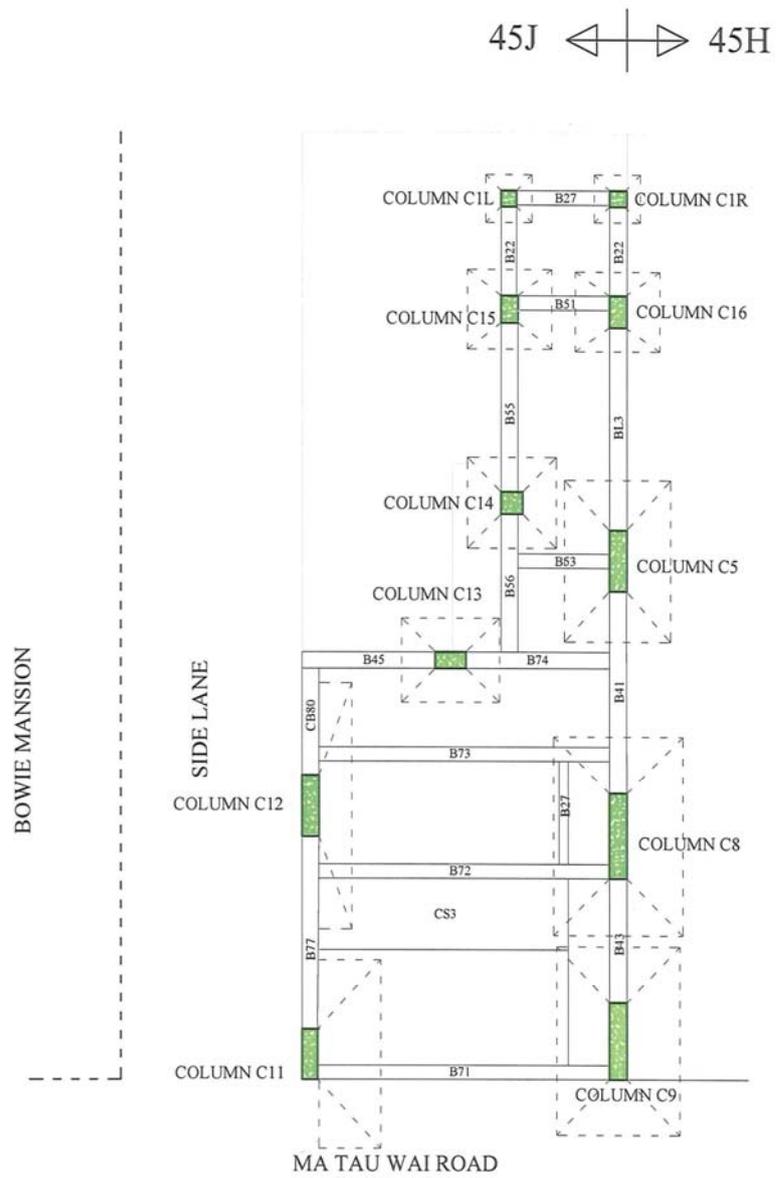
Column Layout Diagram-  
No.45J Ma Tau Wai Road

- (a) Alterations in the form of sub-divided flats were noted on all upper floors.
- (b) Repair works and removal of unauthorized building works on G/F commenced on 23 January 2010 and were still in progress in the morning of 29 January 2010.
- (c) Three columns, namely C11, C12 and C13, collapsed in the incident. Remnants of the three columns were noted at ground level after the collapse. The column layout diagram is at Annex.

11. A further scenario assessment was conducted. When column C13 was further disturbed by some external forces, its loading capacity would be reduced. Without the provision of any precautionary measures such as steel I-props and bracing ties to share out the loading, the loading that column C13 had to bear would have exceeded its ultimate loading capacity and the destructive effect spread to the nearby columns C11 and C12, thereby increasing the loading on these two columns.

13. Once the three structurally unbalanced columns C11, C12 and C13 reached their ultimate failure state, they would have crushed progressively within a very short period of time and failed to support the loading of the 5-storey building. This would have caused the lower portion, about two storeys, of the building to collapse first.

16. Based on the site inspections, structural analysis and statements obtained from the interviewees, the collapse of the building at 45J was likely to be triggered by the disturbance of column C13 by some external forces. As for the identification of the origin of these forces, further investigation has to be conducted including building material testing and forensic study.
