**Legislative Council Panel on Transport**

**Structural Safety of Hing Fat Street Slip Road  
to Island Eastern Corridor**

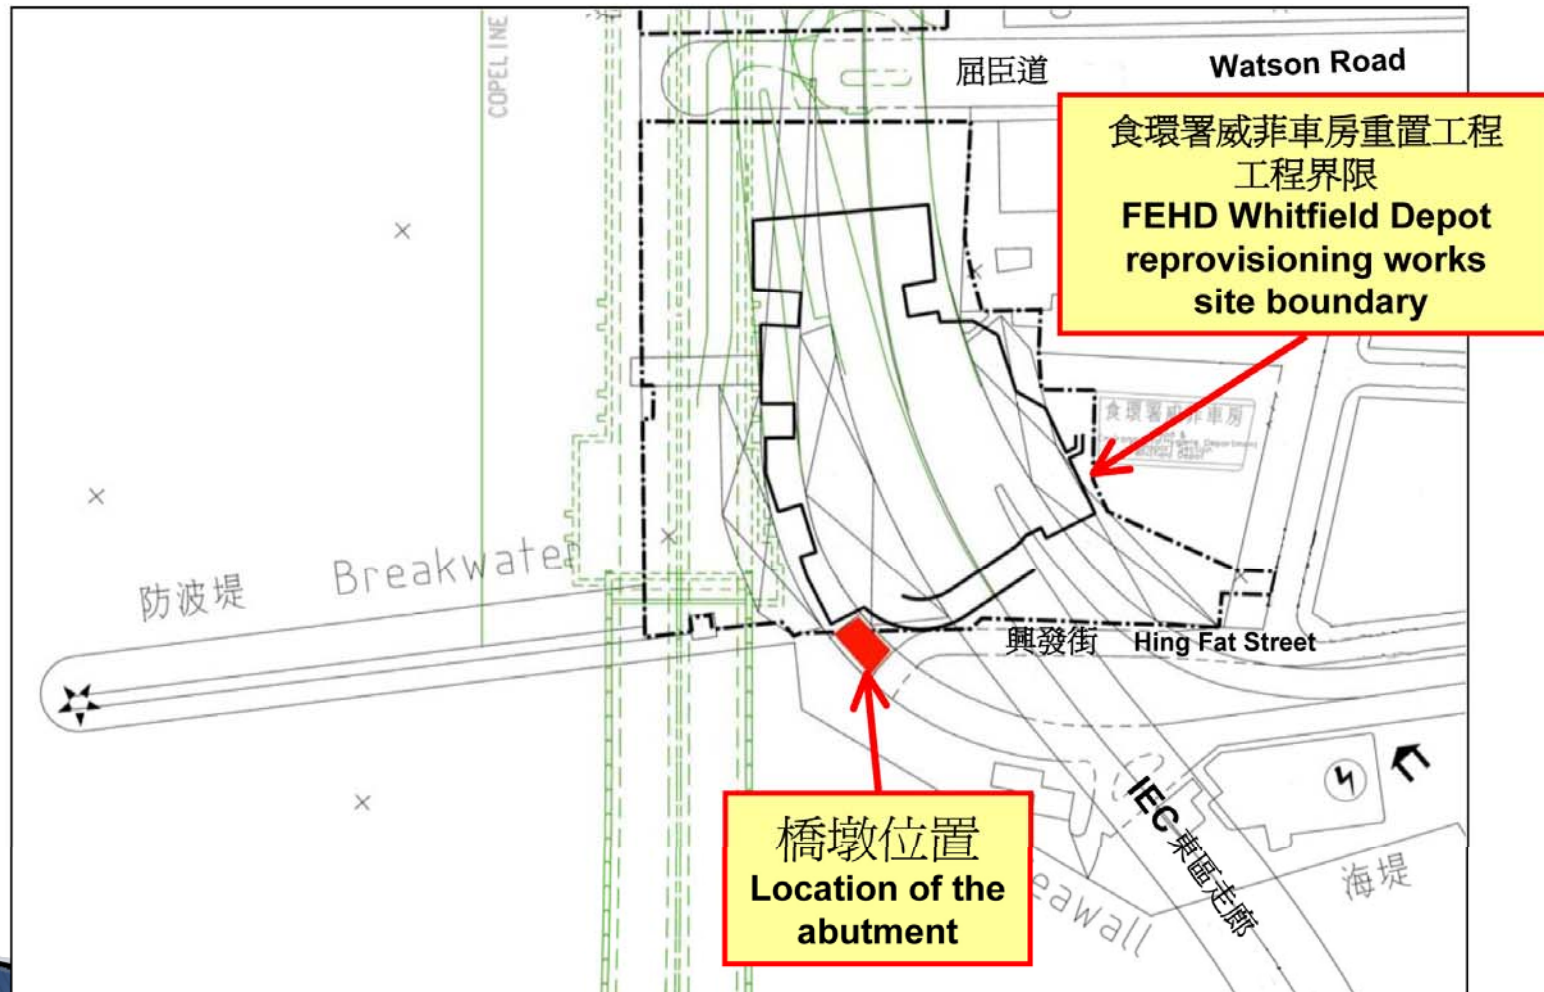
Central - Wan Chai Bypass — FEHD Whitfield Depot Reprovisioning Works

8. The IEC Hing Fat Street slip road abutment is situated near the work site of the FEHD Whitfield Depot reprovisioning works (see **Annex 1**). The works commenced in February 2010 and are expected to complete in 19 months. The works involve the conversion of part of the existing Whitfield Depot into an underground car park for use by FEHD so that space at ground level can be released for construction of the CWB.
