**Legislative Council Panel on Transport  
Subcommittee on Matters Relating to Railways**

**MTR Tsuen Wan Line Service Disruption on 21 October 2010**

**MTR Tsuen Wan Line Train Service Disruption  
on 21 October 2010**

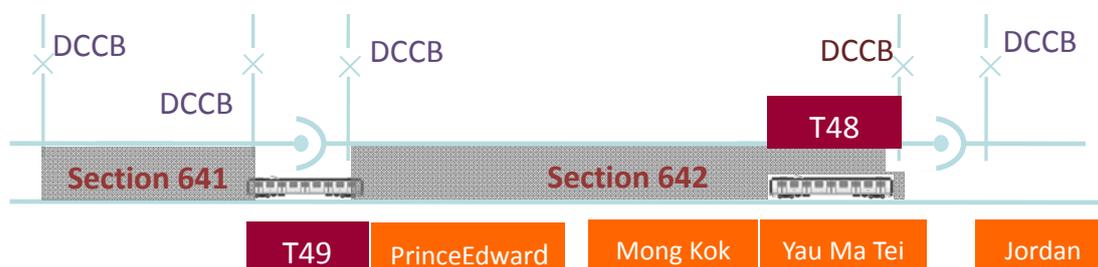
3. At 6:46 a.m. on 21 October 2010, the Direct Current Circuit Breaker (DCCB) for the overhead line section between Prince Edward and Yau Ma Tei stations in the Central-bound direction (Section 642) tripped open, cutting off power supply to trains in the section. Train T48, which had just departed Mong Kok Station, was de-energised and coasted under its own momentum to berth at Yau Ma Tei Station. The Train Captain of T48 reported to the Operations Control Centre (OCC) that he had heard some noises from above the train and saw a flash of light reflected off the tunnel wall. At the time, the in-train computer was indicating a fault in the train's power supply system. Arrangements were made for all passengers of T48 to alight and the train to be sent back to the depot for inspection.

4. At 6:47 a.m., the DCCB for another overhead line section in the Central-bound direction - that between Prince Edward and Cheung Sha Wan stations (Section 641) - also tripped open. Train T49 was just

5. While OCC was able to restore power supply to Section 641 between Prince Edward and Cheung Sha Wan stations, it was not able to do so for Section 642 between Yau Ma Tei and Prince Edward stations. Yau Ma Tei Station staff deployed to investigate on-site reported that the overhead line was broken at a point above the second car of T48.

16. The situation had been exacerbated previously by T49 “bridging” the two overhead line sections when it approached Prince Edward Station. When the first and second pantographs crossed from the energised Section 641 into the de-energised Section 642, it sent more high current down the overhead line and into T48 until the DCCB of Section 641 also detected an abnormal current flow and tripped open.
