Report of the Commission of Inquiry into
the Collision of Vessels near Lamma Island on
1 October 2012

(The Redacted Version)

The Honourable Mr Justice Michael Lunn, JA
Mr Benjamin Tang, GBS, JP

April 2013

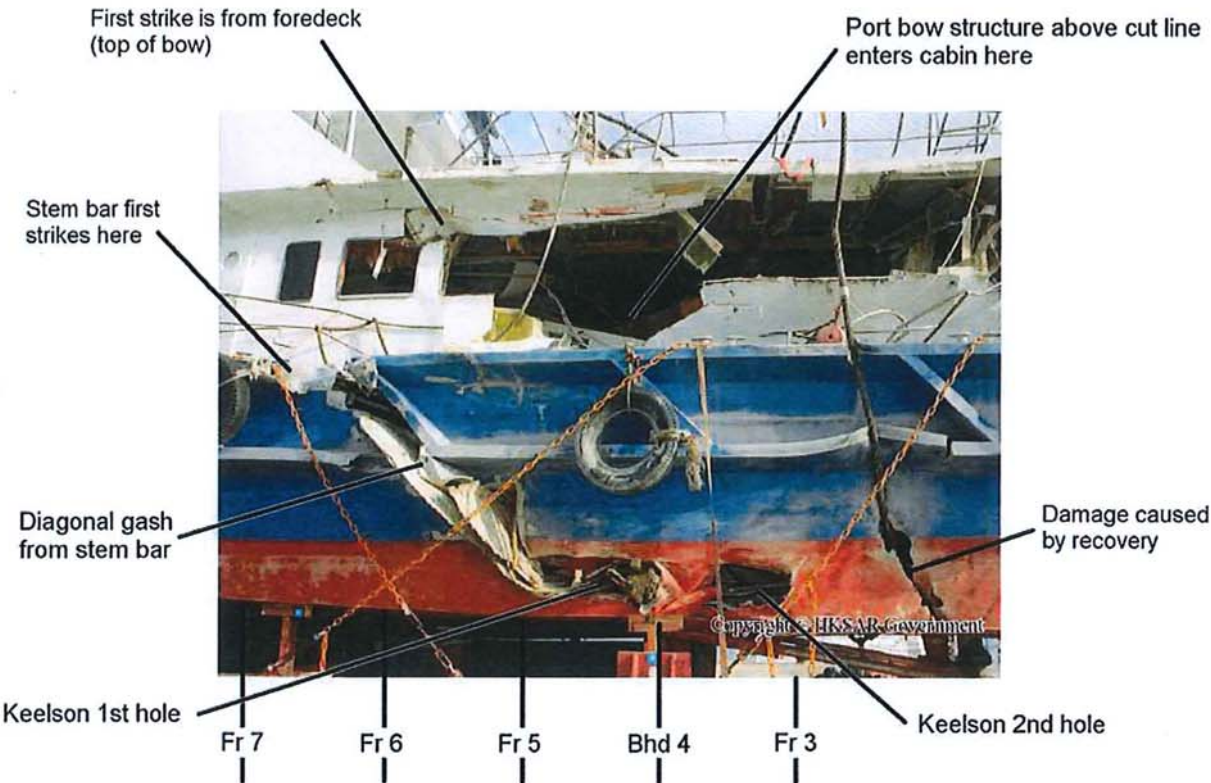
The gash and the jagged hole on the port side of the hull of the Lamma IV

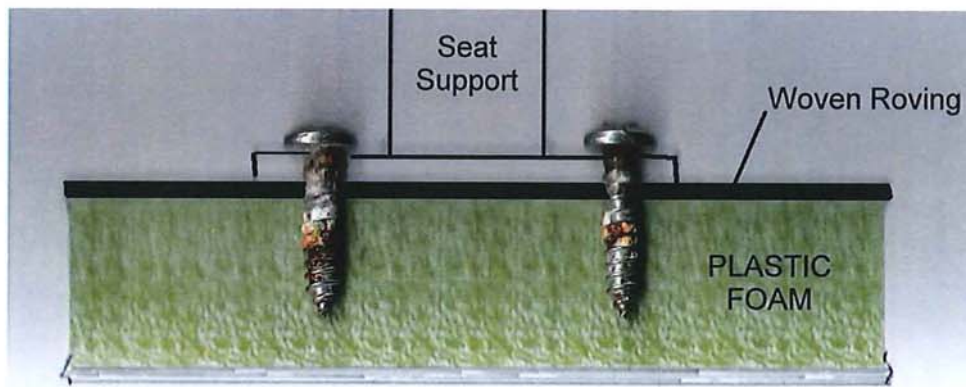
Sketch of the seat foundation arrangement on the Upper deck of the Lamma IV

This sketch is drawn to scale from the construction drawings, using two of the actual screws remaining on the upper deck.

Only the black part marked as “Woven Roving” makes a structural connection with the screws, the plastic foam having no strength to resist “pull-out”.

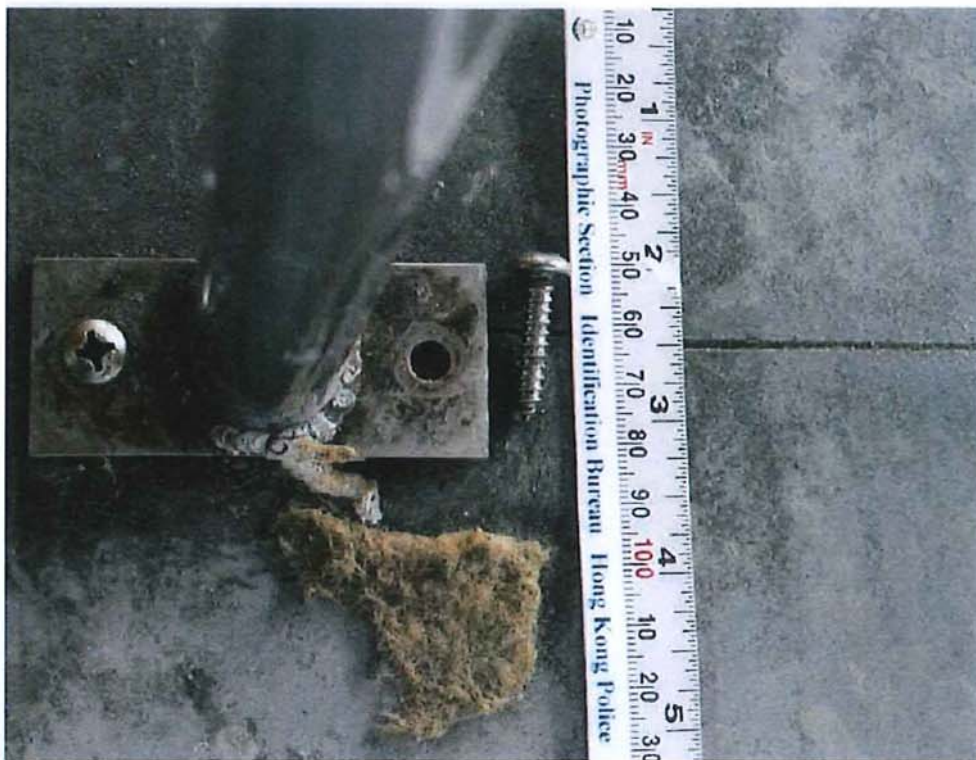
The rectangular mounting plate at the base of the leg of seat in the Upper deck cabin of the Lamma IV and the screw for affixing the seat

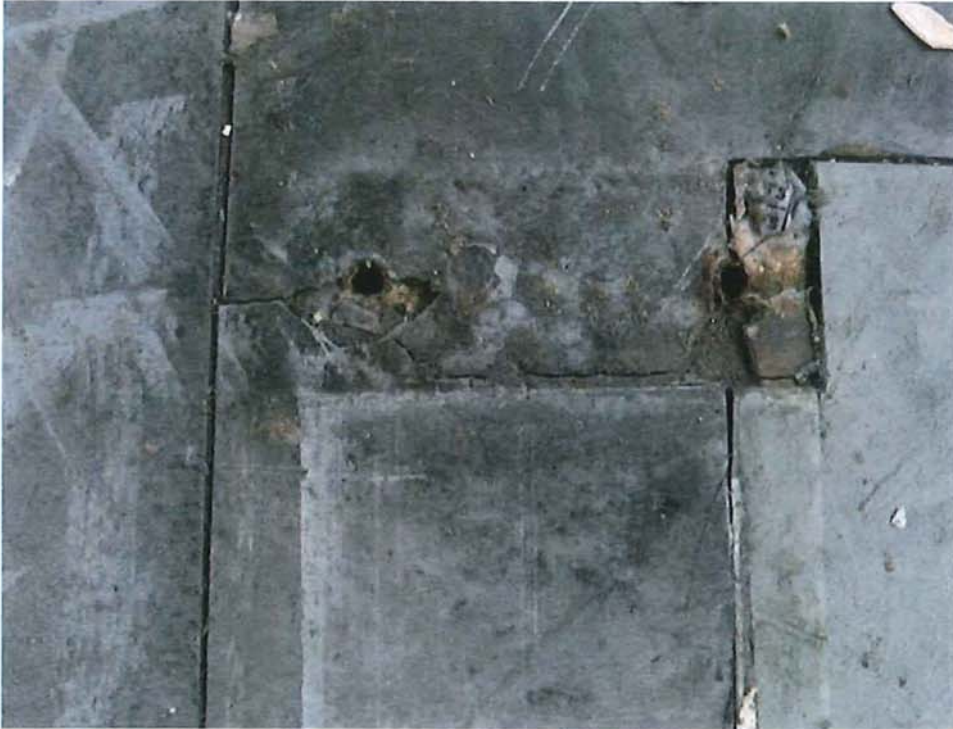
The rectangular imprint on the deck of the Upper deck cabin of the Lamma IV

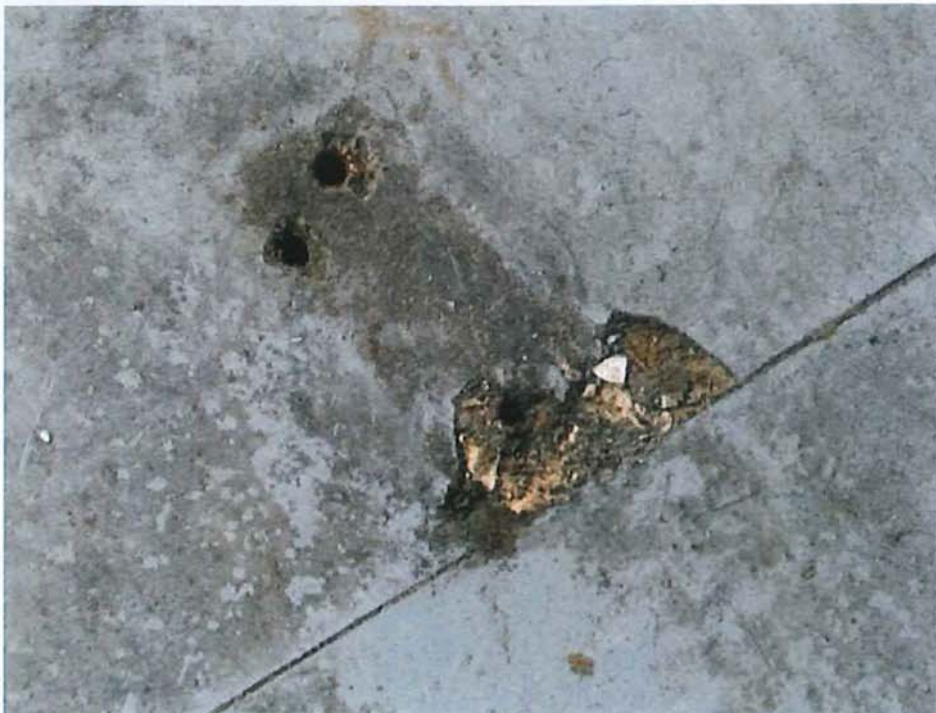
The mounting place had more than a pair of mounting holes

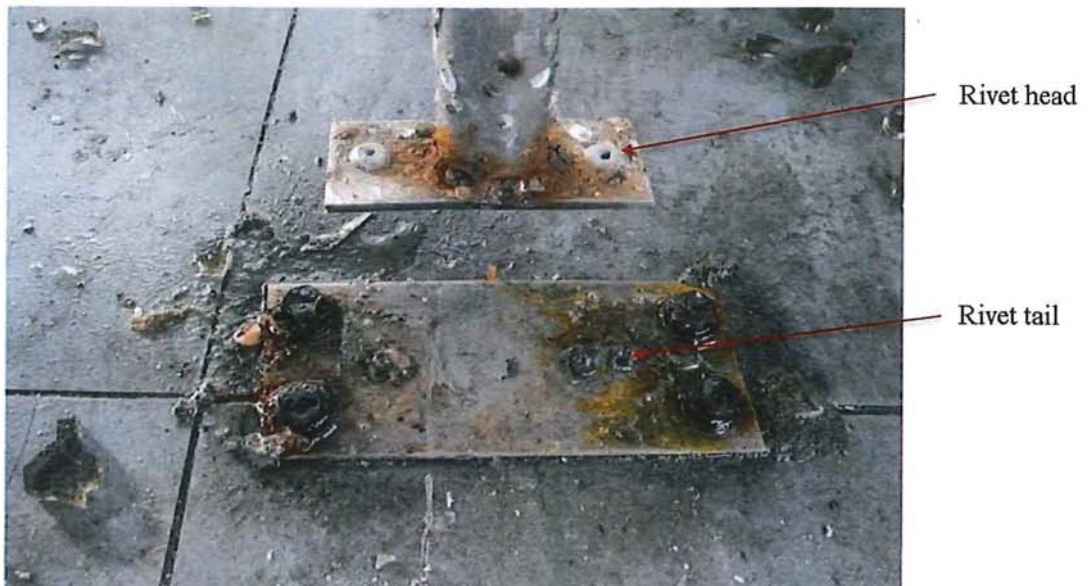
The mounting plate of the leg attached with heads of two rivets and the rectangular metal plate attached with rivet tails

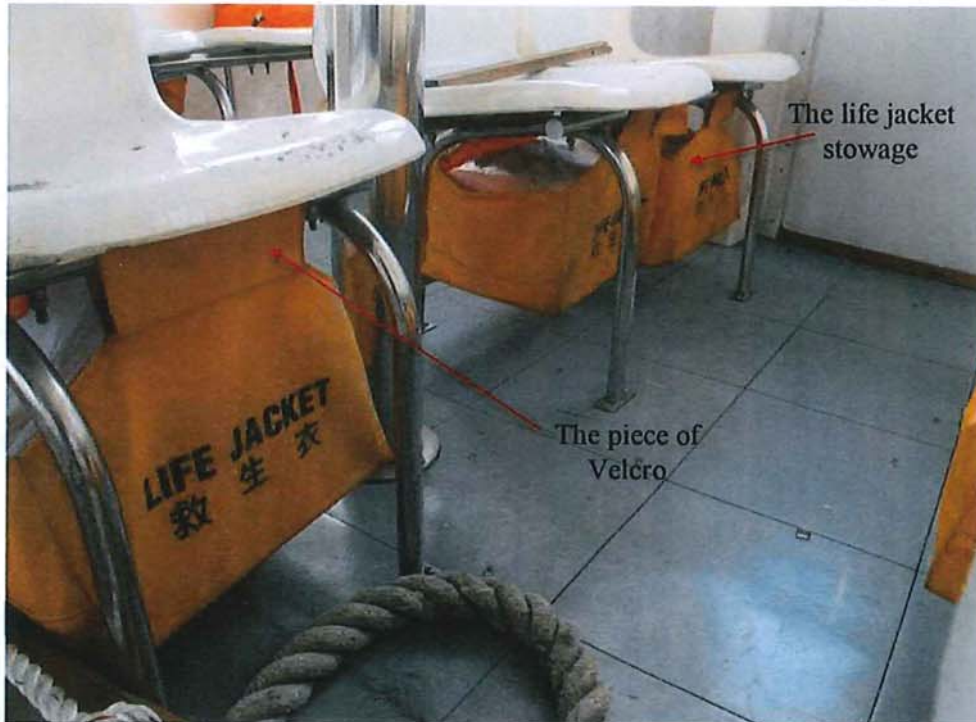
The lifejacket stowage beneath the seats in the Main deck cabin of the Lamma IV

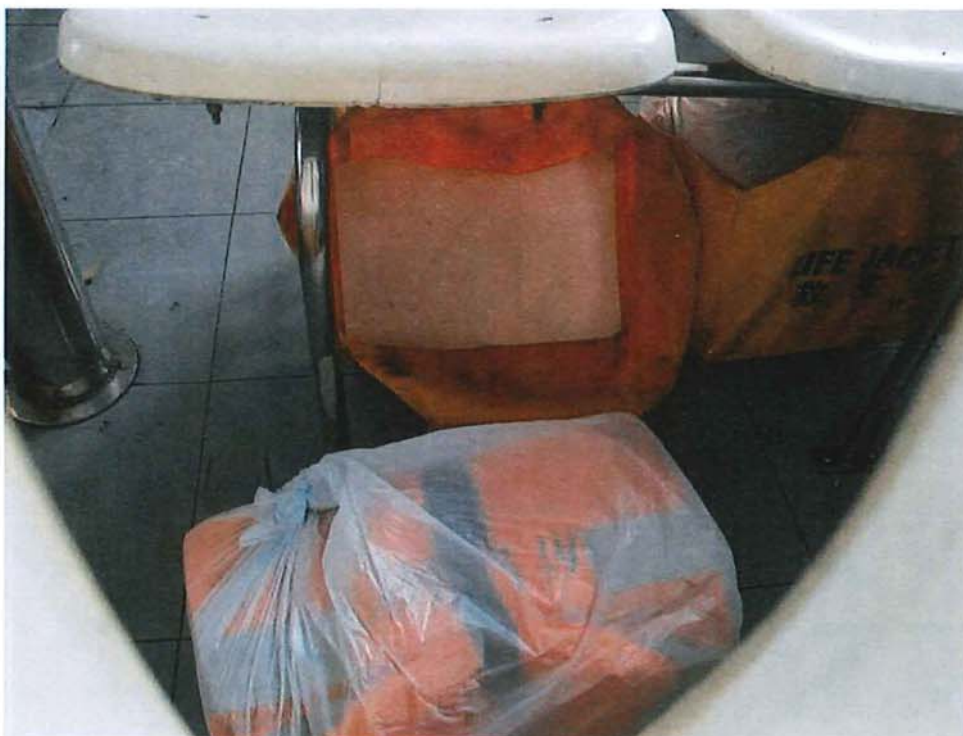
The white plastic bag containing the lifejacket

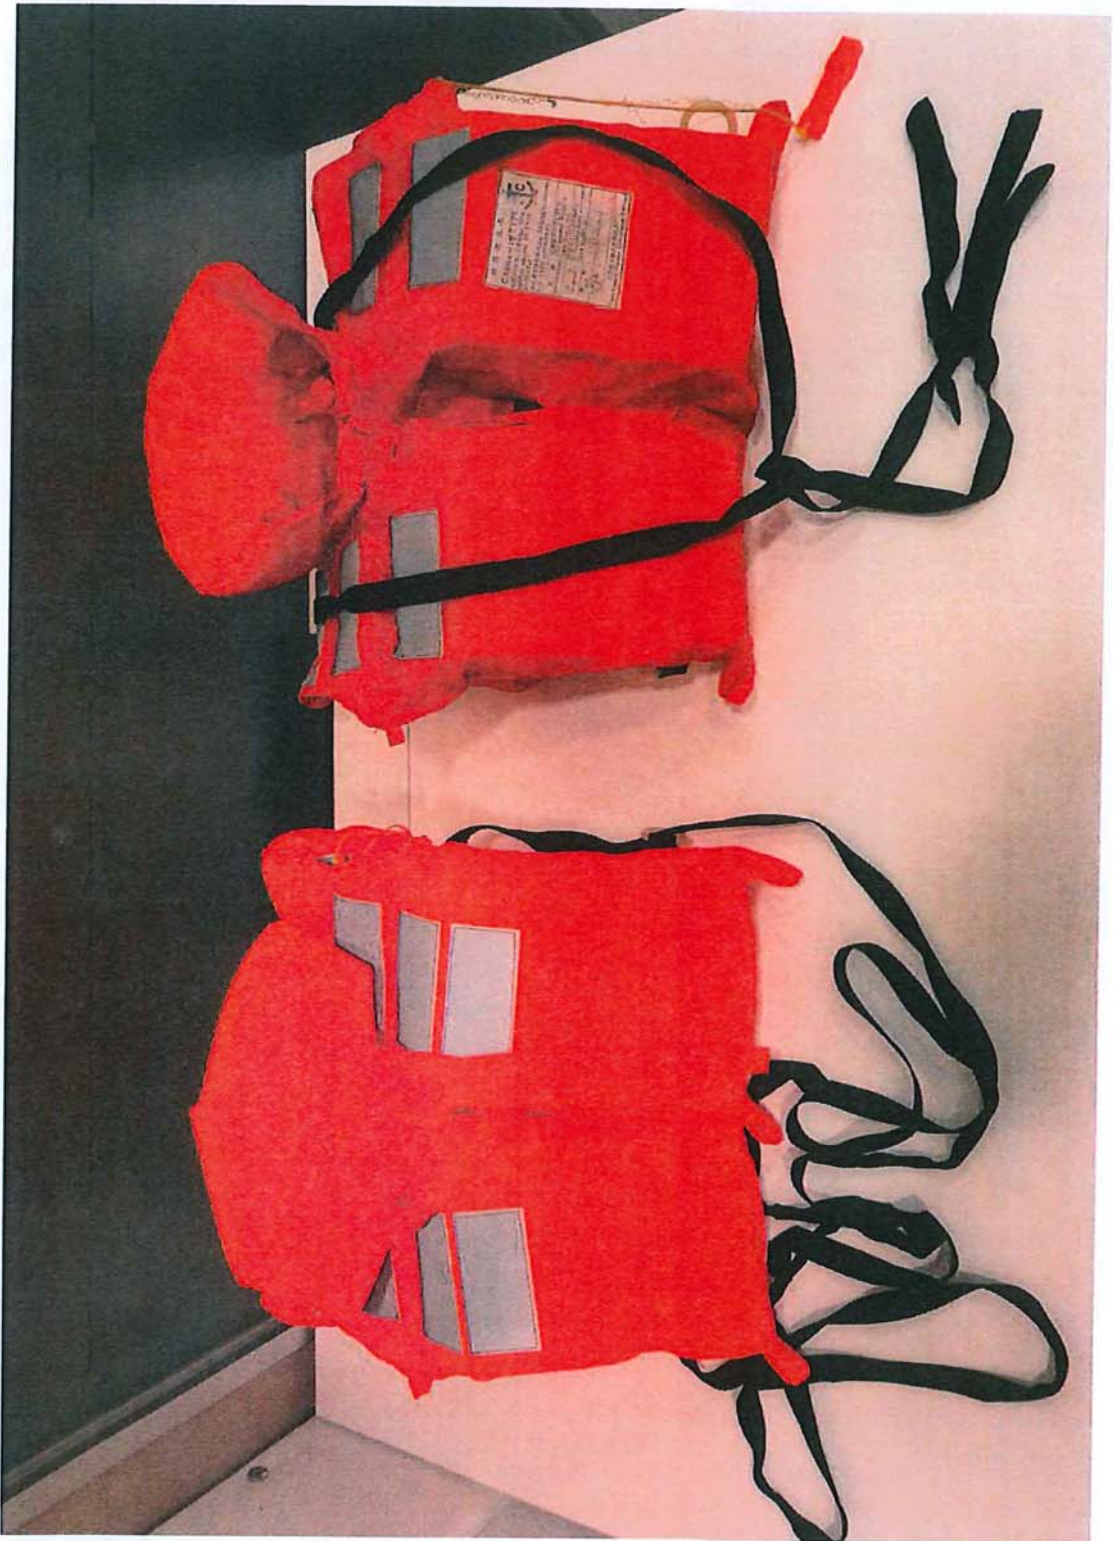
Lifejackets retrieved from the Lamma IV (lace-type)
