**The Legislative Council
Panel on Environmental Affairs**

**Emergency Sewage Discharge Incident
at Pillar Point Sewage Treatment Works
on 25 and 26 August 2014**

This note reports on the emergency sewage discharge incident at Pillar Point Sewage Treatment Works (PPSTW) due to equipment breakdown at the PPSTW and the follow-up actions taken.

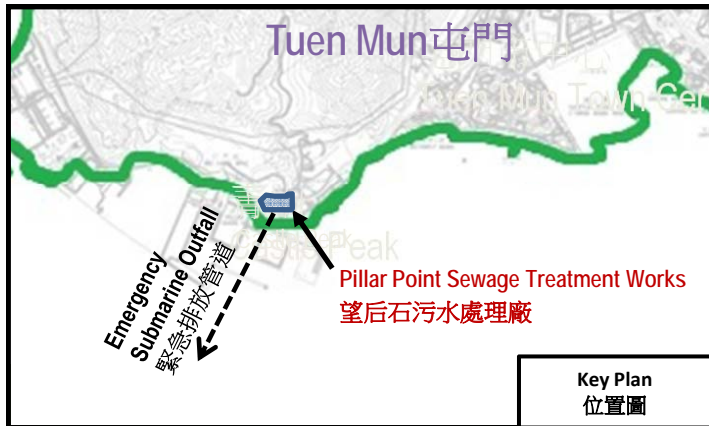
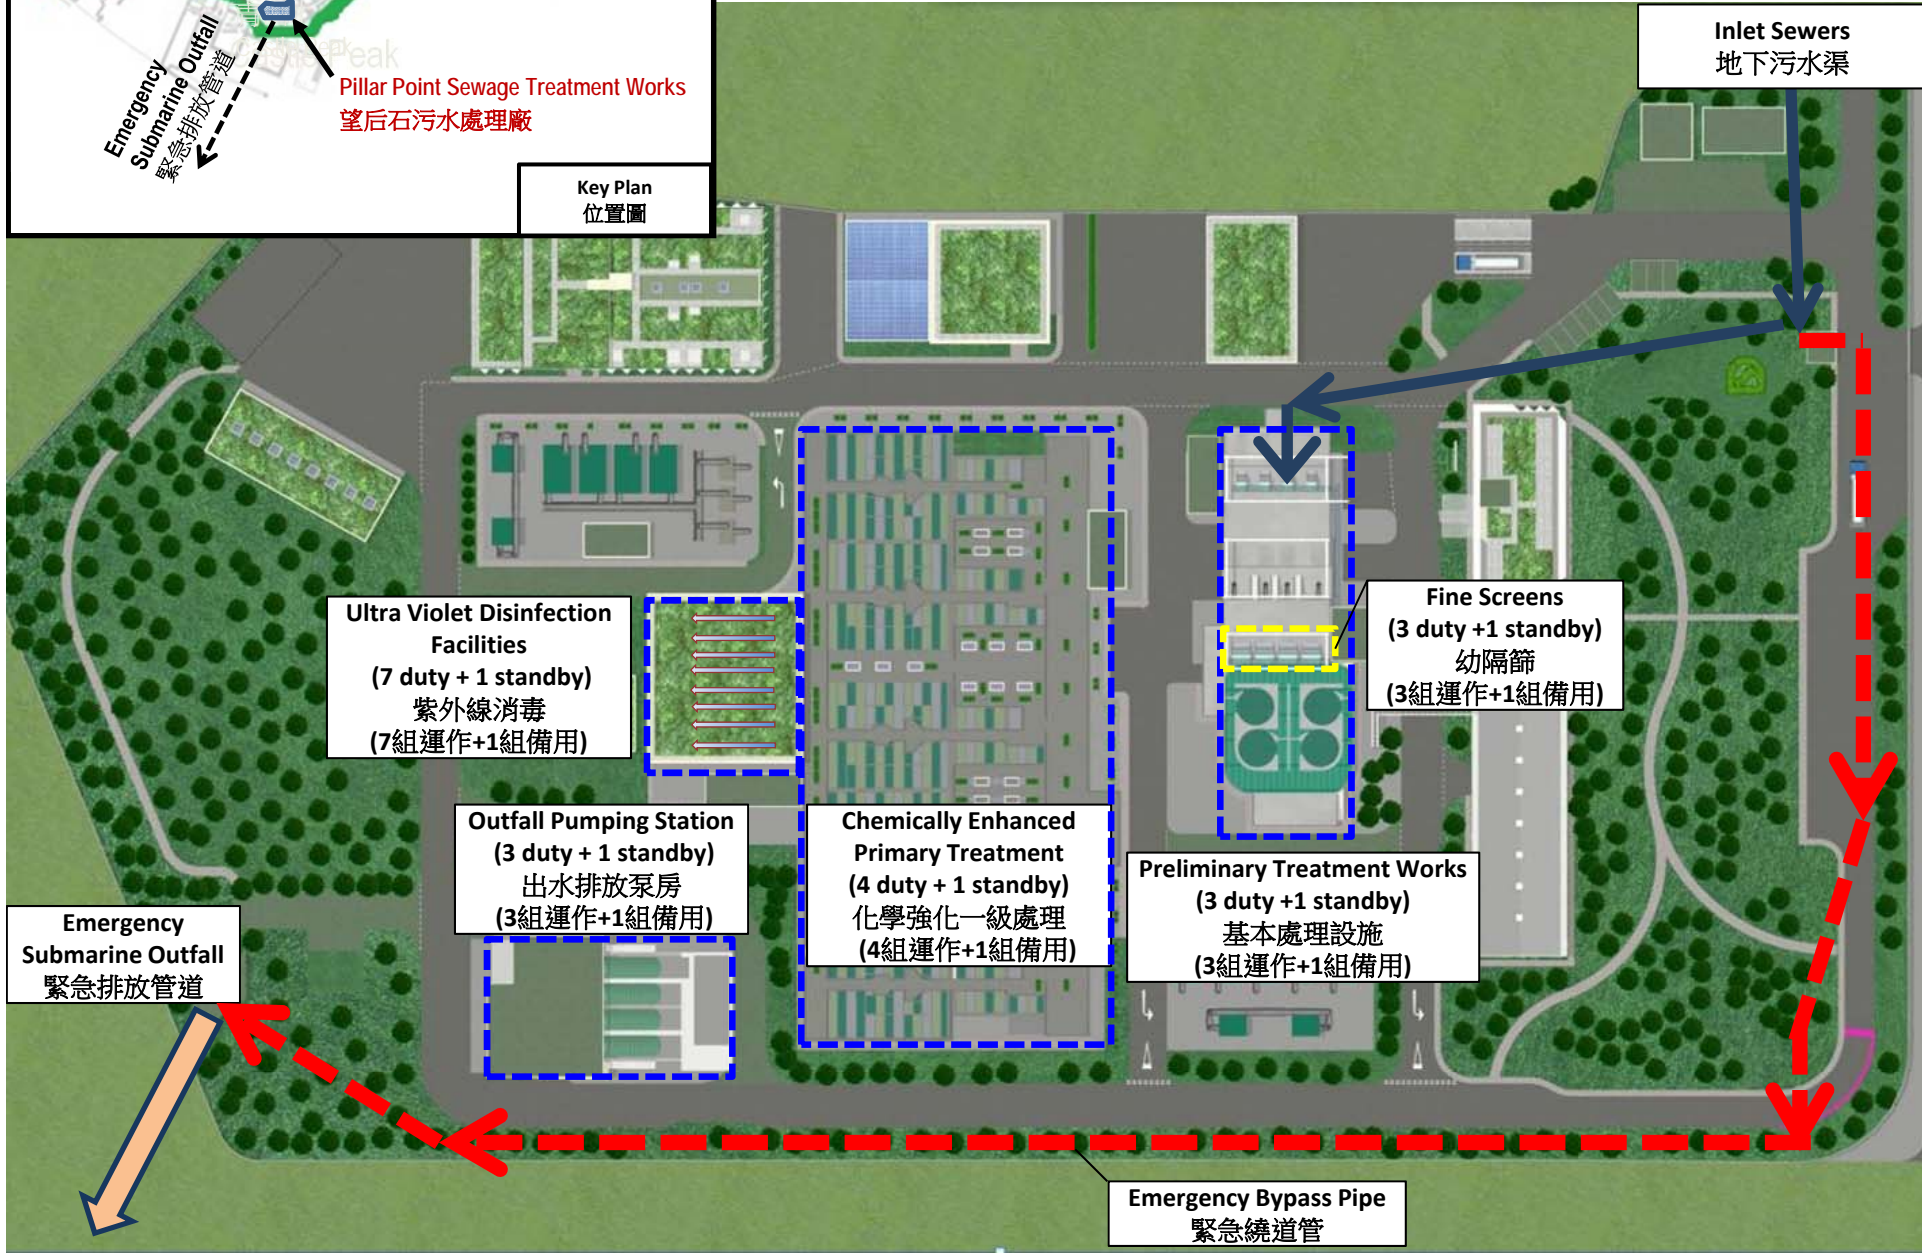
Annex 1 附件一

3. The upgraded PPSTW is equipped with dual power supply and standby facilities for the major treatment units in order to minimize the possibility of plant failure. In the event of an emergency mechanical or other plant failure which would prevent the incoming sewage to be delivered to the downstream sewage treatment units within the plant, the sewage would be bypassed at the plant inlet upstream for discharge through an emergency submarine outfall into the marine waters of Urmston Road, of about 700m offshore. A plan showing the treatment process configuration and the emergency submarine outfall of the plant is given in **Annex 1**.

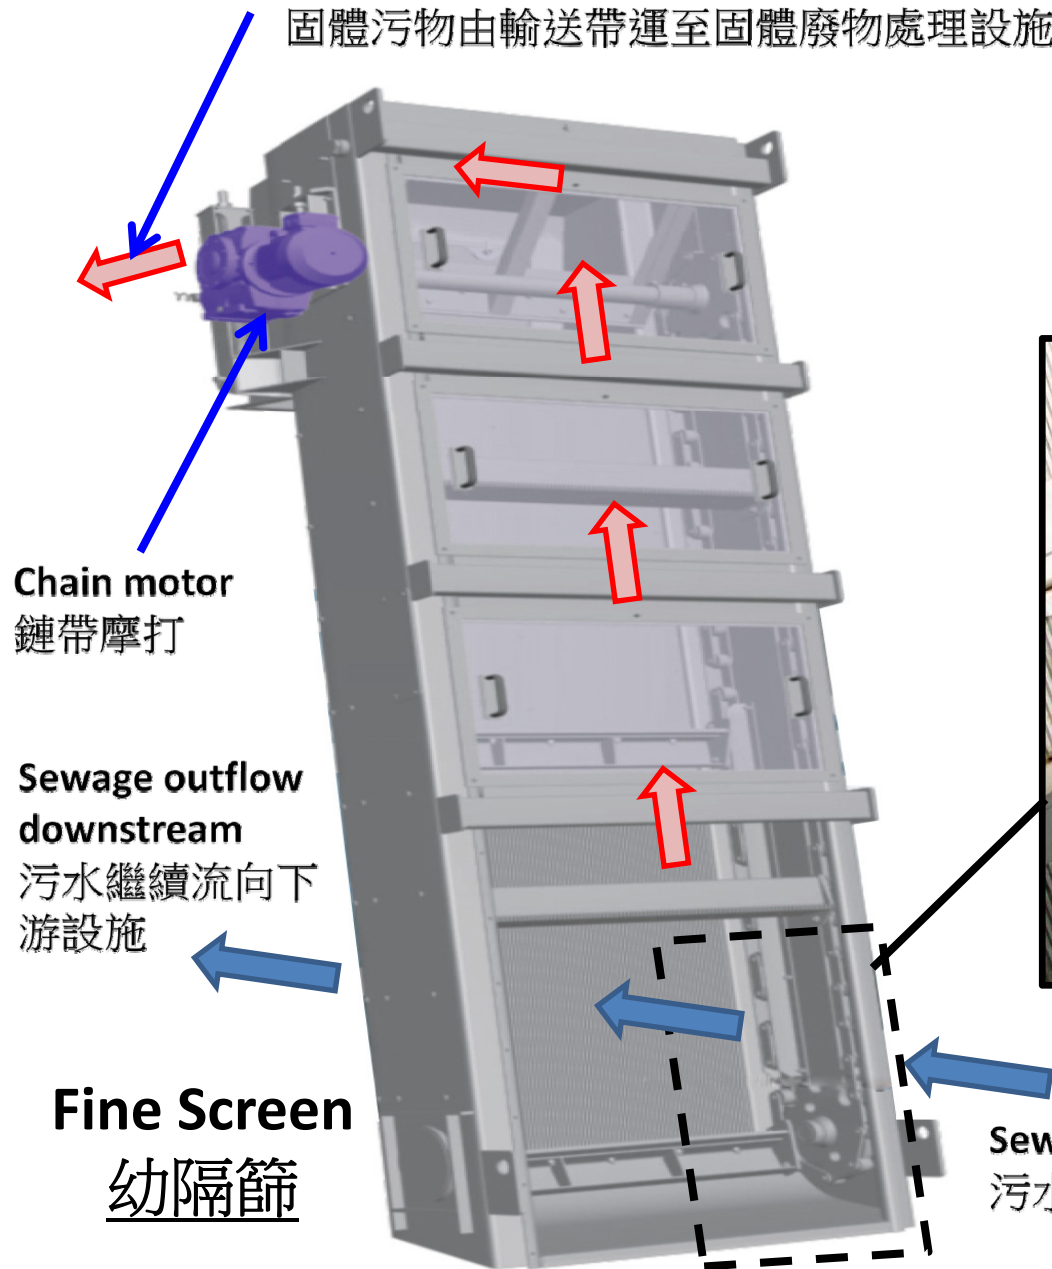
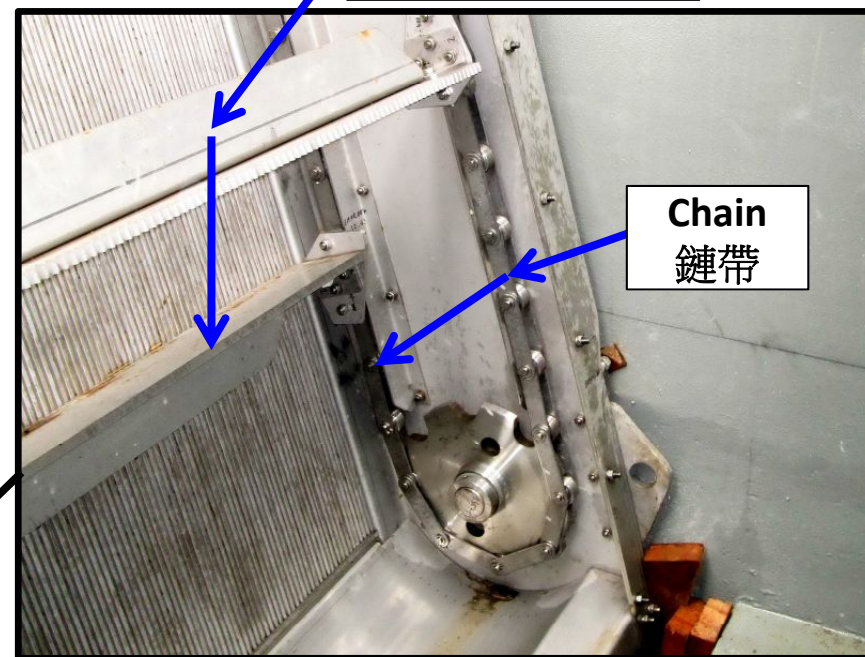
Annex 2
附件二

4. On 25 August 2014 at about 2:30 p.m., mechanical failure occurred to all the four fine screens^{*1} at the PPSTW. The general design of the fine screen units is illustrated in **Annex 2**. The chains that drive scrappers for removing small sized particles caught on the fine screens fell apart. While emergency repair works commenced immediately, the small sized particles in the incoming sewage quickly accumulated and clogged the fine screens thus stopping the sewage from passing through them and continuing with the downstream sewage treatment process. As sewage continued to come to the PPSTW, after depleting the small temporary storage space upstream, there was no other alternative but to discharge the sewage influent through the emergency submarine outfall of the plant commencing from 3:36 p.m. Otherwise, overflowing of sewage in upstream urban areas might occur.

11. Upon completion of the emergency repair works on 26 August 2014, DSD has immediately tightened its control. This includes warning the contractor that such incident of failure of all the four fine screens including the stand-by one was unacceptable and urged them to take proper and immediate steps to prevent recurrence. The contractor has immediately replaced all fine screens with new chains. They have also strengthened their resources for operation and maintenance of the plant and have increased the inspection frequency of the fine screens from once per day to three times per day. The

contractor has further carried out reinforcement works on the chains to further minimize the risk of their failure. Other than the above, DSD has also asked their consultants to further tighten the supervision of the plant operation and the essential installations.

- (b) DSD is examining the feasibility of modifying the process of the PPSTW so that incoming sewage flows could be channeled into the plant for treatment notwithstanding failure of the fine screens at the plant inlet;
