**Final Report of
Stray Dog Incident on 20 August 2014**

Operations Manager – WRL & LR

Date: 11 December 2014

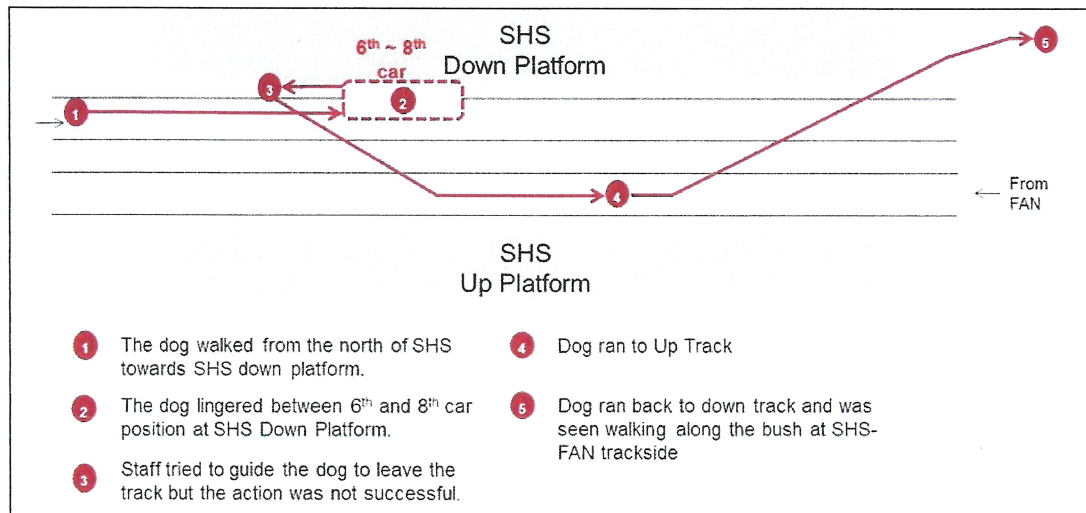
Figure 1. The dog's movement at Sheung Shui Station

At 1001 hours, the train on Down Line left SHS at cautious speed and ready to stop quickly for any emergency. The TCap saw the dog in the trackside bush at a distance from the running track.

The course taken by the dog at SHS is shown in Figure 1.

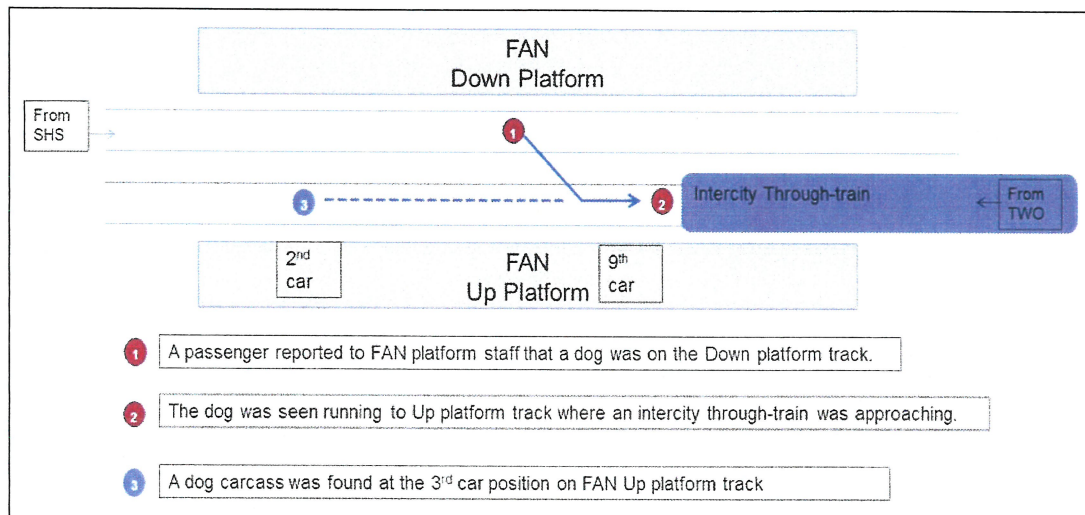
Figure 2. The dog's movement at Fanling Station

At 1008 hours, the dog was spotted on the tracks within the platform area in FAN by a passenger who alerted the staff at the Platform Supervisor Booth (PSB). The staff immediately reacted and rushed out from the PSB to look into the situation. He immediately displayed danger handsignal to signal the approaching train to stop. An Intercity Mainland Through Train (MTT) from Tai Wo Station (TWO) approaching FAN platform on Up Line was braked to stop at 2nd car position when the driver saw the danger handsignal displayed by the staff of PSB.

The PSB staff searched for the dog from the platform but could not find it. After the MTT moved off from the platform, the dog was found dead on the track at 3rd car position.

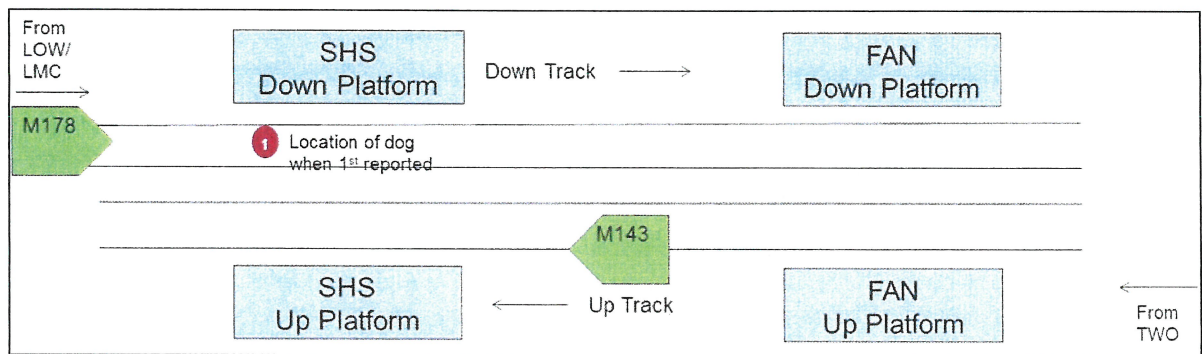
Figure 3. Platform configuration at SHS and FAN and train positions at the beginning of the incident.

The incident involved two stations of East Rail Line –SHS and FAN. Both stations have split platforms with Down track and Up track in the middle (Figure 3).

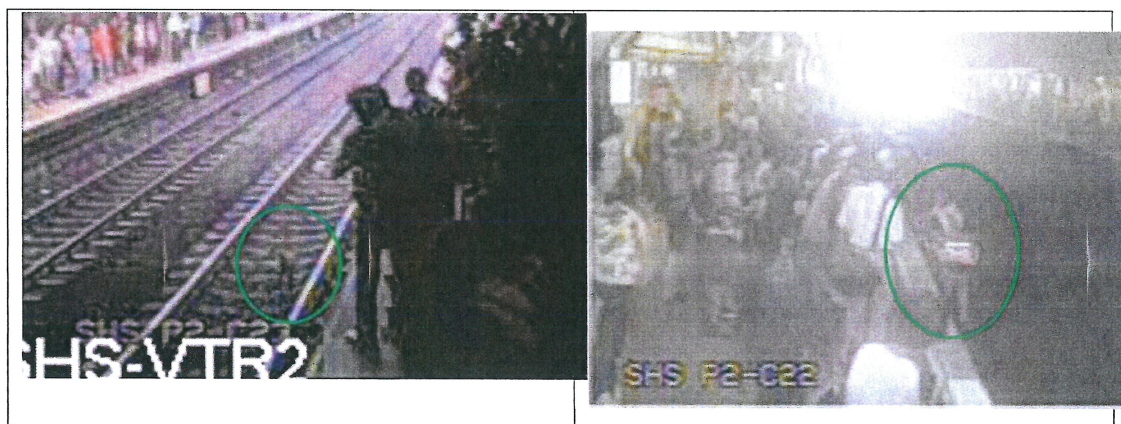
Figure 4. The onlooking crowd on the platforms in SHS

The appearance of the dog attracted attention from passengers on platform in SHS who crowded near the platform edges (Figure 4). Some even extended their arms outside the platform to take photographs with their mobile phones. A noisy environment was created by the crowd.

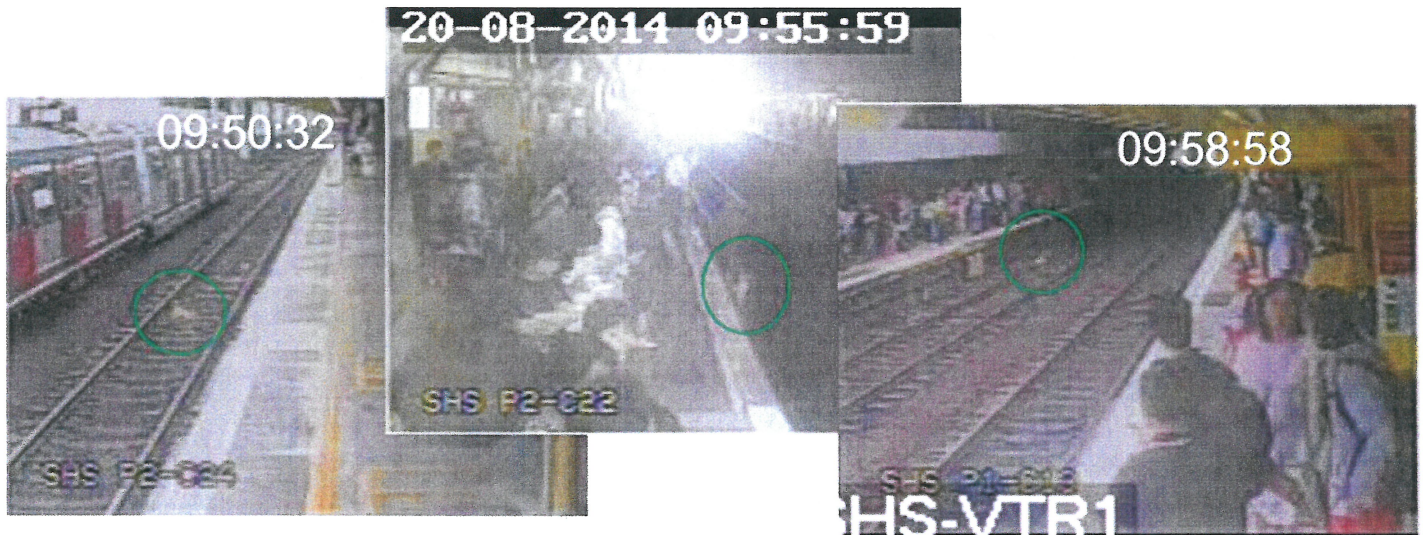
Figure 5. The dog's movement on platform track in SHS

According to CCTV footage, the dog was seen mainly lingering on the 4-foot way and the underside of the platform. It only walked across the 6-foot space when it crossed from one track to another (Figure 5).

For some periods of time, it was blocked from the view of the cameras when it stayed close to the underside of the platform. It had attempted to climb up the platform by putting its front paws on the platform edge.

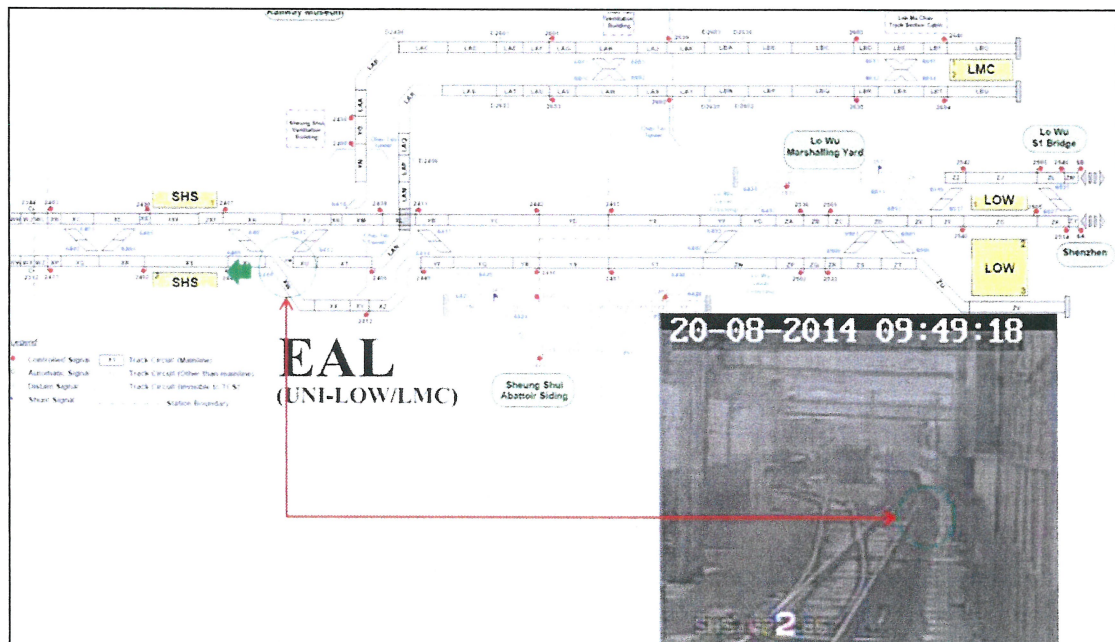
Figure 6. First appearance of the dog in CCTV footage

According to CCTV footage, the dog was seen moving on EAL Down track towards SHS station 2 minutes before the incident outbreak (Figure 6). Hence, the dog might have entered the track through the boundary fence north of SHS.

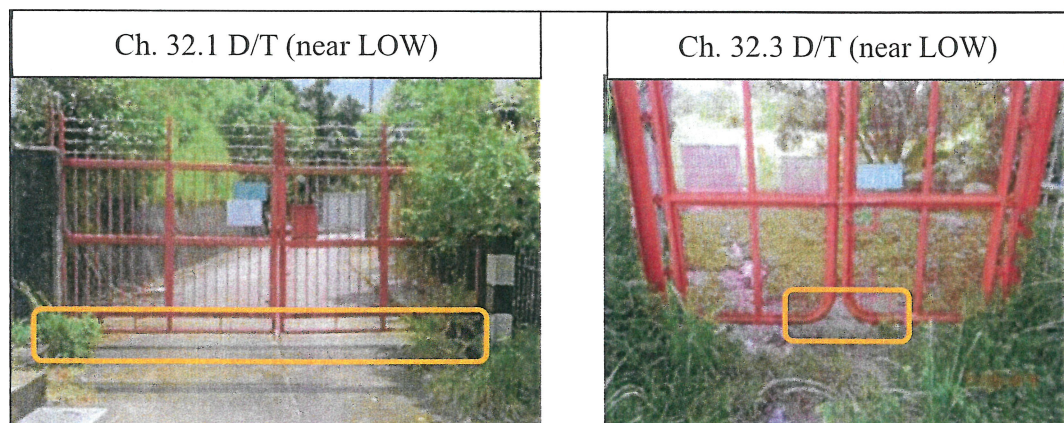
Figure 7. Examples of boundary fence which had gaps

After the incident, Infrastructure Maintenance staff identified a few possible entry points where the gaps in the fence might have allowed the dog to get through (Figure 7). The original design intent of the fence was for keeping out trespassers (human), but not small animals like cat and dog, from entering the railway.

The Task Force has recommended that the inspection and maintenance regime for fencing be enhanced to strengthen the boundary fencing so as to prevent intrusion into track area by dogs.

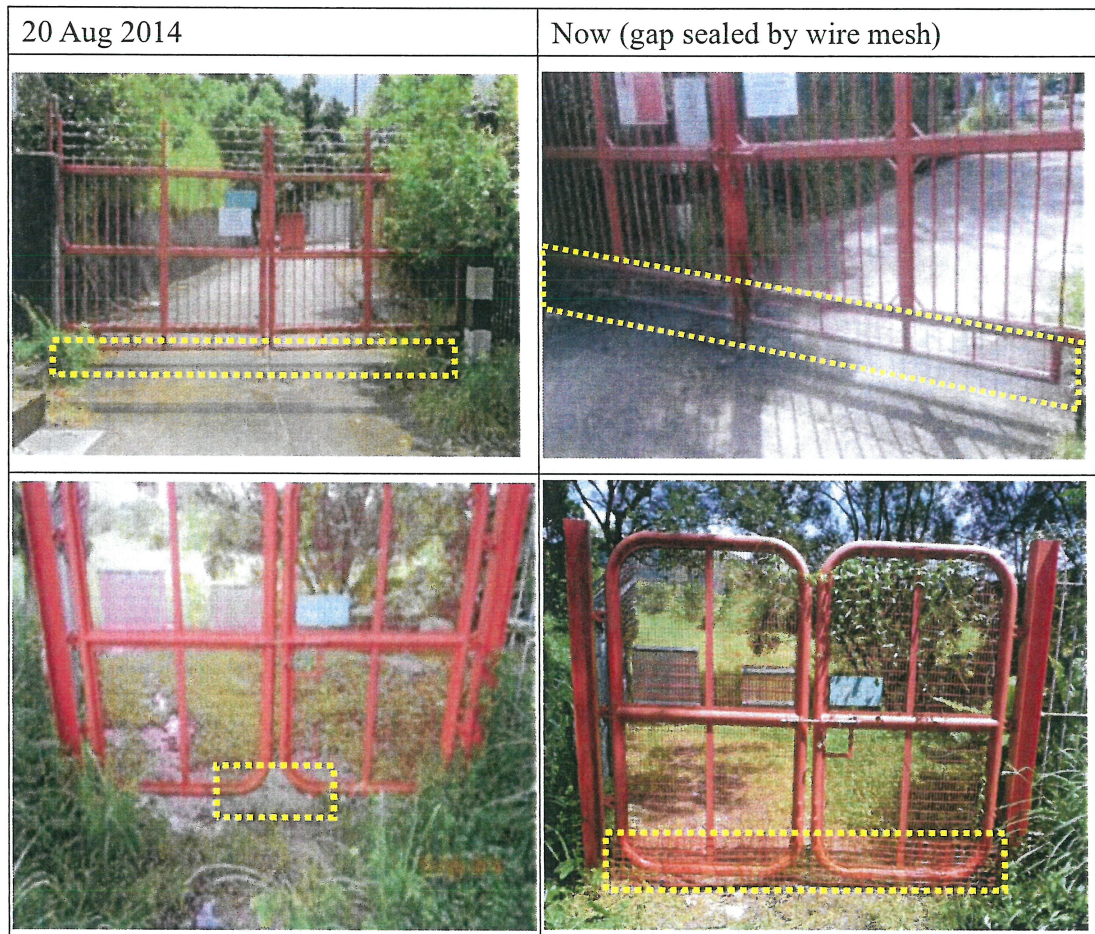
Figure 8. Improvement work performed on the gaps of two gates.

The boundary fencing of EAL is designed to prevent human trespassers from intruding onto the railway tracks. As the land level along EAL is uneven, there are around 100 narrow gaps identified along the boundary fencing in a comprehensive check by Infrastructure Maintenance Department and inspections made by stations. Two such gaps were identified in the Lo Wu area as possible entry points for the dog (Figure 8). All the identified gaps were subsequently sealed up or blocked by adding wire mesh, grating or steel bar. A sample list of such locations with the remedial actions taken is in Appendix 1.
