Technical Investigation of the Escalator Incident at Langham Place

**Technical Investigation Report on
Escalator Incident at Langham Place,
Mong Kok, Kowloon**

Date of Incident: 25 March 2017
事故日期：2017年3月25日

Issued Date: 9 June 2017
出版日期：2017年6月9日

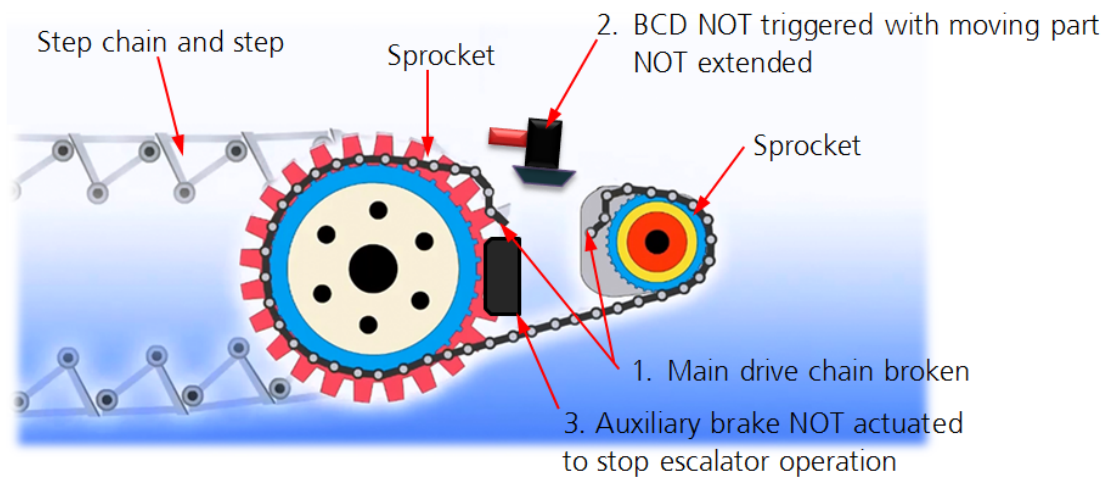
5.2 Under normal circumstance, the breakage and/or excessive elongation of the main drive chain are continuously monitored by the broken chain safety device (BCD, Figures 1 and 3 refer). In case of breakage or excessive elongation of the main drive chain, the BCD will be triggered and will send a signal to activate the auxiliary brake to stop the moving escalator (Figure 2a refers). In this incident, upon breakage of the main drive chain, the BCD failed to detect the chain breakage and the auxiliary brake was not activated to stop the moving escalator (Figure 2b refers).

Figure 2b: Double failure of the main drive chain and BCD in the incident

5.3 The incident was caused by the double failure of both the main drive chain and BCD. Such double failure is very rare. According to the EMSD's records, there was no similar failure occurred in Hong Kong previously.

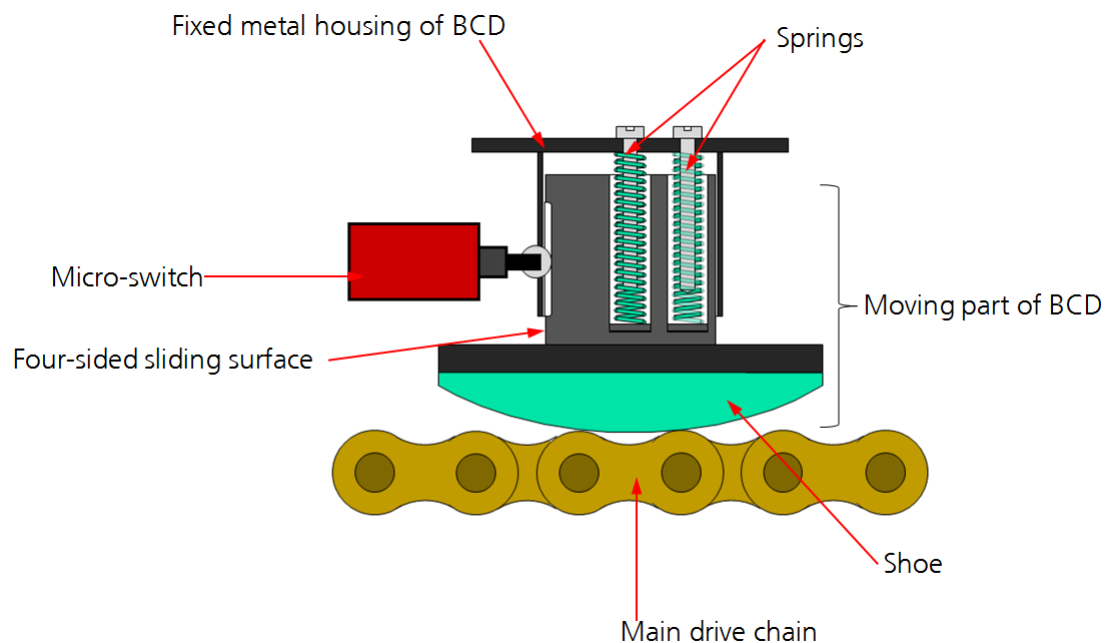
Figure 3: Construction of BCD

6.3.2 As shown in Figure 3, the BCD moving part is installed within the fixed metal housing. At the bottom of the moving part, there is a plastic shoe. The moving part is designed to move freely up and down within the fixed metal housing. There are two compression springs installed at the fixed metal housing. Under normal circumstances, the two compression springs press the moving part and the plastic shoe so that the shoe is in contact with and is sliding on the moving main drive chain during escalator operation. When the main drive chain is broken or has excessive elongation, the compression springs will push the moving part and the shoe downwards. There is a micro-switch fixed at the BCD housing. When the moving part is pushed downwards, the curvature at the sliding surface of the moving part will trigger the micro-switch. The micro-switch will then provide a signal to activate the auxiliary brake.

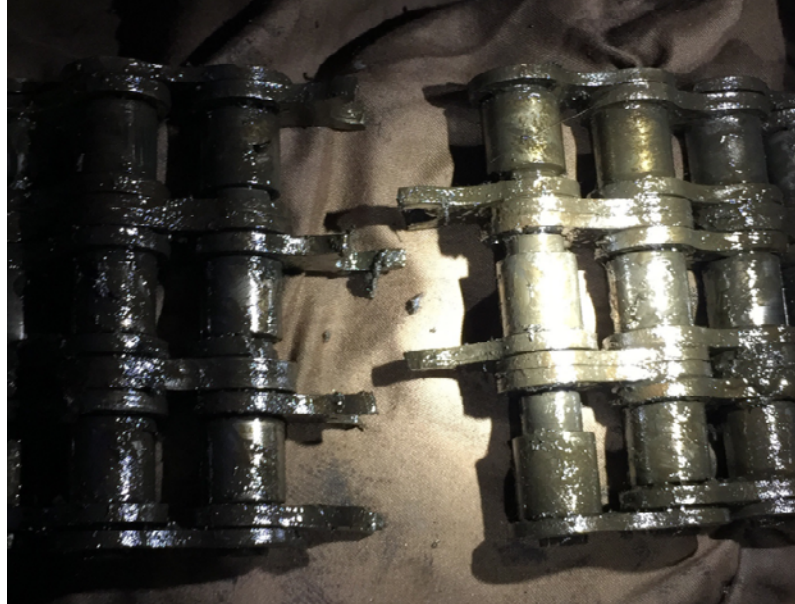
6.2.3 After the incident, the main drive chain was found broken. According to the numbering system, the breakage occurred between pin Nos. 1 and 104. Figure 4 shows the breakage position of the main drive chain right after the incident.

Figure 4: Photo showing the breakage position of main drive chain

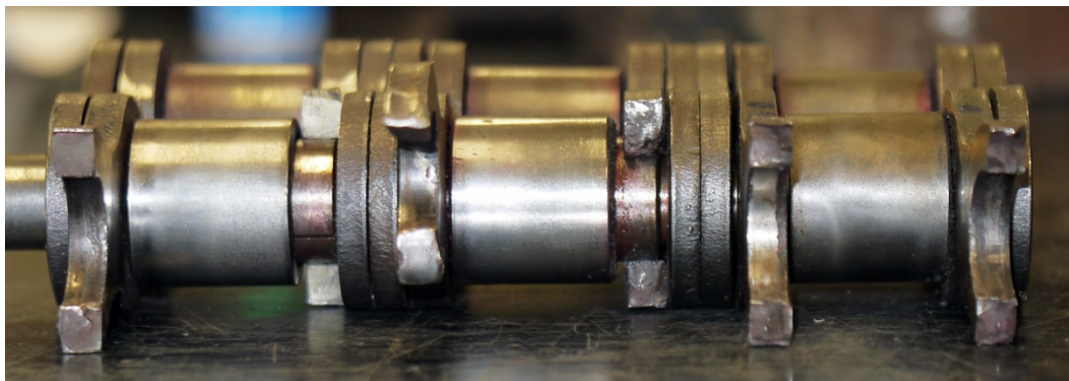
6.2.4 The breakage of the main drive chain was further analysed by material experts at laboratory by stereo micrography and scanning electron micrography. All fracture surfaces contain beach marks, which are characteristics of metal fatigue. (Figures 5 and 6)

Figure 5: Broken roller link plates

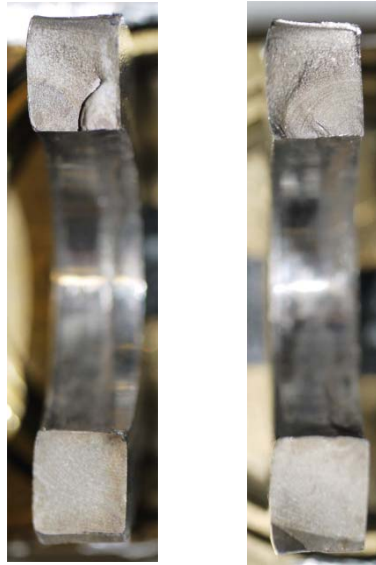
Figure 6: Fracture surfaces

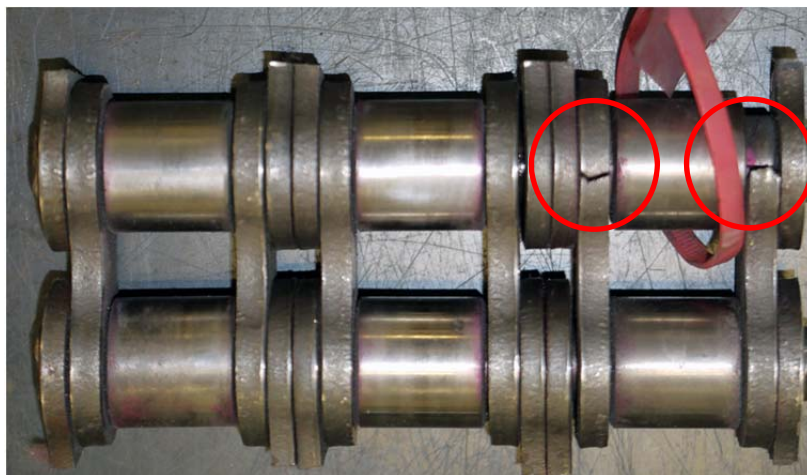
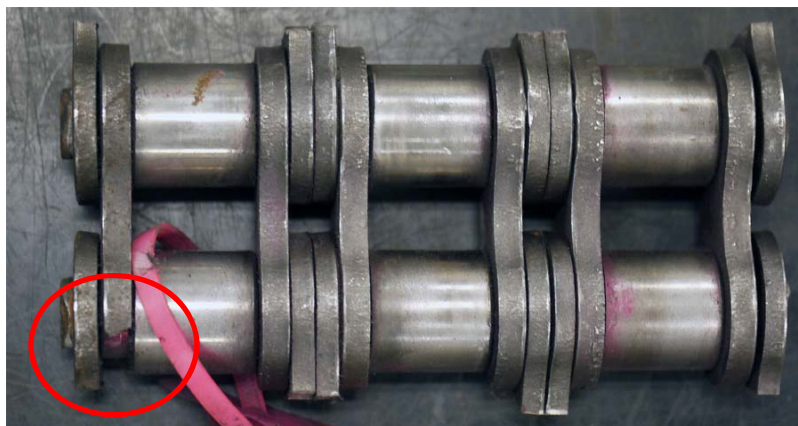
6.2.5 Other than the chain breakage position in between pin Nos. 1 and 104, link plates were also found broken/cracked at other pins (Figure 7).

Figure 7: Other broken/cracked roller link plates

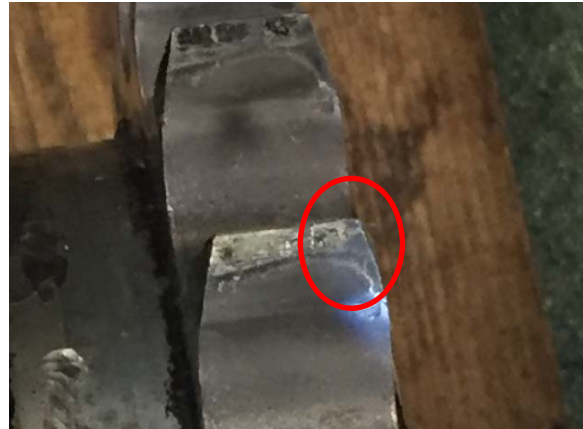
6.2.6 Apart from the abnormal damage to the main drive chain, abnormal wear and scratch were also found at the teeth of the motor sprocket and the step chain sprocket. Figure 8 shows the wear surface on the teeth of motor sprocket.

Figure 8: Photo of wear surface on the teeth of motor sprocket

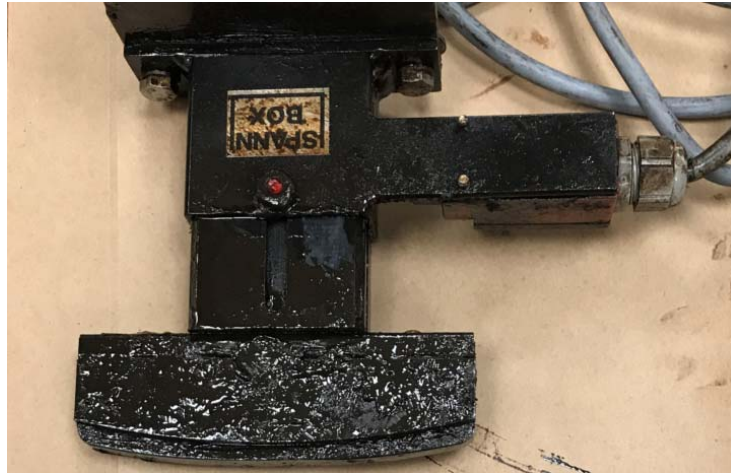
6.3.3 After the incident, the BCD as shown in Figure 9 was seized for laboratory investigation. Having disassembled the BCD, sticky grease was found between the fixed metal housing and the sliding surface of the moving part. The sticky grease was formed from the mixture of oil used for lubricating the main drive chain and dust from the environment.

Figure 9: Photo of the BCD moving part and the shoe. Mixture of lubrication oil and dust formed the sticky grease, which was found on the surface.

6.3.5 The increased friction between the moving part and the fixed metal housing arisen from the sticky grease and the reduced spring force due to an ineffective spring had resulted to the non-operation of the BCD, so that the moving part and the shoe were not extended downwards to activate the micro-switch when the main drive chain was broken. The auxiliary brake was therefore not activated to stop the escalator.

8.5 The EMSD issued a reminder circular No. 3/2017 on 7 April 2017 to remind all registered escalator contractors and registered escalator engineers that the BCD should be properly maintained to ensure the free operation of its entire activation mechanism and to be fully tested to check the full integrated operation of its electrical and mechanical components. Also, the main drive chain should be closely inspected to confirm that it is free from cracks, breakage and excessive elongation, all in accordance with the relevant clauses in the Code of Practice for Lift Works and Escalator Works.

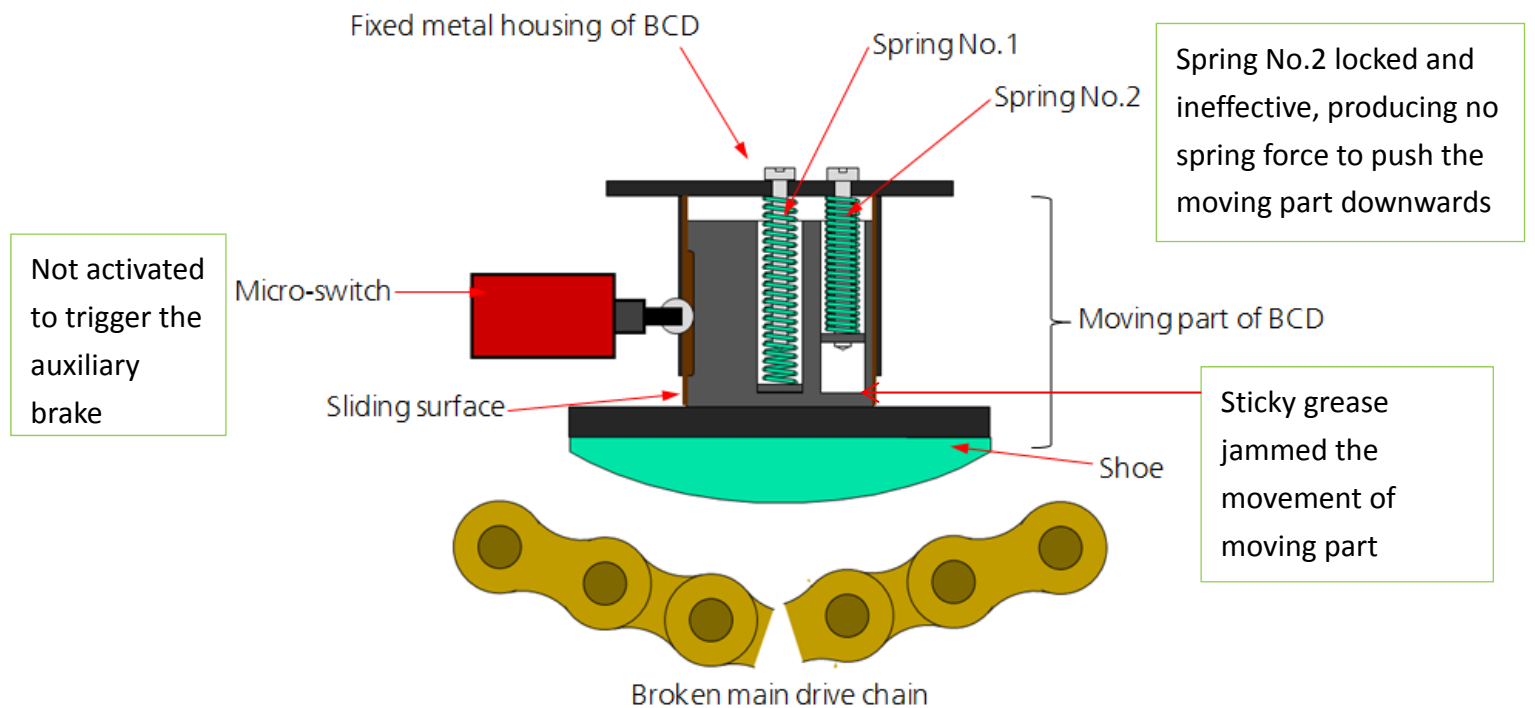
6.3.4 Furthermore, it was found that one of the two compression springs had been locked and made ineffective (i.e. not providing spring force to the BCD moving part), thereby causing reduced spring force to push the moving part downwards. Please refer to Figure 10 for illustration.

Figure 10: Illustration of BCD with spring No. 2 locked and made ineffective

7.2 The breakage of the main drive chain was due to metal fatigue. The malfunction of BCD was due to sticky grease on the sliding surface of the moving part of the BCD and improper setting of the compression springs. The sticky grease and the reduced spring force had hindered the operation of the moving part so that no signal was sent to the auxiliary brake to stop the escalator when the main drive chain was broken.
