Legislative Council Panel on Transport
Subcommittee on Matters Relating to Railways

Overhead Line Incident on MTR Kwun Tong Line
on 10 April 2017

MTR Corporation Limited
April 2017

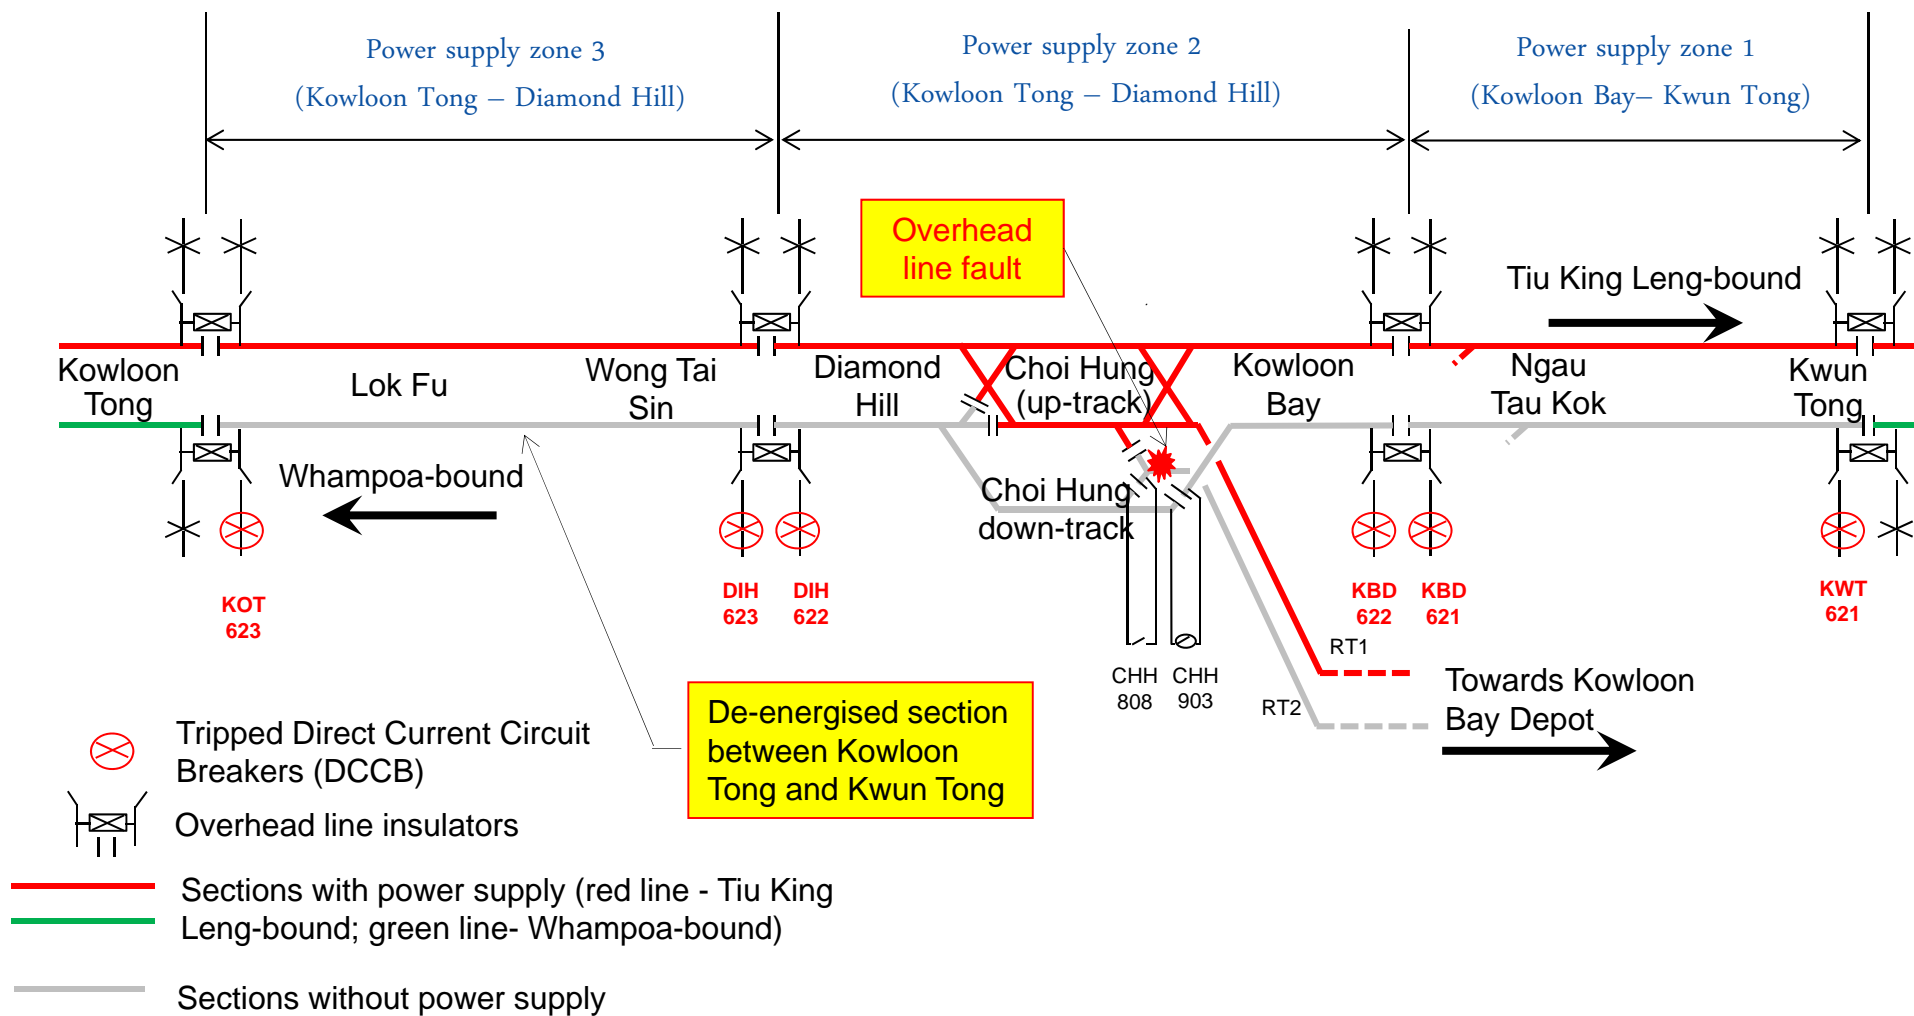
Power supply zones between Kowloon Tong and Kwun Tong stations

- (2) there are three power supply zones along the section between Kowloon Tong and Kwun Tong stations (see Annex 1). OCC attempted to re-energise the overhead line power supply for the three zones one by one and was successful in re-energising two of them, namely the zone between Kowloon Bay and Kwun Tong stations and the zone between Diamond Hill and Kowloon Tong stations. Power supply for the remaining zone (between Kowloon Bay and Diamond Hill stations) could not be resumed. Therefore, OCC narrowed down the cause of the incident to the overhead line of that particular section; and
- (3) maintenance staff was arranged to enter the track between Kowloon Bay and Diamond Hill stations for inspection.
