**Legislative Council Panel on Transport  
Subcommittee on Matters Relating to Railways**

**Progress on Upgrading Signalling System for Railway Lines**

## **Executive Review Panel Report on Signal Control Failure at Kwun Tong Station Area on 5 August 2017**

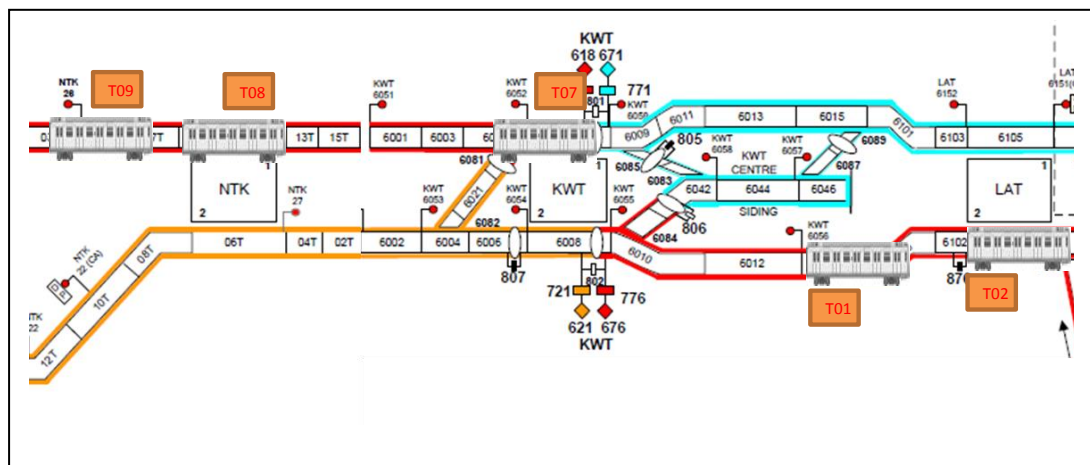
- 4.1 At the start of the incident, there were 2 trains stranded between stations, namely train T01 which had just left Lam Tin station (LAT) and T09 which was approaching Ngau Tau Kok station (NTK).

Diagram 4.1: Locations of Affected Trains  
(NTK = Ngau Tau Kok station, KWT = Kwun Tong station, LAT = Lam Tin station)

- 4.3 While T01 was stranded, the following train T02 was held at LAT platform automatically by the signalling system for LAT area control. After stopping for 5 minutes, T01 was manually driven to KWT platform to release the passengers. As the forward path was cleared, T02 was automatically driven by the signaling system to the next signal KWT6056 at which it became stranded. It took another 48 minutes before T02 can be moved to KWT platform following safety procedures.

- 4.4 It is normal practice to leave trains under automatic signaling control as far as possible because this is the best way to minimize train-running delays. With hind-sight, although this is not in the standard procedure, train T02 could have been manually held at LAT and it would not have been stranded between two stations.

- 4.5 ***The Panel considers that there is room for improving the procedure in releasing stranded trains and preventing additional trains from becoming stranded in incidents.***

- 4.6 ***The Panel also recommends that the revised procedure be included in traffic control staff's normal and refresher training. Drills and exercises should be carried out to ensure competency of all relevant staff in applying the procedure.***

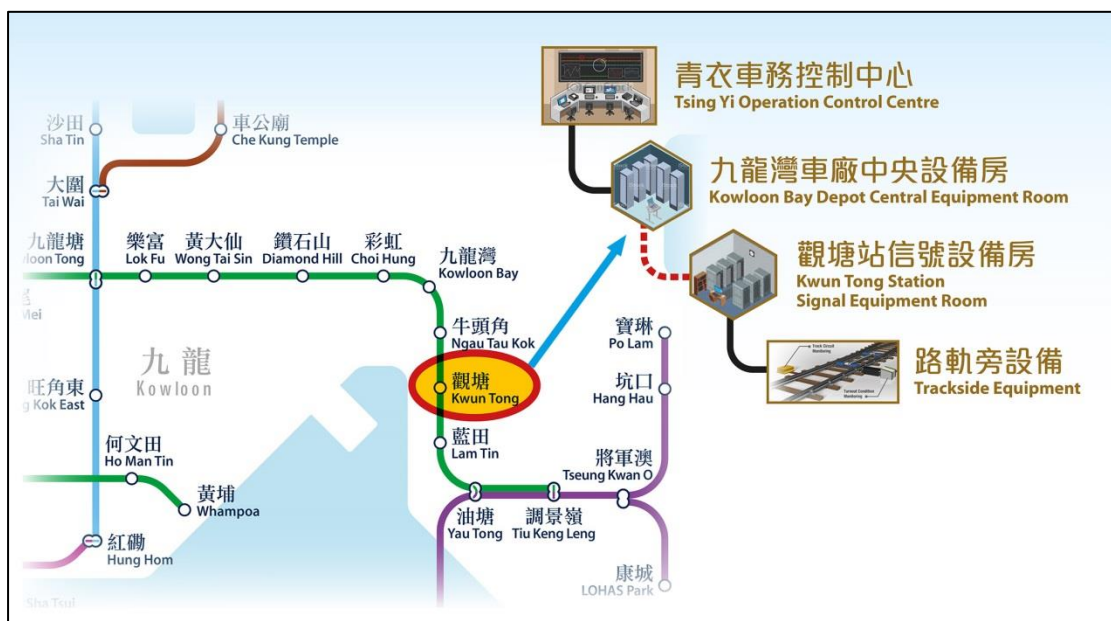
- 6.1 The root cause of the incident was an intermittent open circuit in one of the two concurrent data transmission link cables. The two link cables provide redundancy in the signaling interlocking so that signaling control will work normally as long as one cable is working. However, the intermittent open circuit did not stop data transmission in that cable completely, but rather it caused intermittent loss or corruption of data. The resulting data corruption caused the KWT area interlocking system to automatically shut down according to the fail-safe design principle.

- 6.2 Each of the two data links consists of a twisted pair of copper cables that run along track-side in insulated sheaths. KWT signalling interlocking is the only interlocking in the MTR network that is still using copper cables as long distance data link between equipment rooms. All the rest use fibre optics. Although new systems will use fibre optics, copper cable is a well-established technology for data transmission. The KWT copper cables were originally planned to be removed when the KTL signalling system is replaced in 2020.

Diagram 6.1: Data transmission

- 6.3 The intermittent fault was due to water ingress and corrosion inside one junction box of the copper cables. The corrosion of electrical contacts coupled with train movement vibrations caused intermittent short duration open-circuits, resulting in intermittent loss or corruption of data. As the inter-locking system detected inconsistent data set, it executed the fail-safe protocol and shut down all the 3 Multiple-Processor Modules (each module is like a computer), causing all trains in the affected interlocking area to stop. Such an intermittent cable fault had never happened in the KTL interlocking system in the past.

- 6.4 The junction boxes were supplied with the original cables and had sufficient water proofing for track-side / outdoor environment. It appeared that in one box the water-proof seals had not been able to completely prevent water ingress, perhaps during the recent typhoons and heavy rainfall. The water ingress then led to corrosion of electrical contacts inside the boxes.

- 6.7 ***The Panel recommends to convert the KWT signal interlocking data-links into a fibre optic system before end of October 2017.***
