Legislative Council Panel on Transport
Subcommittee on Matters Relating to Railways

Train Service Disruption on MTR East Rail Line on 11 January 2018

**Investigation Results on
Train Control System Failure on
East Rail Line on 11 January 2018**

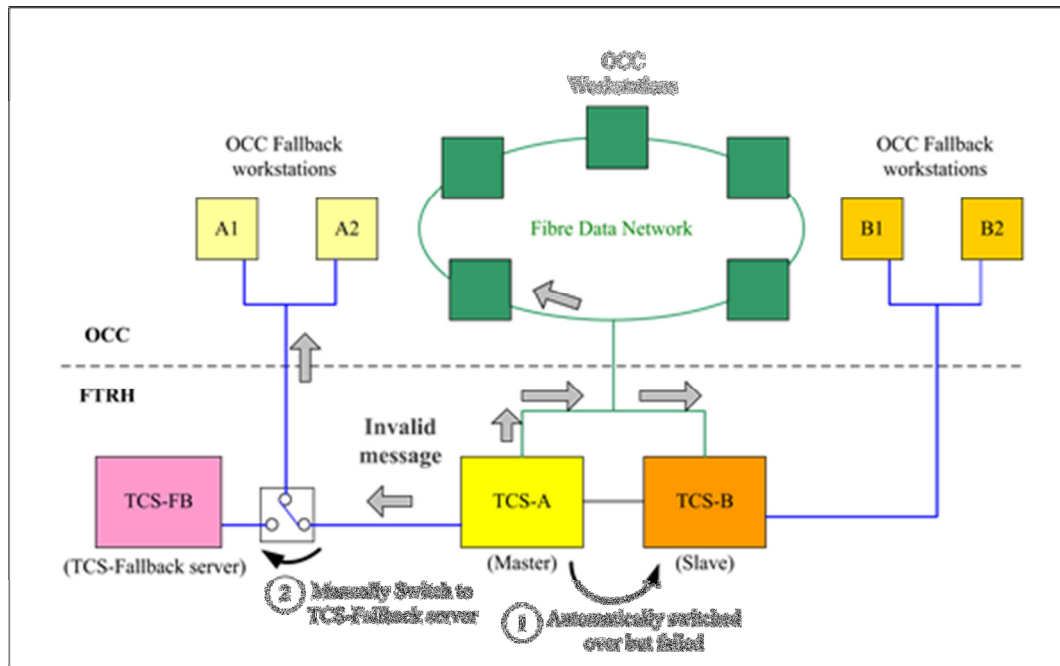
Figure 1: EAL TCS Servers and Workstations configuration

3.3 It was identified in subsequent investigation that TCS-A sent out an “invalid message” after the controller had executed the concerned train regulation command, which triggered a situational software issue. It resulted in the halting of all the OCC workstations including the fallback ones at the OCC as well as TCS-A due to surge use of its software memory resource. Figure 1 below shows the TCS servers and workstations configuration during the incident.

- 3.4 At the beginning of the failure, the system automatically switched over the server from TCS-A to TCS-B, but the system failed to recover with sluggish response because TCS-B was busy performing synchronization of trackside signalling status with the SSI and responding to the workstations rebooting.
- 3.5 The technical team had to manually switch over the server to TCS-FB while carrying out a few attempts to reset TCS-A and TCS-B servers. It took more time than expected because the fallback workstations were also disturbed by the “invalid message”, which needed to be rebooted.
- 3.6 The system eventually resumed normal operation at 1021 hours after the TCS-FB server and fallback workstations had been activated successfully.
