**Legislative Council Panel on Transport
Subcommittee on Matters Relating to Railways**

**Shatin to Central Link
Incidents relating to the works at
To Kwa Wan Station and Exhibition Centre Station**

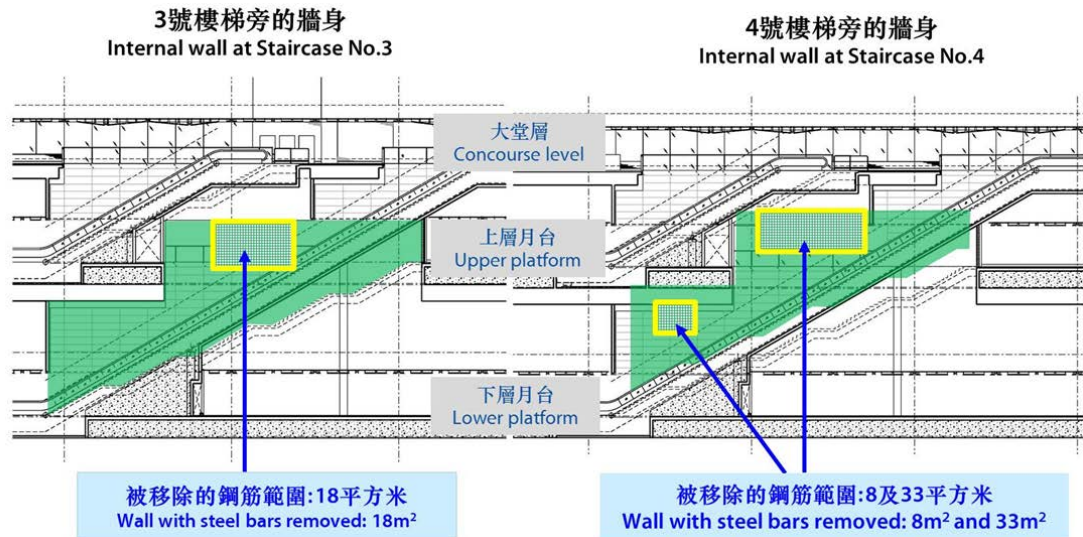
3. As stated in the Report submitted to the Government, the internal wall was constructed in accordance with the drawings, as confirmed by relevant inspection records. According to the Contractor, during the trimming of over-cast concrete to achieve a smooth surface for tiling over the internal wall, some of the reinforcement bars at three localised areas totalling 60m² were removed.

Figure 1 – Steel bars removed at three locations on an internal wall of TKW

6. The Contractor has submitted a proposal on the reinforcement rectification works, which involves removing the architectural finishes and opening up the concrete from the front face of the defective sections of the wall. The Contractor will carry out the rectification works once necessary consent has been obtained from the Corporation and Government. The reinforcement rectification works are expected to commence in July, which is envisaged to take around three months and expected to be completed by mid-October. The Corporation will closely supervise these reinforcement rectification works.

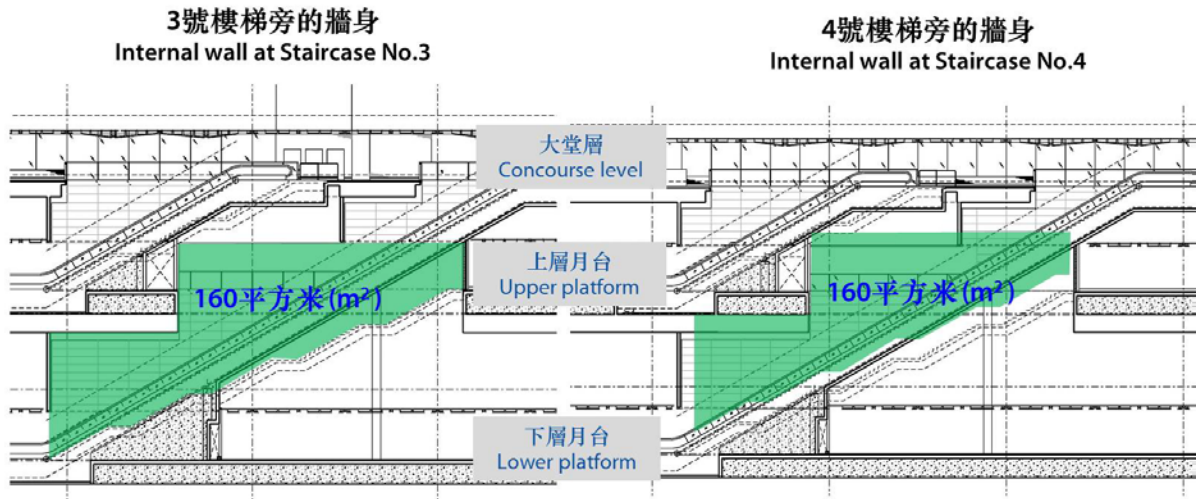
5. The Corporation is very disappointed with the Contractor for not following the approved concrete repair method statement when undertaking the minor remedial works for the over-cast concrete, and we take such contravention very seriously. Although the Contractor has stated that it suspects that the areas of concern are limited to the areas described above, as a matter of prudence and to address public concerns, the Corporation has instructed the Contractor to open up the whole area that was previously trimmed, to ensure that either the works are in accordance with the drawings or to undertake remedial works in accordance with the approved method statement.

Figure 2 – Checking on all wall surfaces previously trimmed at TKW

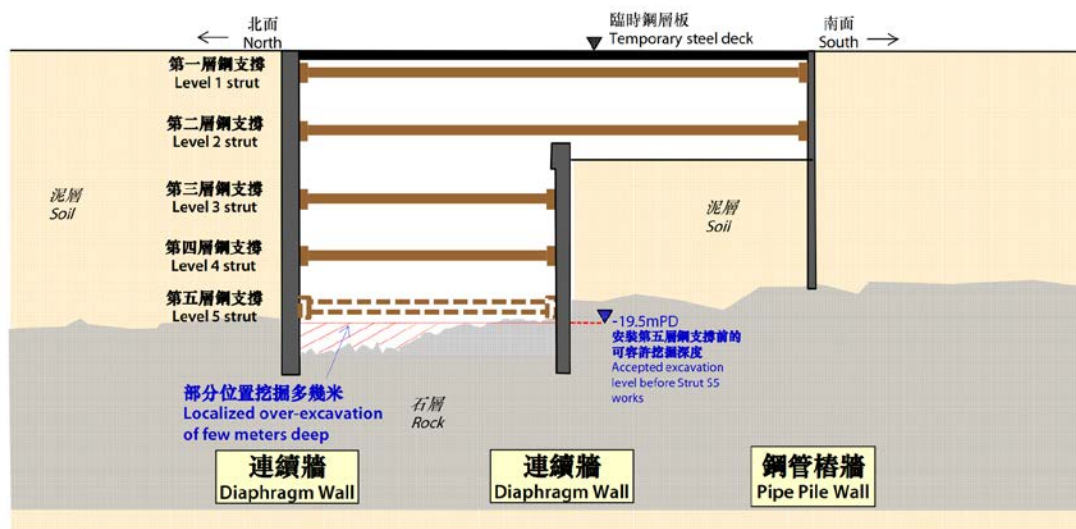
6. The Contractor has been installing the temporary steel strutting in accordance with the contractual requirements from first to fourth layers. On 9 May 2018, the Corporation observed a localised over-excavation by approximately a few metres lower than the allowable depth of -19.5mPD level during rock breaking without installation of the fifth and final layer of temporary steel strut.

7. The Corporation issued to the Contractor an NCR on 10 May 2018 and discussed the appropriate remedial proposal with the Contractor on the same day, including backfilling and installing of the required strut at level 5. Backfilling and the necessary general excavation and rock breaking along the southern diaphragm wall for the level 5 strut installation were carried out afterwards. Backfilling works at this localised area had been subsequently completed and the installation of the required strut at level 5 was completed on 17 June 2018.

Figure 3 – The non-conformance

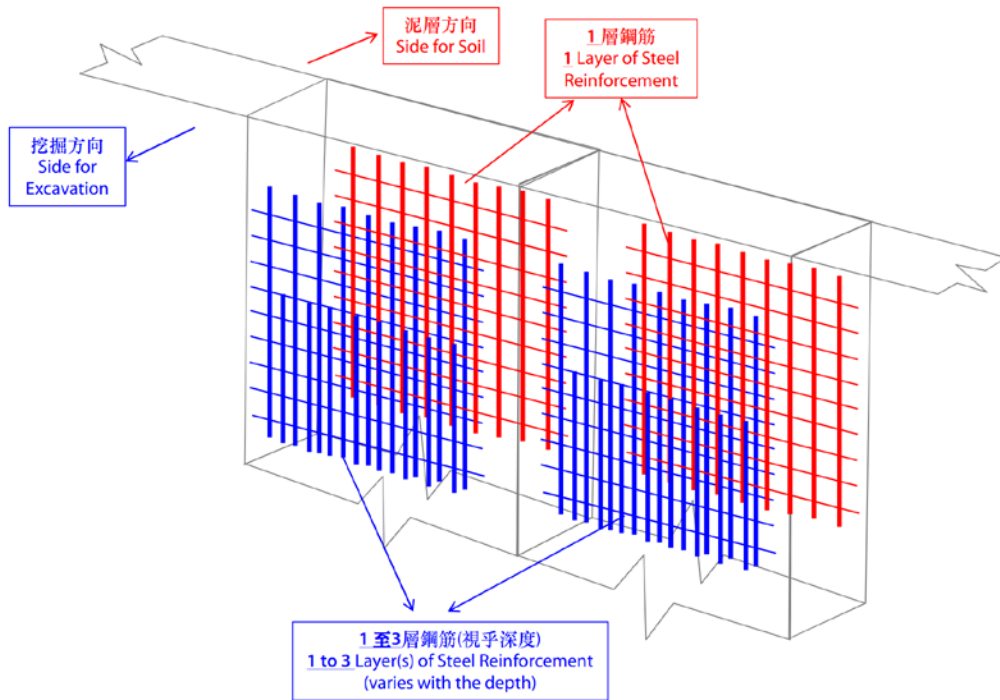
8. The design drawings of the works concerned were correctly prepared by the Contractor's design consultant and accepted by relevant Government departments in early 2016. Instead of the typical notation of "Excavation Face" and "Soil Face", "East/South Face", "West Face", "North/West Face", "South/East Face", etc. were used in these design drawings.

Figure 3 – Layer(s) of steel reinforcement in design drawings

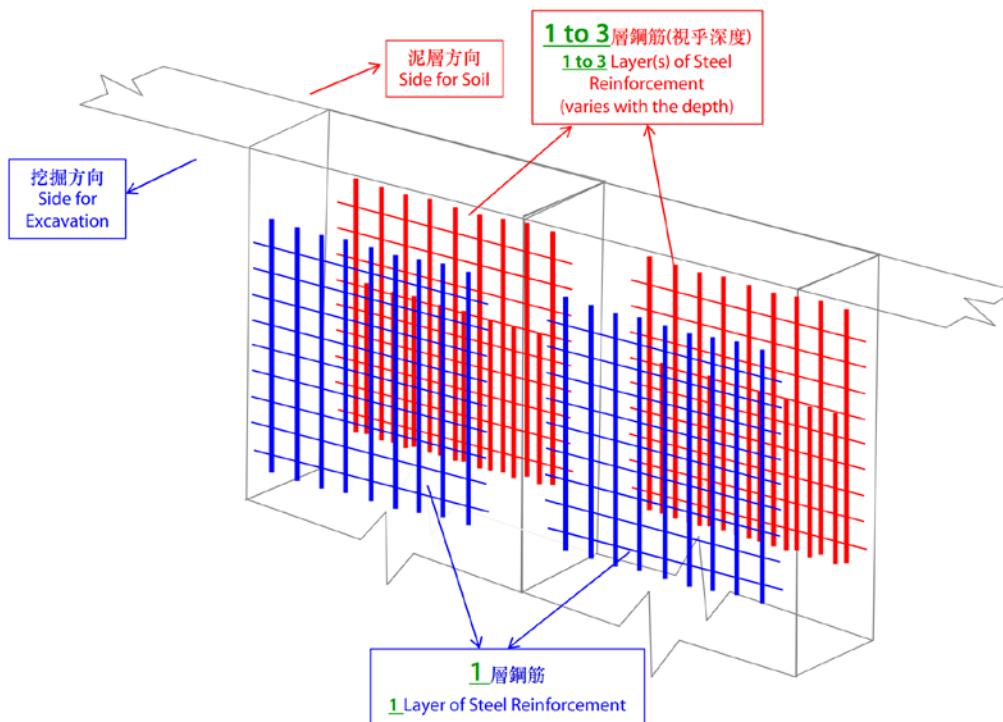
9. Shop drawings for the reinforcement steel cage for these diaphragm wall panels were then prepared by the diaphragm wall subcontractor based on the design drawings. When preparing the shop drawings for the reinforcement steel cage of two diaphragm wall panels at Area C2, the subcontractor misinterpreted the direction of the "East/South Face", "West Face", "North/West Face", "South/East Face", etc., leading to errors in the shop drawings. The layer(s) of steel reinforcement at the excavation face was wrongly placed at the soil face in the shop drawings.

Figure 4 – Layer(s) of steel reinforcement in shop drawings

40. After the misplacement of reinforcement inside the diaphragm walls was discovered, the MTRCL revised the diaphragm wall design by adding concrete buttress wall to share the original design load. Having due regard to structural safety, the amendment proposed by the MTRCL was considered acceptable to the HyD. The Contractor had also carried out the works in accordance with the amendment. At that time, the HyD had urged the MTRCL to strengthen the management and supervision system of the project in order to avoid the recurrence of similar incidents.

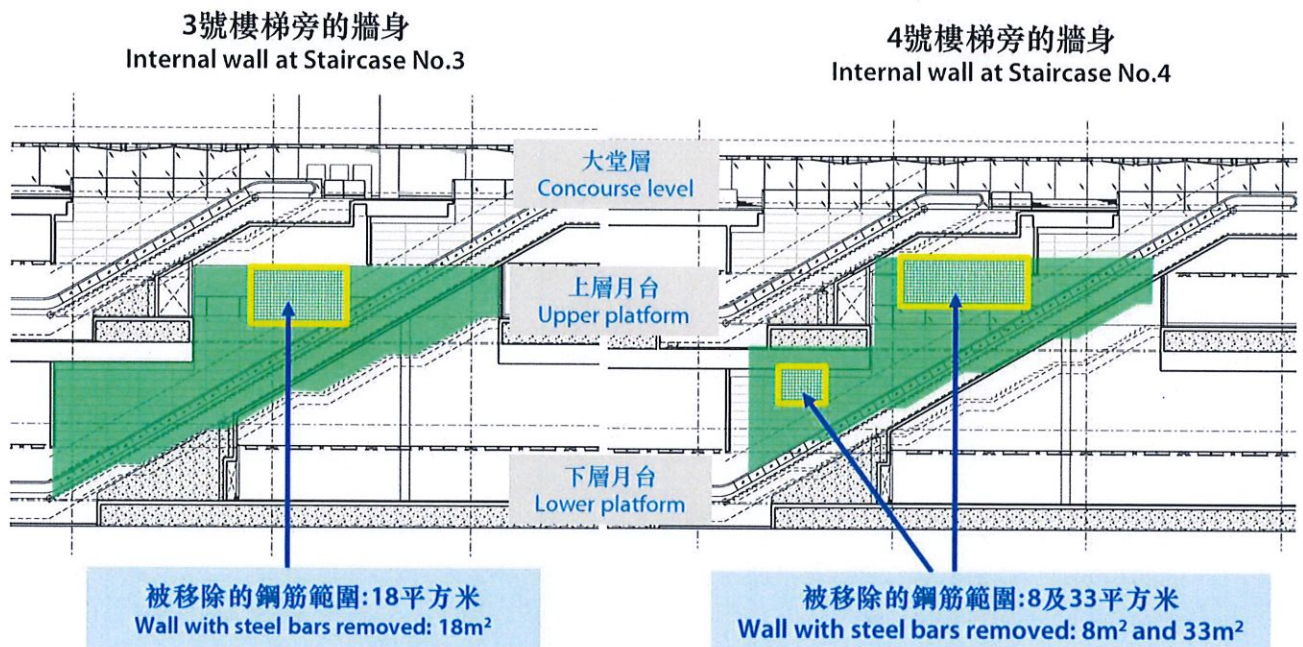
Following construction, part of the front face of the Internal Wall was found to have slightly shifted toward the public area of the station due to bulging of formwork during the concreting process, resulting in over-casting of concrete in uneven thickness at different areas of the wall surface. To remedy this bulging the process is a straight forward concrete trimming and repair for which there is a clear approved

method statement. However, during the subsequent remedial trimming of the over-cast concrete to achieve a smooth surface for tiling, some of the reinforcement bars at a localized area (which the Contractor estimates at approximately 18m²) were removed from one face of the Internal Wall. This is an unauthorised deviation from the approved method statement. The Contractor reported on 15 June 2018 that similar situations are suspected to have occurred at two other localized areas (which the Contractor estimates at approximately 8m² and 33m²) of the same Internal Wall adjacent to Staircase ST-04. It should also be noted that the average thickness of the internal wall after trimming ranges from 175mm to 180mm respectively at staircases ST-03 and ST-04.

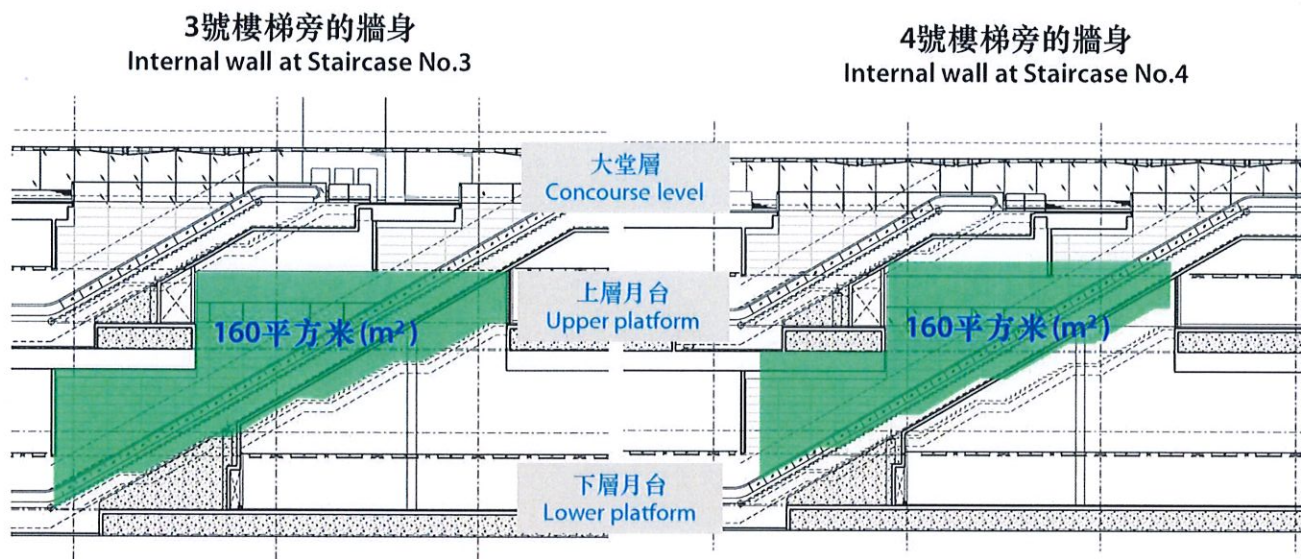
The total area of the Internal Wall adjacent to each Staircase (i.e. ST-03 and ST-04) is approximately 350m² (i.e. 700 m² in total for both staircases) and the area of concrete trimming for each Staircase estimated by the Contractor was approximately 160 m² (i.e. 320 m² in total for both staircases). The Contractor has advised that it has carried out extensive review of the “suspected areas” requiring further investigation and has employed a specialist to conduct non-destructive testing over these areas. The Contractor’s estimate is that of the approximately 320 m² concrete trimmed area a total area of approximately 60 m² may not have been in accordance with approved drawings. Contrary to media reports, there is no evidence

suggesting reinforcement bars were removed from the 250mm thick parapet wall (the “Parapet Wall”).
