**Legislative Council Panel on Transport
Subcommittee on Matters Relating to Railways**

**Incident of the new signalling system testing on
Tsuen Wan Line on 18 March 2019**

(Information Paper)

**Investigation Report on
Incident of the New Signalling System Testing on
MTR Tsuen Wan Line**

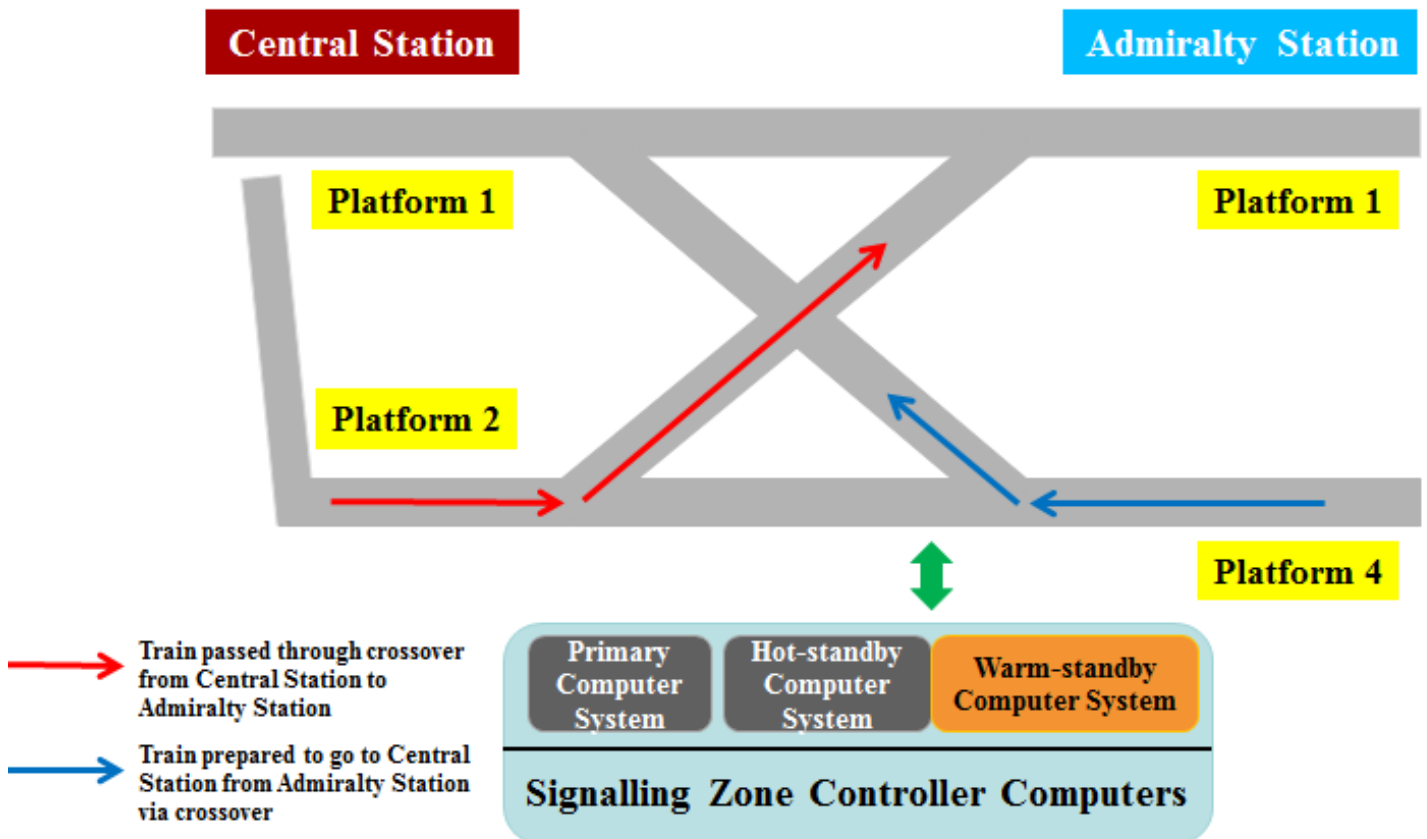
Diagram of the incident

10. During the drill at around 2:44 am, the first train car of an MTR train, while entering the platform of Central Station through a crossover, collided with another train that was departing Central Station for Admiralty Station through the same crossover at the same time. The collision damaged the second to fourth cars of the latter train. Please refer to **Annex 1**.

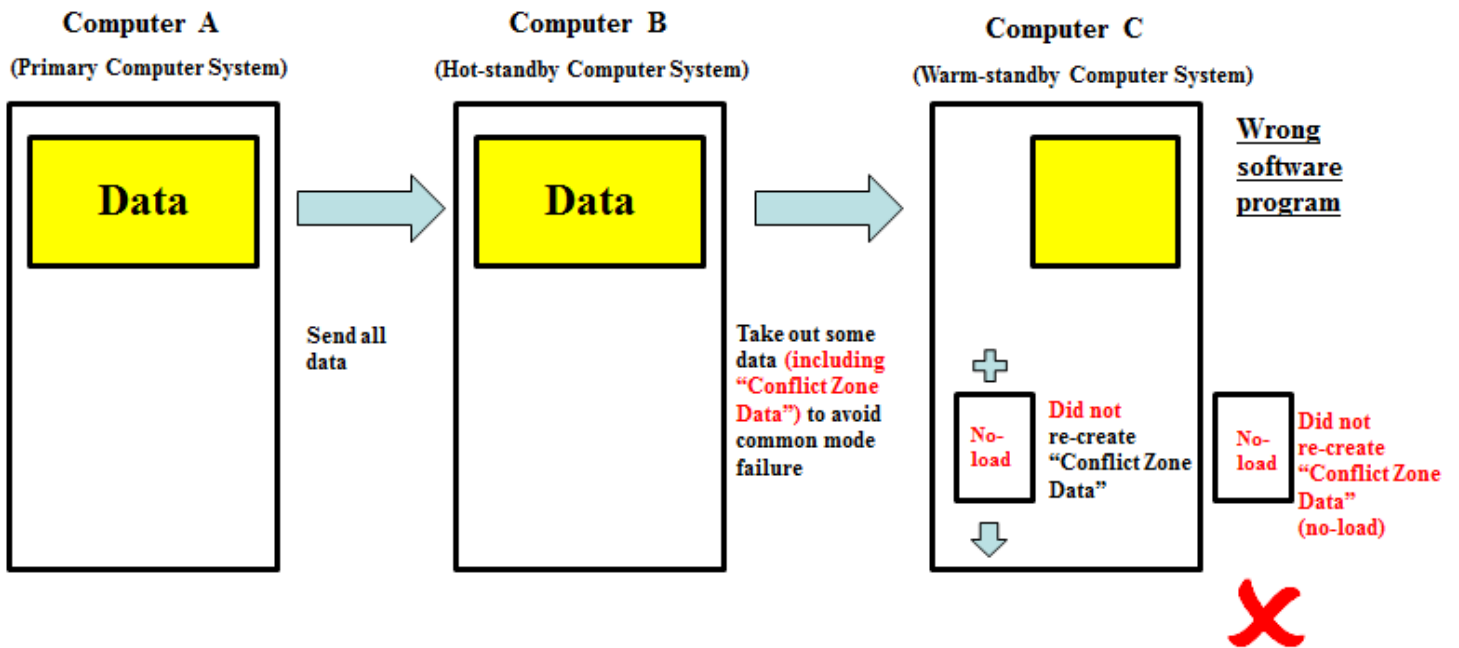
Annex 4

- (b) irrespective of the first implementation error, the contractor had excluded the transfer of the “Conflict Zone Data” from the Primary and Hot-standby Computer Systems to the Warm-standby Computer System during the software change. Nonetheless, its software design and development team had made a software implementation error which caused the Warm-standby Computer System failing to re-create the “Conflict Zone Data” properly. The details of the software implementation error are at **Annex 4**; and

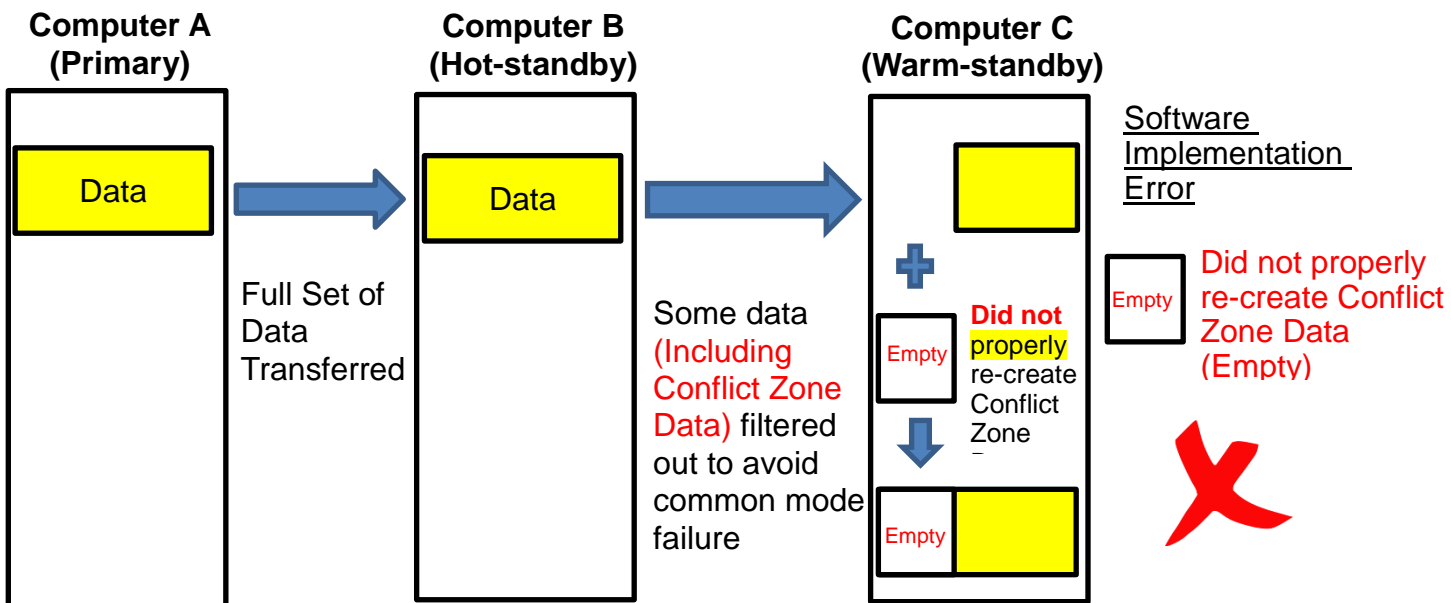
Software Implementation Errors resulted into an unknown software issue

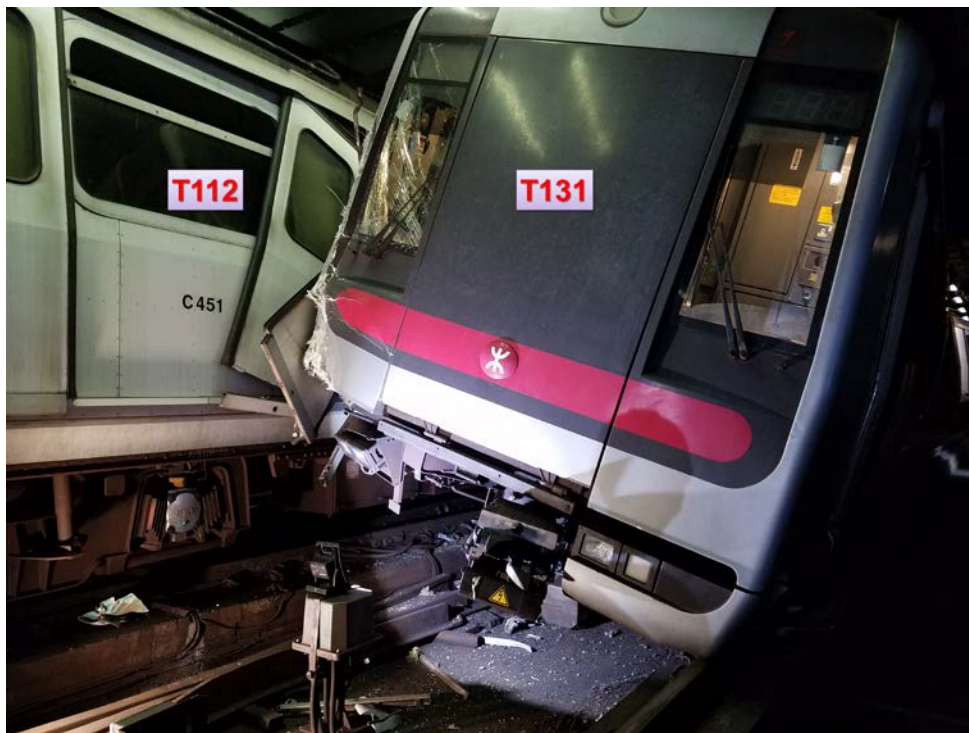
2.3 According to the train logs, train T131, which was travelling from Admiralty Station to platform no. 1 of Central Station, collided with train T112 at a speed of 19 kph at the Central Station crossover track (Figure 1) at the time of the incident. At that moment, train T112 was travelling from Central Station to Admiralty Station at a speed of 31 kph when passing through the crossover track. The collision resulted in damages to the second to fourth cars of train T112 (Figure 2) and derailment of two bogies of the first car of train T131. The two train captains were taken to hospital for medical check and discharged on the same day.

Figure 1: Condition of the trains after collision

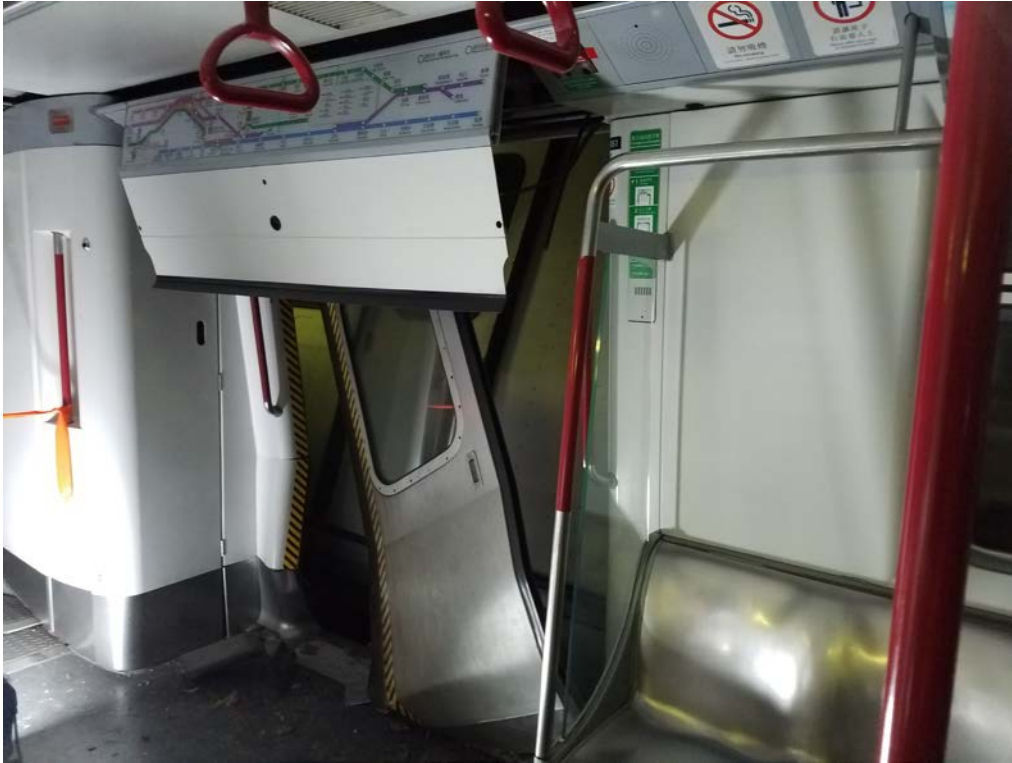
Figure 2: Damage to the saloon of train T112

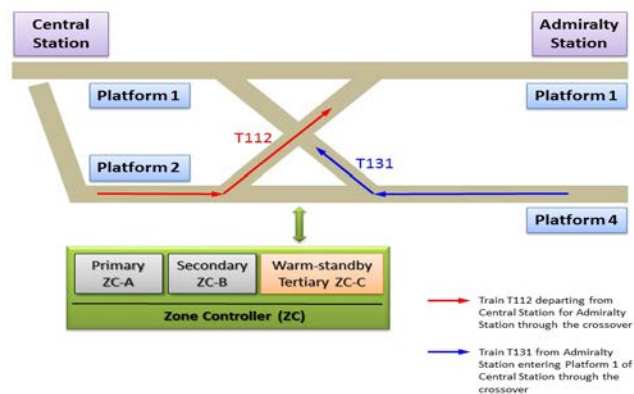
2.4 According to the train logs and the train captains' interview records, the train captain of train T131 had pressed the emergency brake button before the collision to try to stop the train, but train T131 could not be stopped timely and collided with train T112. Moreover, according to the train logs, the ATP system could not function at that moment to restrict these two trains from entering into the crossover track at the same time. Figure 3 illustrates the train movements during the incident.

Figure 3: Train movements during the incident

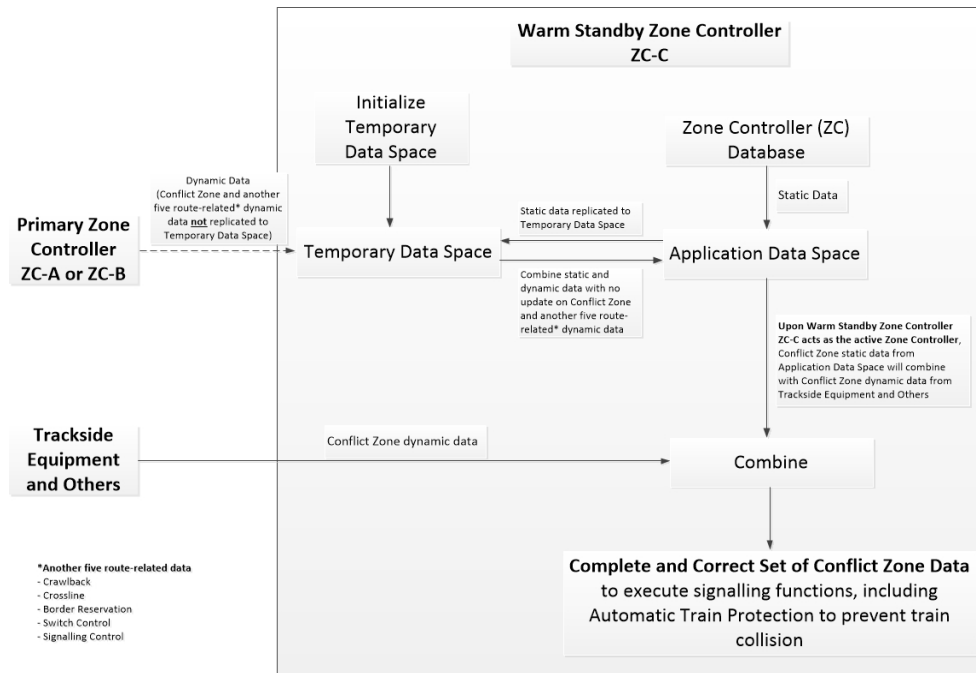
Figure 5: Integration of conflict zone data from primary/secondary ZCs, warm-standby tertiary ZC and trackside equipment

3.8 However, during the collision incident, due to programming error, the software subroutine mentioned above for conflict zone was not executed in the warm-standby ZC-C when it took up the active ZC role, and therefore the conflict zone data in ZC-C could not be re-created correctly. This error allowed two trains to enter the incident conflict zone and caused the collision.

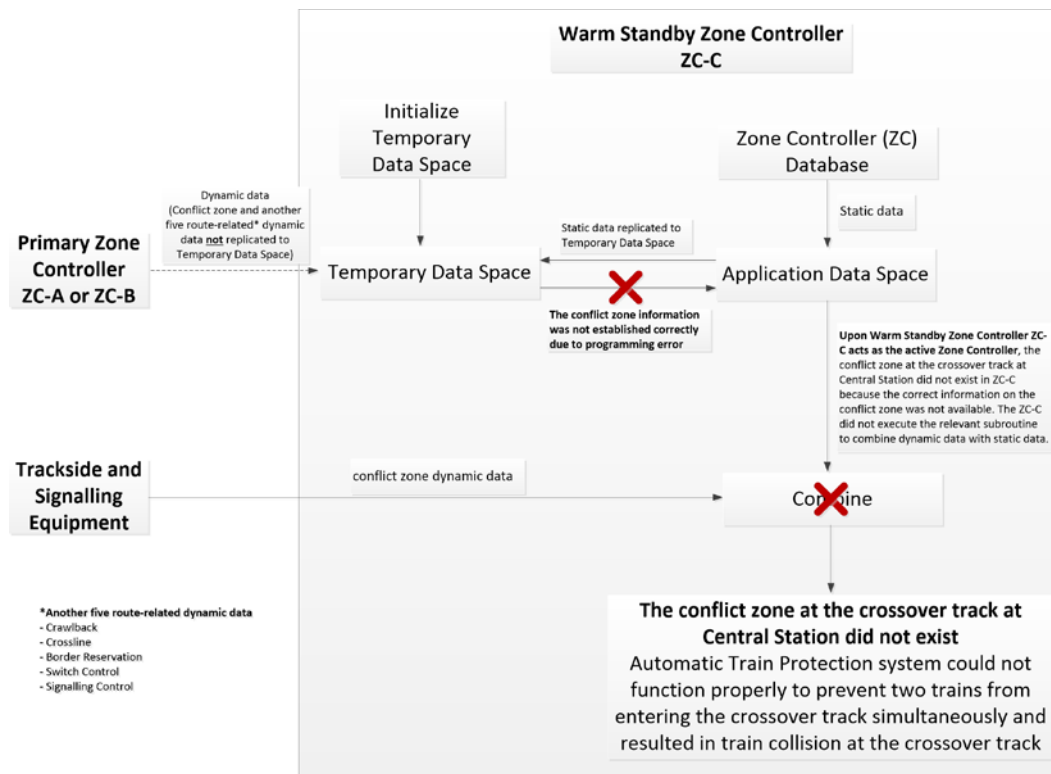
The investigation revealed, when ZC-C took up the active ZC role, the computer programme for handling conflict zone data did not execute the relevant subroutine to combine the dynamic data with the static data and did not re-create the conflict zone information correctly (Figure 6). Because the correct information on the conflict zone was not available, the conflict zone at the crossover track at Central Station did not exist in ZC-C. In the end, the ATP system could not function properly to prevent two trains from entering the crossover track simultaneously and resulted in the train collision.

Figure 6: The tertiary ZC did not execute the relevant subroutine to combine the dynamic data with static data

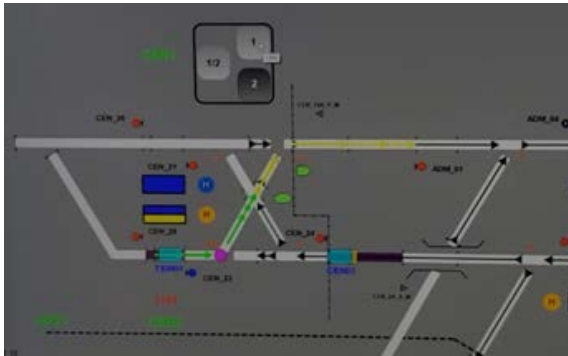
Figure 7: Simulator in ATDJV Hong Kong Office showed the route setting for trains T112 and T131 entering the conflict zone at Central Station at the same time.

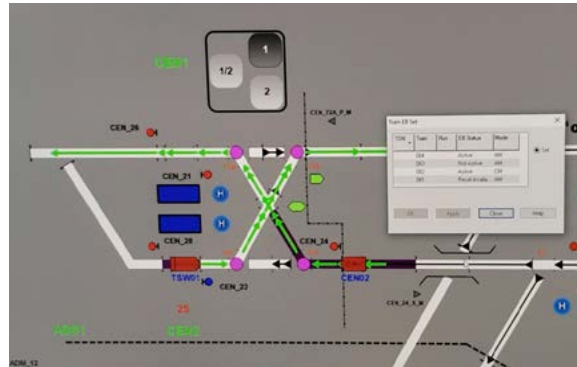
Figure 8: Simulator in ATDJV Hong Kong Office showed the trains entering the conflict zone at Central Station, as the route setting had allowed them to do so.

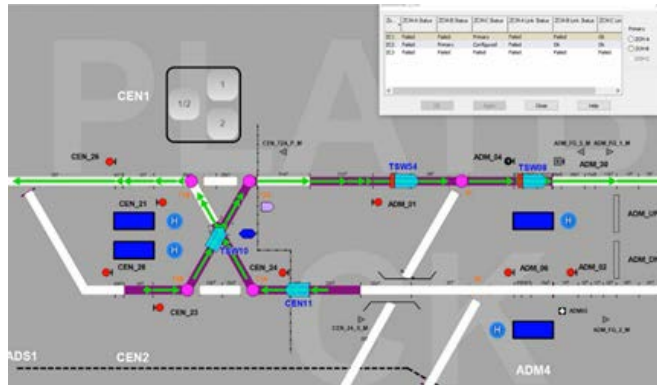
Simulation tests (Figures 9 and 10) were conducted at Ho Man Tin Station by using the ZCs and VOBCs of the incident trains with the same location and conditions of the incident, with a view to ascertaining whether the incident was caused by the incident ZCs and VOBCs. According to the results of the simulations, the same incident would happen by using the incident ZCs and VOBCs in the simulator.

Figure 10: Simulation results showed the ZCs and VOBCs of the incident trains allowing the trains to enter the conflict zone at Central Station at the same time

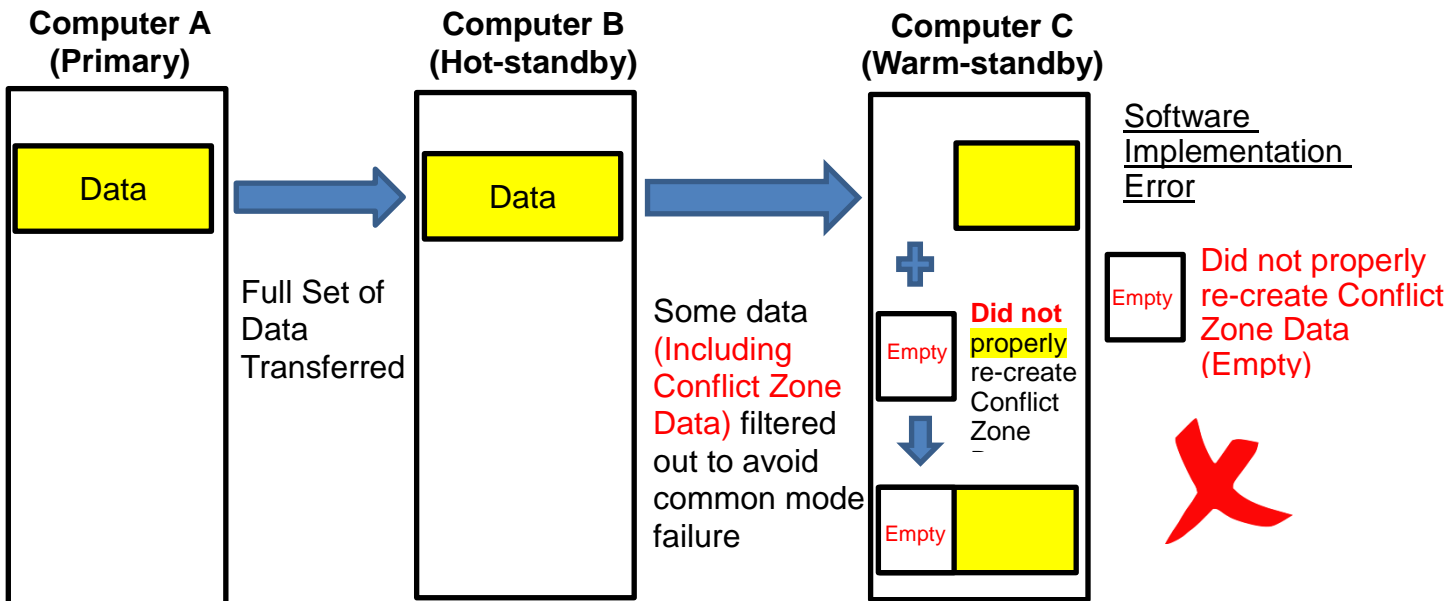
Software Implementation Errors resulted into an unknown software issue

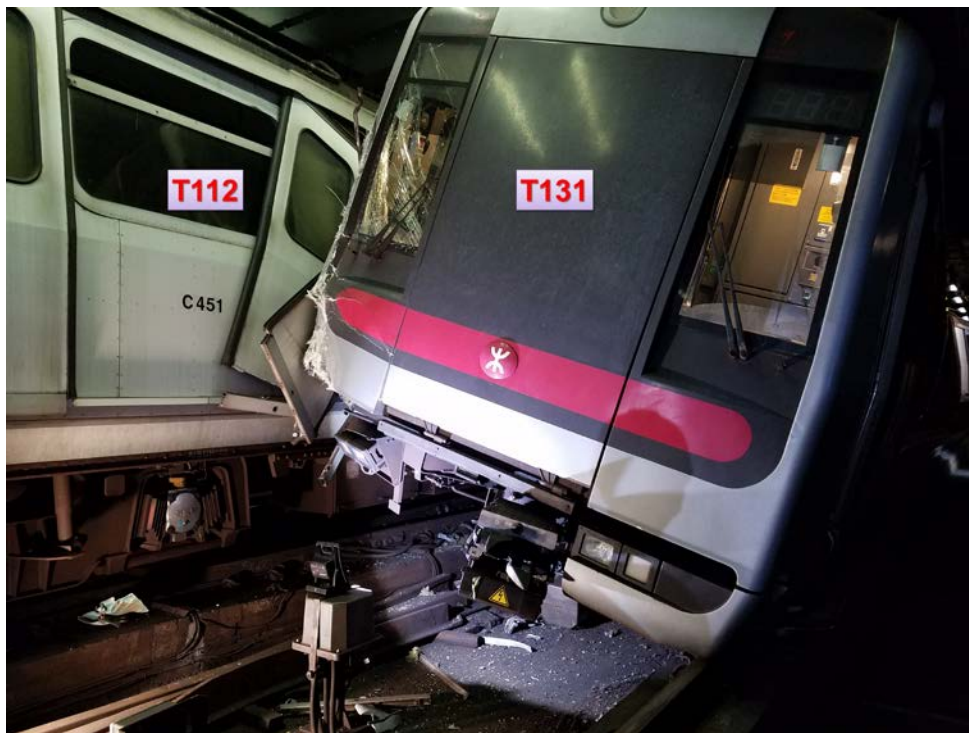
2.3 According to the train logs, train T131, which was travelling from Admiralty Station to platform no. 1 of Central Station, collided with train T112 at a speed of 19 kph at the Central Station crossover track (Figure 1) at the time of the incident. At that moment, train T112 was travelling from Central Station to Admiralty Station at a speed of 31 kph when passing through the crossover track. The collision resulted in damages to the second to fourth cars of train T112 (Figure 2) and derailment of two bogies of the first car of train T131. The two train captains were taken to hospital for medical check and discharged on the same day.

Figure 1: Condition of the trains after collision

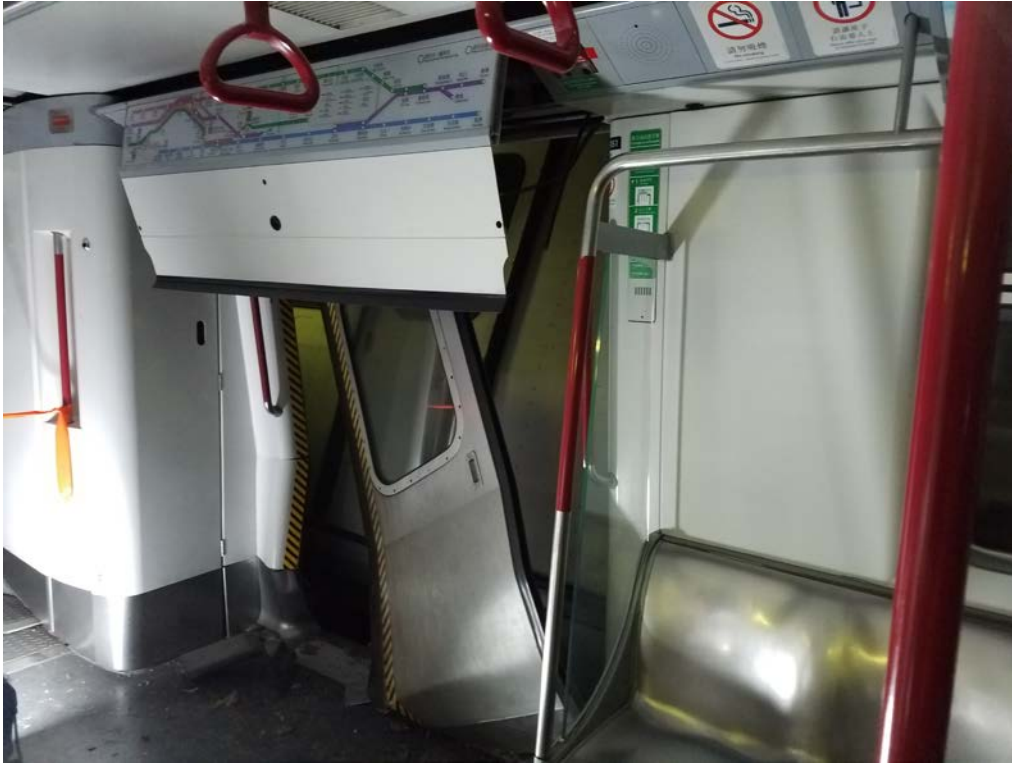
Figure 2: Damage to the saloon of train T112

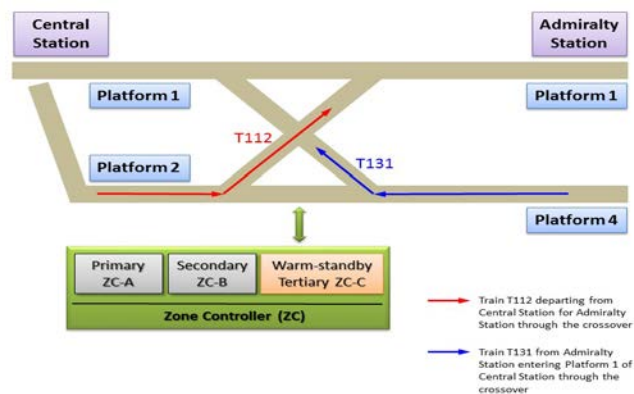
2.4 According to the train logs and the train captains' interview records, the train captain of train T131 had pressed the emergency brake button before the collision to try to stop the train, but train T131 could not be stopped timely and collided with train T112. Moreover, according to the train logs, the ATP system could not function at that moment to restrict these two trains from entering into the crossover track at the same time. Figure 3 illustrates the train movements during the incident.

Figure 3: Train movements during the incident

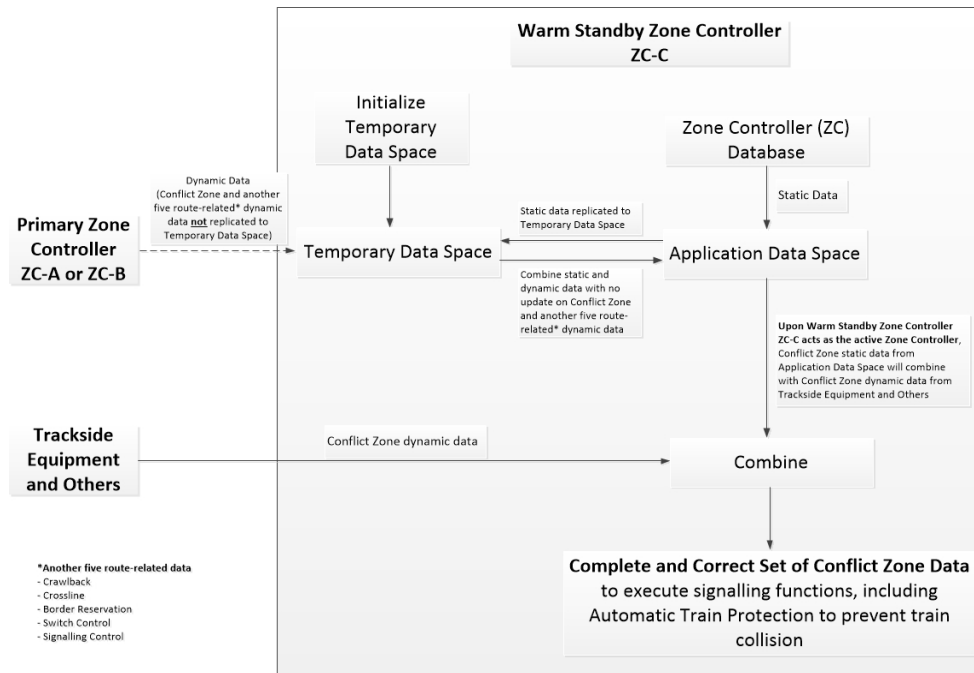
Figure 5: Integration of conflict zone data from primary/secondary ZCs, warm-standby tertiary ZC and trackside equipment

3.8 However, during the collision incident, due to programming error, the software subroutine mentioned above for conflict zone was not executed in the warm-standby ZC-C when it took up the active ZC role, and therefore the conflict zone data in ZC-C could not be re-created correctly. This error allowed two trains to enter the incident conflict zone and caused the collision.

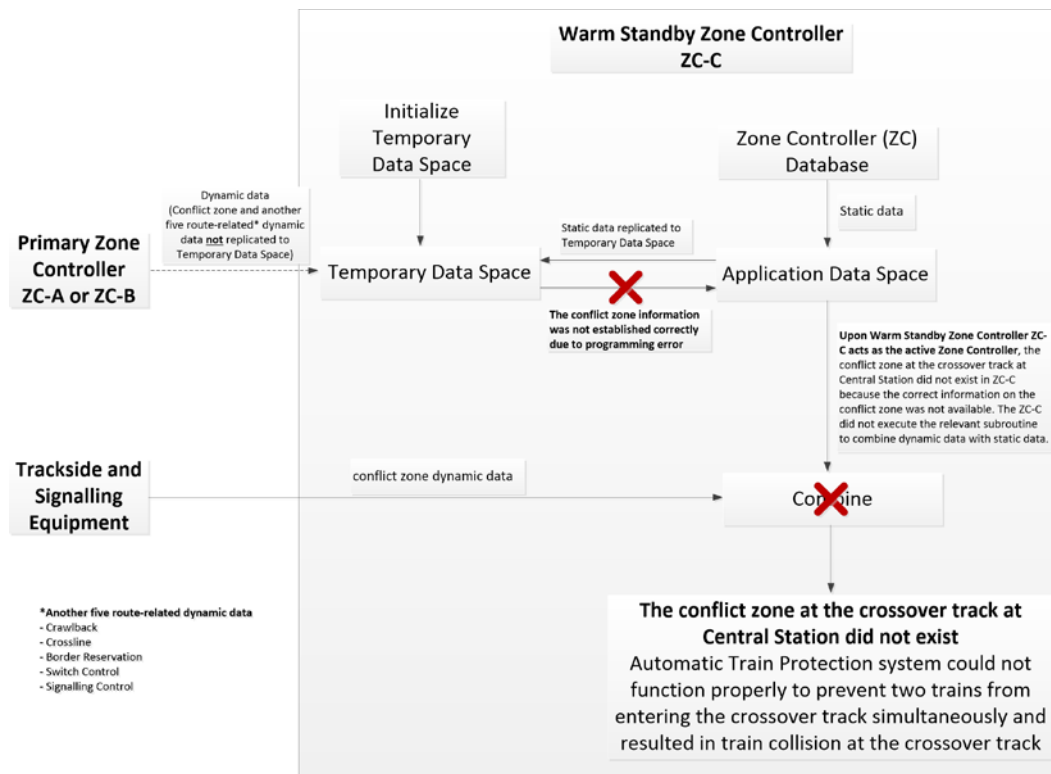
The investigation revealed, when ZC-C took up the active ZC role, the computer programme for handling conflict zone data did not execute the relevant subroutine to combine the dynamic data with the static data and did not re-create the conflict zone information correctly (Figure 6). Because the correct information on the conflict zone was not available, the conflict zone at the crossover track at Central Station did not exist in ZC-C. In the end, the ATP system could not function properly to prevent two trains from entering the crossover track simultaneously and resulted in the train collision.

Figure 6: The tertiary ZC did not execute the relevant subroutine to combine the dynamic data with static data

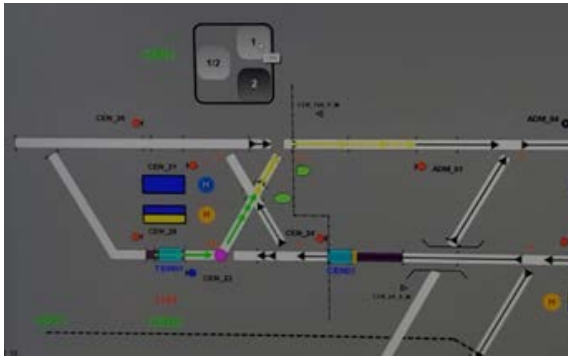
Figure 7: Simulator in ATDJV Hong Kong Office showed the route setting for trains T112 and T131 entering the conflict zone at Central Station at the same time.

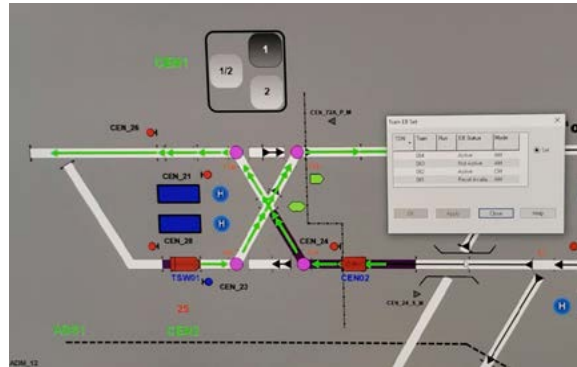
Figure 8: Simulator in ATDJV Hong Kong Office showed the trains entering the conflict zone at Central Station, as the route setting had allowed them to do so.

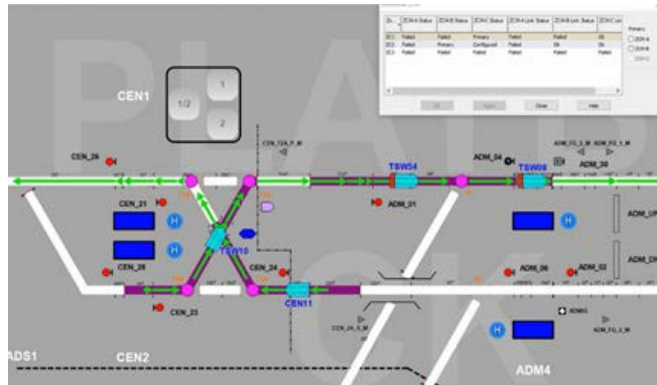
Simulation tests (Figures 9 and 10) were conducted at Ho Man Tin Station by using the ZCs and VOBCs of the incident trains with the same location and conditions of the incident, with a view to ascertaining whether the incident was caused by the incident ZCs and VOBCs. According to the results of the simulations, the same incident would happen by using the incident ZCs and VOBCs in the simulator.

Figure 10: Simulation results showed the ZCs and VOBCs of the incident trains allowing the trains to enter the conflict zone at Central Station at the same time
