Derailment Incident at Hung Hom Station on East Rail Line (17 Sept 2019)

Legislative Council
Subcommittee on Matters Relating to Railways

5 May 2020

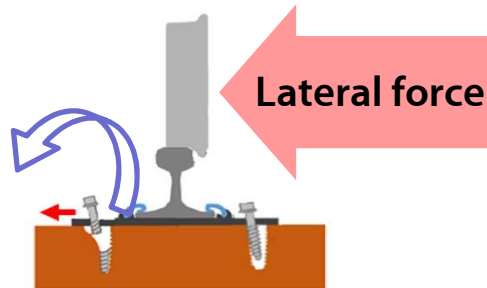
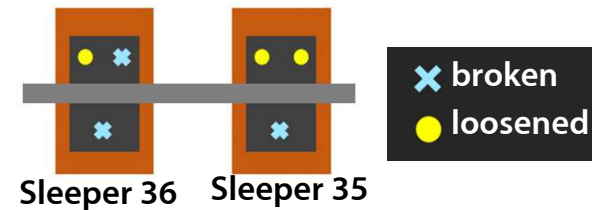
Lateral force generated by trains passing through sharp curve exerted onto the new sleepers resulting in loosened screws

Incident cause - Knowledge Gap of Interaction between the two types of sleepers

- 5 Developed measures to address the variation in lateral stiffness after timber sleepers are replaced by synthetic sleepers
