Legislative Council Panel on Economic Services

Power Disruption Incident at the Hong Kong International Airport

PRELIMINARY FINDINGS ON THE POWER INTERRUPTION IN THE PASSENGER TERMINAL BUILDING OF HKIA ON 10 JUNE 2004

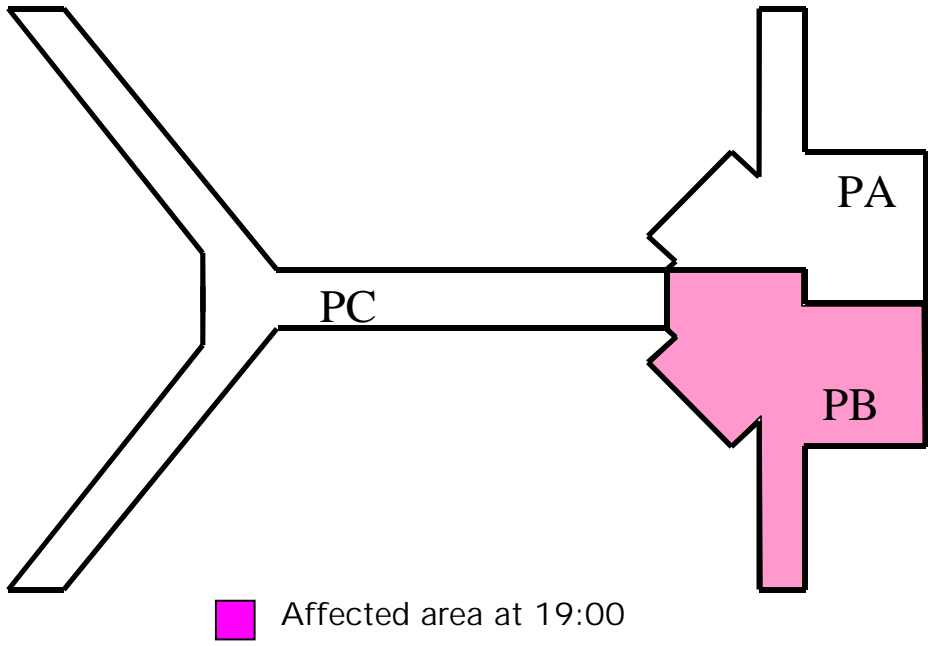
Diagram 1 – PTB Affected Areas

A disruption to the high voltage (11,000 volt) power distribution system occurred at 1900 hours on Thursday, 10 June 2004. Power was lost to all levels of the southern part, i.e. one third of the Passenger Terminal Building (PTB). Power was restored in phases. By 1901 hours, power was restored to half of the affected areas (see **Diagram 1**), with full restoration to all the affected area by 1935 hours. As power was gradually restored, airport systems, for safety reasons, required inspection and re-setting before resuming normal operations. By 2045 hours, all airport operations were restored.
