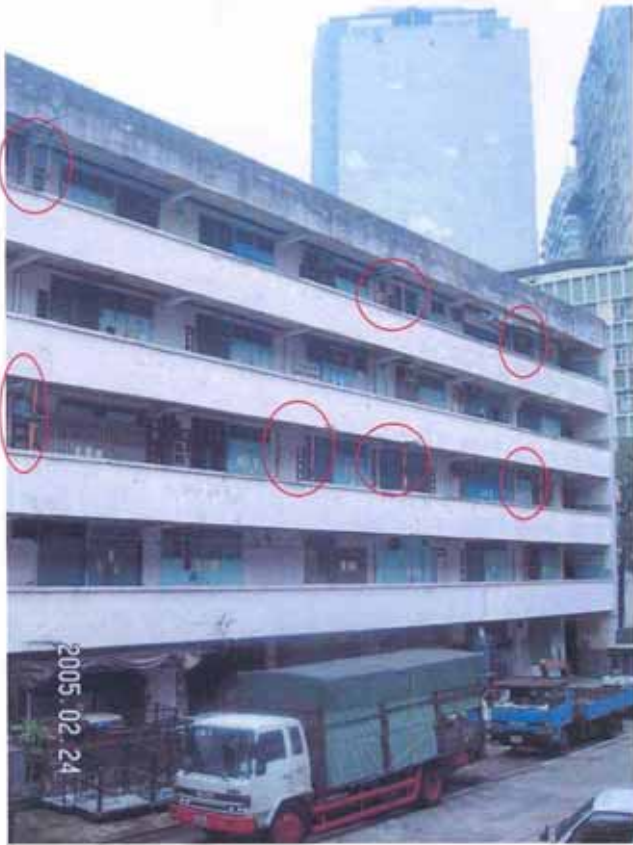
Location : Block 1 Balcony corridors
Defect : Defective cantilever beams propped

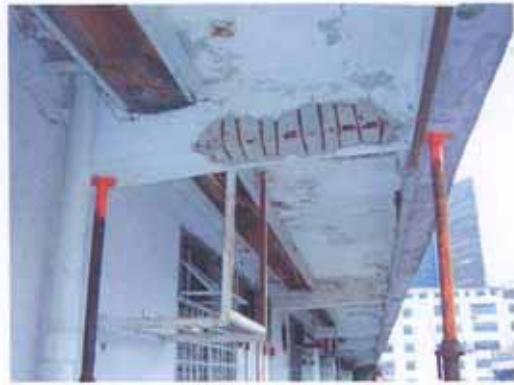
Location : Cantilever Beam at 4/F of Block 1
Defect : Cantilever beam propped

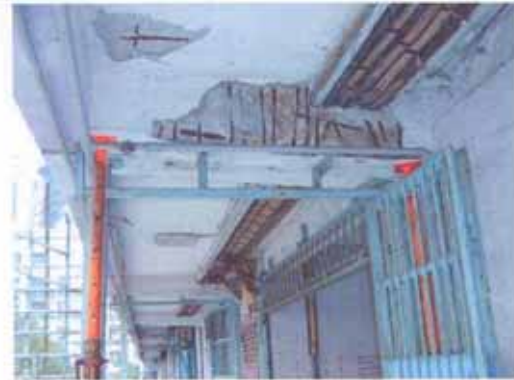
Location : Cantilever Beam at 2/F of Block 1
Defect : Seriously spalled

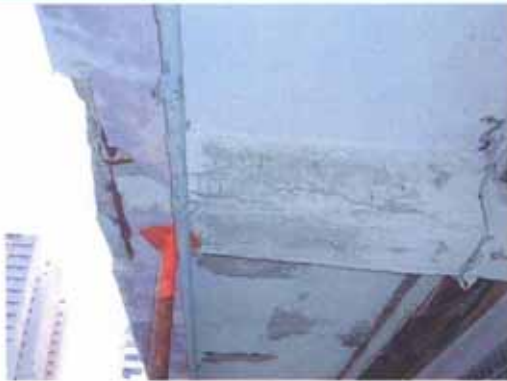
Location : Cantilever Beam at 2/F of Block 1
Defect : Seriously spalled

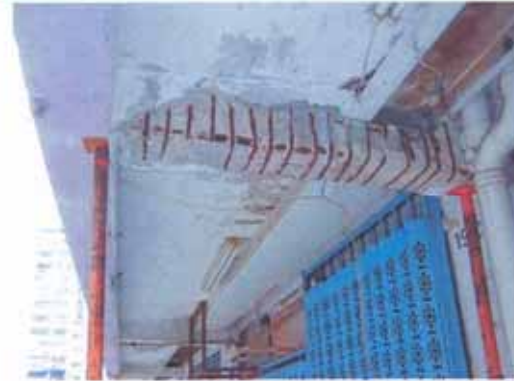
Location : Cantilever Beam at 2/F of Block 1
Defect : Seriously spalled

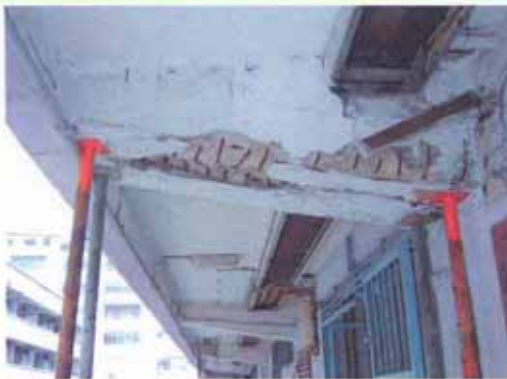
Location : Cantilever Beam at 2/F of Block 3
Defect : Seriously spalled

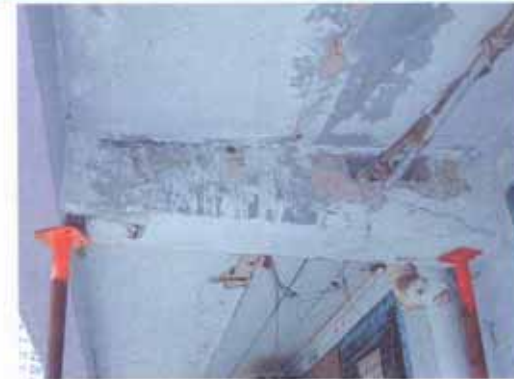
Location : Cantilever Beam at 4/F of Block 5
Defect : Seriously spalled

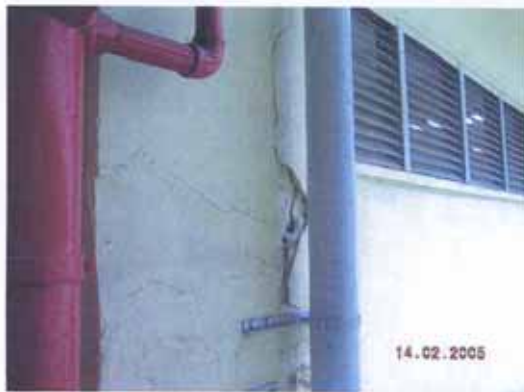
Location : 4/F Column in Link Block
Defect : Cracks

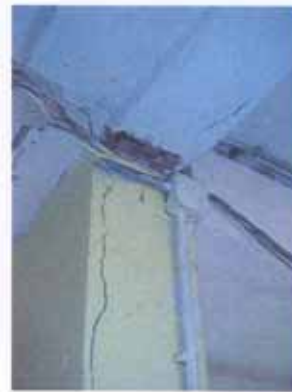
Location : 3/F Column & Beam in Link Block
Defect : Vertical cracks

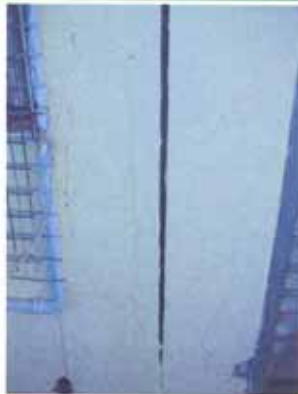
Location : 2/F Columns at Unit 208 & 209
Defect : Vertical cracks

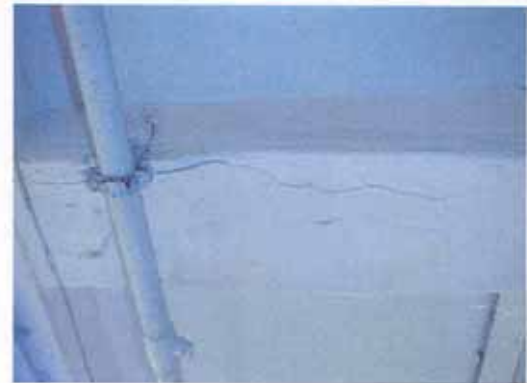
Location : 1/F Cantilever Beam at Unit 28 & 29
Defect : Longitudinal cracks

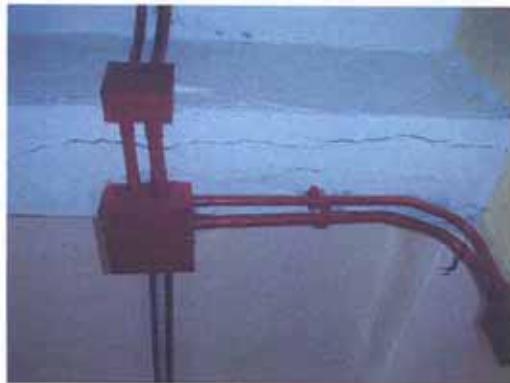
Location : 1/F Beam at Link Block
Defect : Longitudinal cracks

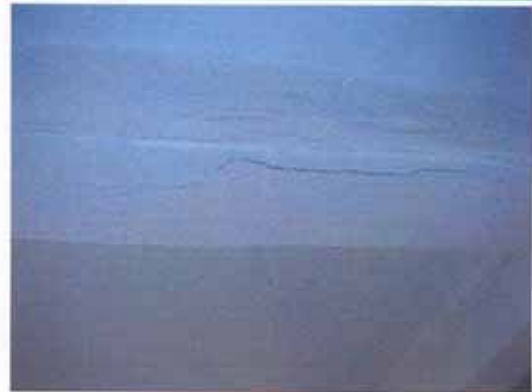
Location : 1/F Beam at Link Block
Defect : Longitudinal cracks

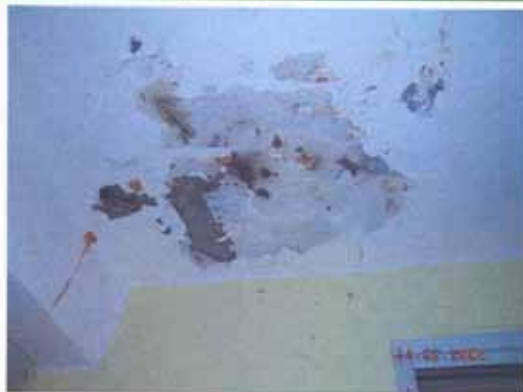
Location : 3/F Slab at Link Block
Defect : Dampness at Ceiling

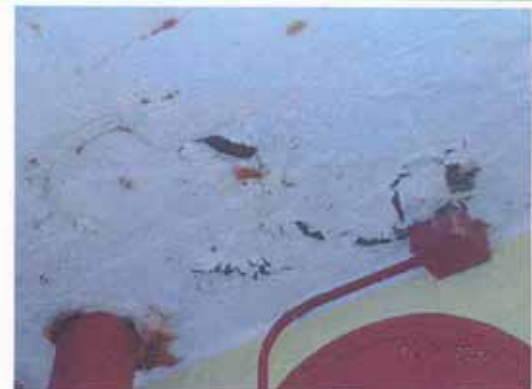
Location : 3/F Slab at Link Block
Defect : Dampness at Ceiling

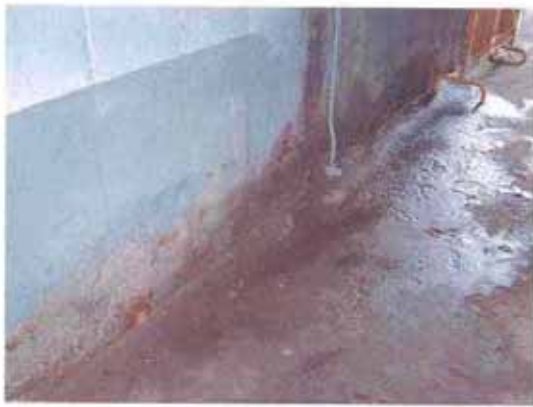
Location : Block 2 - corridor at 4/F
Problem : Water seepage from toilet

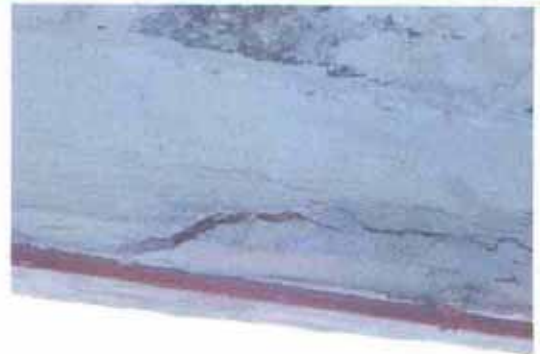
Location : Block 2 - 6/F edge beam
Defect : Spalled concrete

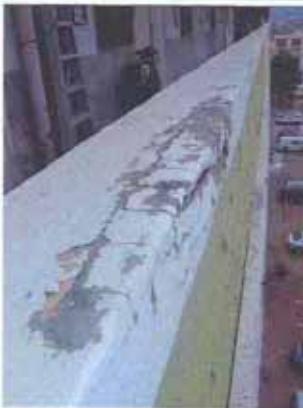
Location : Block 1 - parapet at 5/F
Defect: Concrete spalled

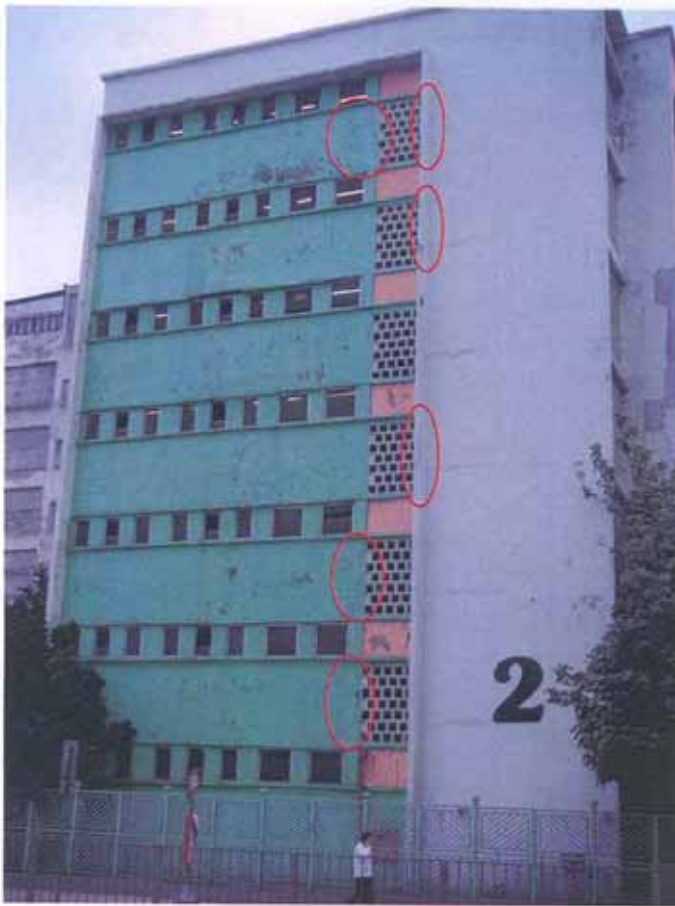
Location : Block 2 – External wall
Defect : Structural elements in bad condition

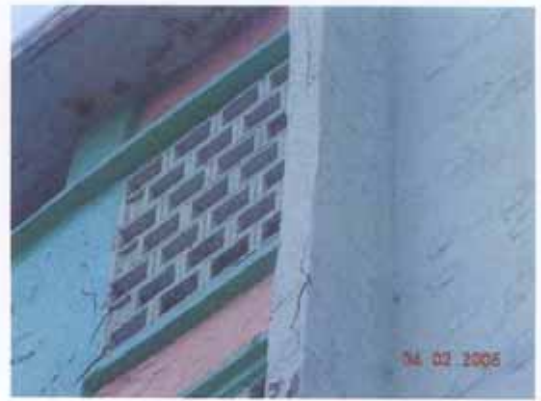
Location: Wall at 6/F
Defect : Broken edge, seriously spalled

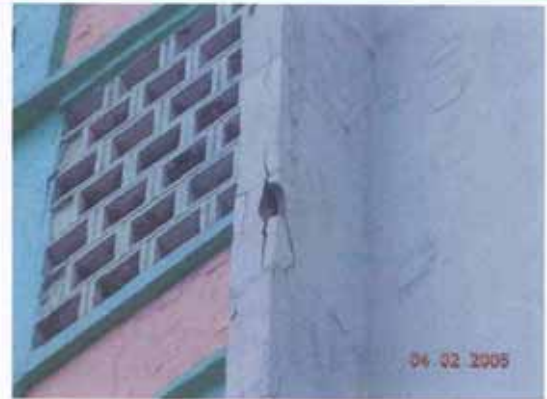
Location : Wall at 5/F
Defect : Broken edge, seriously spalled

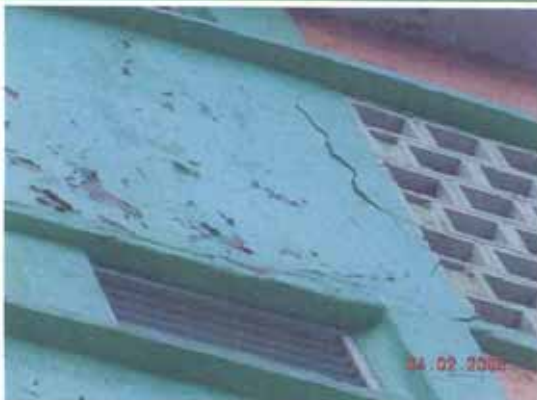
Location : Wall at 6/F
Defect : Seriously spalled

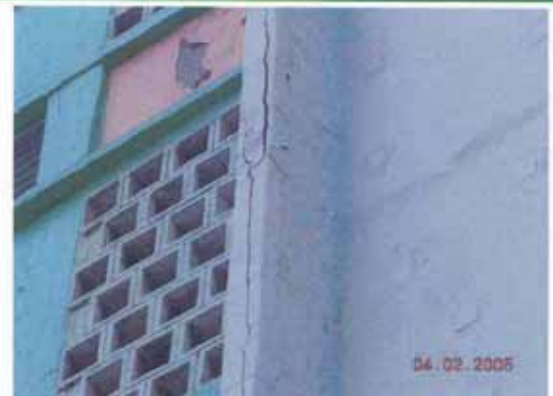
Location : Wall at 3/F
Defect : Seriously spalled

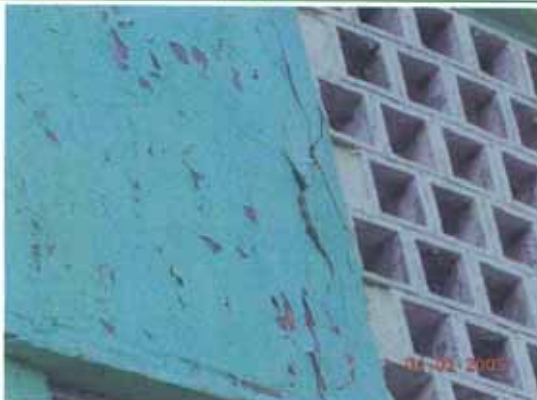
Location : Wall at 2/F
Defect : Seriously spalled

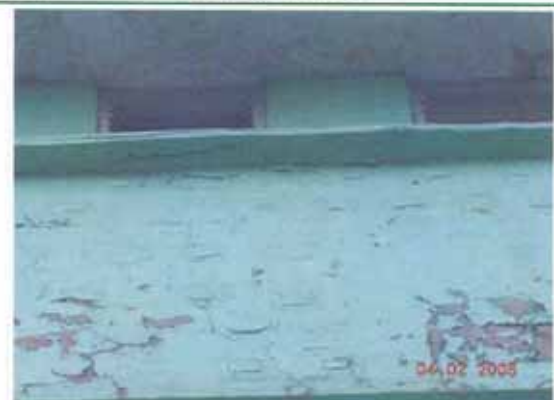
Location : Wall at 1/F
Defect : Seriously spalled

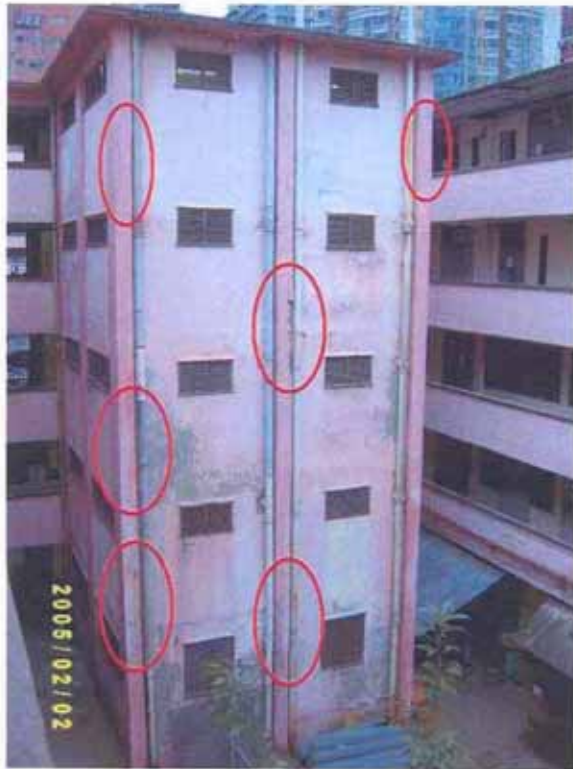
Location : Block 1/link block edge columns
Defect : Seriously spalled

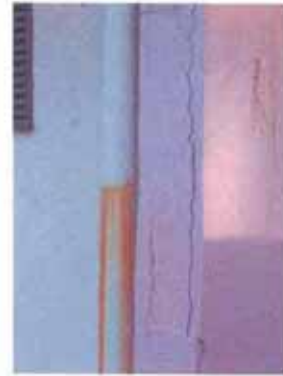
Location : Block 1/link block – 4/F column
Defect : Cracked

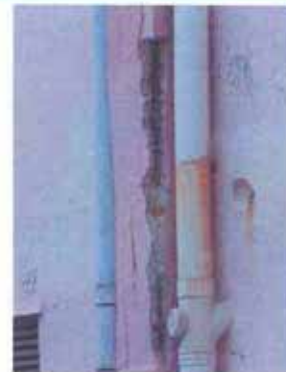
Location : Block 1/link block – 4/F column
Defect : Seriously spalled

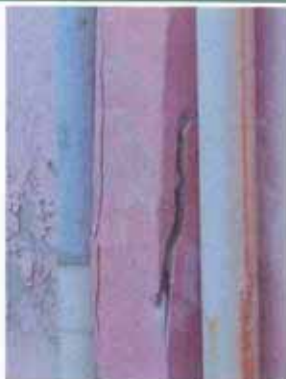
Location : Block 1/link block - 2/F column
Defect : Seriously spalled

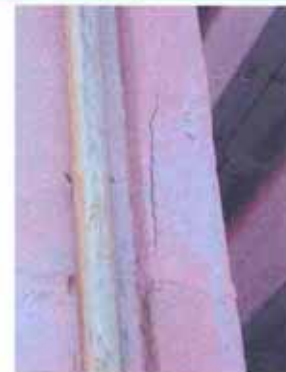
Location : Block 1/link block - 1/F column
Defect : Cracked

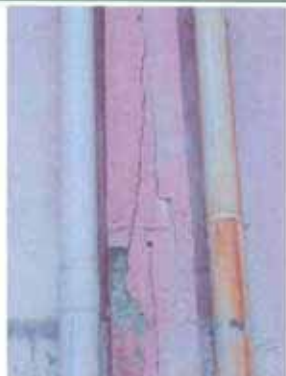
Location : Block 1/link block - 1/F column
Defect : Seriously spalled

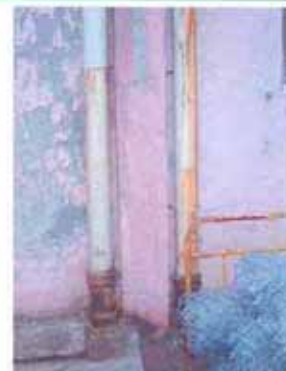
Location : Block 1/link block - G/F column
Defect : Cracked
