**For discussion
on 24 April 2006**

**Legislative Council Panel on Environmental Affairs
Tung Chung - Ngong Ping Cable Car Project**

東涌吊車工程環境保護建議書 保護昂平珍貴生態資源

立法會陳偉業議員
2006 年 3 月 10 日

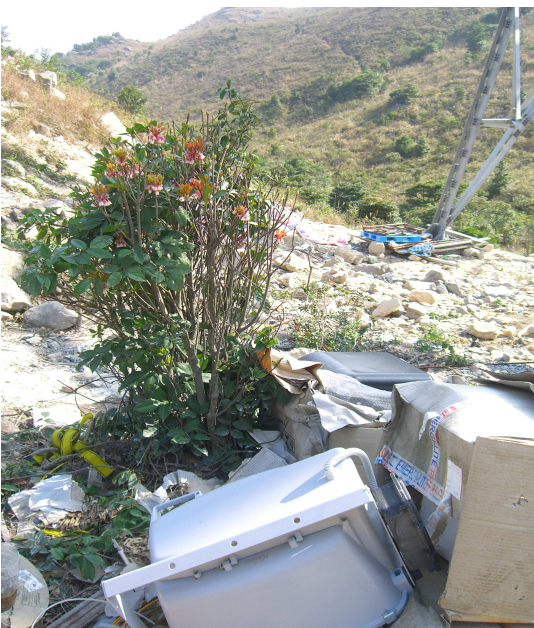
2.1.2.2 承建商為了補償因工程而填平的溪流，建造了一條人造溪流。為此，承建商砍去百多棵樹木。另外，在珍貴樹木旁邊並無放置警告牌或圍欄，承建商任由大型建築物料和垃圾，如廢棄的鋼纜捲筒等，放置在樹木旁和植被上（見附圖一、二）。這些重物均會壓毀樹幹及樹根，對植被造成損害。此外，工程中將一些索緊了的鋼纜靠著樹幹，樹幹因此而受到破壞。工程進行期間，承建商更把部份樹木的樹枝砍去，但由於採用不適當的方法砍去樹枝，在砍去樹枝後又沒有妥善修復樹木受損的部份，因而使細菌、真菌或昆蟲輕易透過樹枝的破口侵食樹幹內部，對樹木構成威脅（見附圖三）。而承建商在遷移受工程影響的植物時，有接近六成被搬遷的植物死亡，更有不少珍貴的自然植物被偷去或失蹤，當中更包括在中國受保護的自然植物，例如中國吊鐘等。由於承建商的疏忽，導致了珍貴樹木的大量死亡和損傷，造成不可補救的結果。

附圖一：承建商在中國吊鐘旁邊胡亂放置建築材料及垃圾，對中國吊鐘構成威脅。

3.1.1.1 工地垃圾、損害樹木及污染等問題，需由加強工程監管著手。工地附近棄置的垃圾必須加以清理，妥善處置堆放的建築物。傷害植被和樹木的大型鋼纜捲筒和鋼纜應盡快移走，避免進一步傷害樹木。承建商應聘請專業人士負責遷移樹木，並投入更多資源，避免樹木因遷移而死亡。在遷移過程中，應由專人負責及監察，避免珍貴植物失蹤或被盜。而附近被挖掘過的土壤應加上帆布保護，以免被雨水沖刷後造成土壤流失。承建商應避免將建築材料及垃圾堆放在溪流旁邊，以免因意外或雨水沖刷掉落溪中，以防止因工程而產生的污染物流入溪流。承建商亦應定期檢測水質，以及時作出補救及應變。油承建商應為工作人員提供合適的流動廁所，並將已污染的地方清理。桶應存在安全地方，並在附近標示清晰的警告。以上問題均由於人為疏忽及監管不力，故此必須加強對工程的監管，以免再次因人為因素而對環境造成破壞。

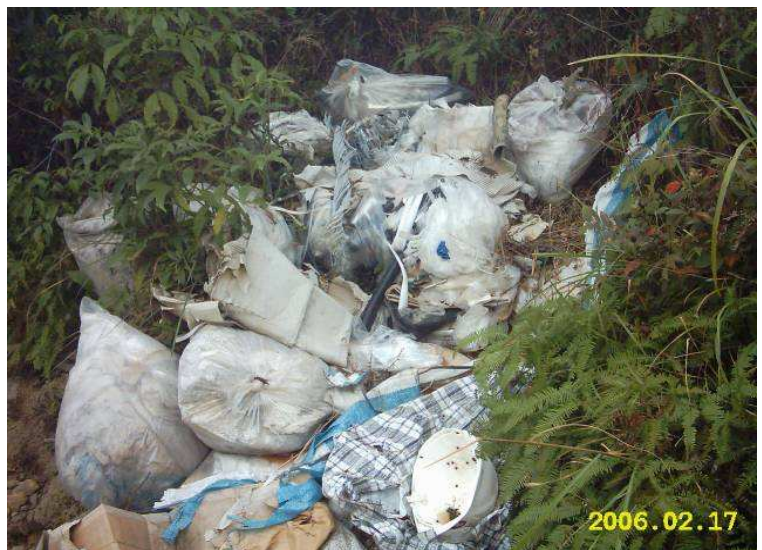
附圖二：承建商把大量建築材料放置在植被上，引致大量植物枯死，破壞自然生態及景觀。

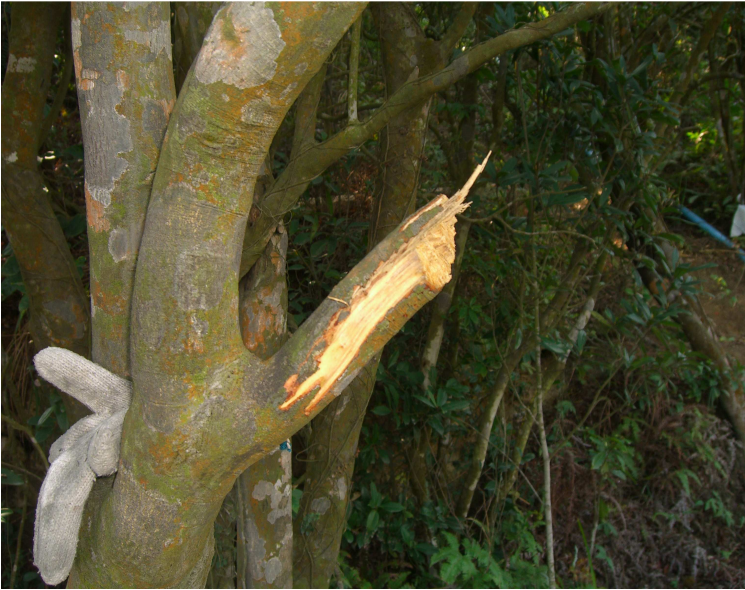
附圖三：樹木的樹枝被不適當地砍去，承建商又沒有妥善修復樹枝被砍去後出現的破口，使樹木容易被細菌及真菌感染。

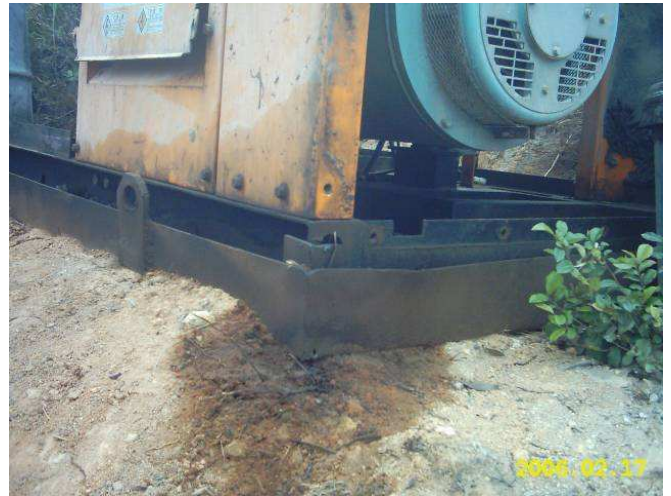
8.4.1 Oil Spillage – In January 2006, there was an incident whereby oil leaked from a power generator polluted the soil immediately adjacent to the generator. The leaking was not due to non-provision of drip tray but spillage from a damaged drip tray. MTRCL had subsequently removed the generator from site. The spilled oil only affected a very small area and the polluted soil was cleared. No permanent ground contamination is observed and MTRCL has been reminded to tighten site management to prevent recurrence.

2.1.3.1 承建商並無對昂平土壤作出適當保護，終會引致土壤受污染及土壤流失。工程進行期間，承建商在操作發動機時，沒有為發動機設置接油盤，引致燃油滲漏到附近的土壤，對附近土壤構成永久性的污染（見附圖四）。此外，承建商將翻起的泥土和建築廢料一起堆在溪邊。在長時間缺乏保護下，泥土將被雨水侵蝕，造成水土流失，結果令樹木無法生長。

附圖四：由於地盤的發動機沒有設置接油盤，導致燃油慘漏，對附近的土壤造成永久損害。

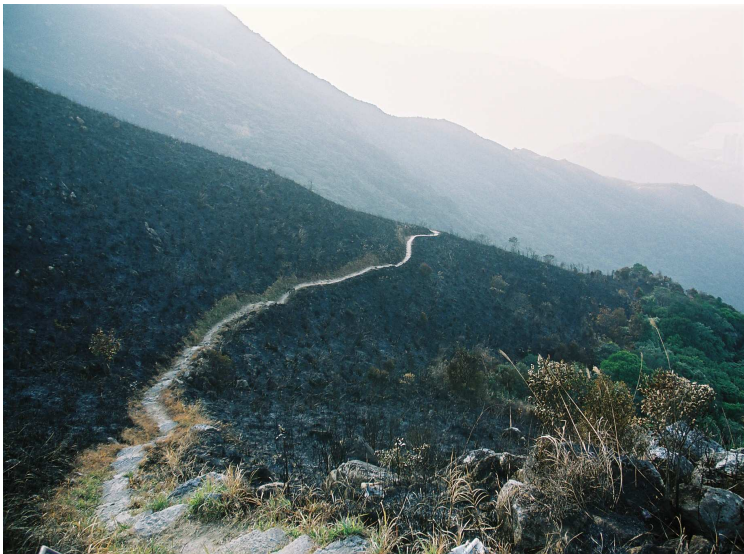
草，容易發生山火。山火不但燒燬林木，更會燒死動物，對昂平的生態環境構成嚴重威脅。另外，工地中的油桶旁的不准吸煙告示已經殘舊，模糊不清，不能對工地工人起警示作用。而油桶附近既無滅火筒，在旁更發現被掉棄的空煙盒，可見工地防火設施不足，工人防火意識薄弱，此外，東涌吊車沿途缺乏山火拍、隔火路等防火設施，若發生山火，火勢將難以控制，對整個昂平的生態環境造成嚴重破壞(見附圖五)。

附圖五：上圖為大東山附近山坡的植被被山火破壞後的情況的由於大東山的山坡空曠並且佈滿雜草，如發生山火，便一發不可收拾。東涌吊車沿途的植被和大東山的植被屬同一類型，如不能妥善防止山火，沿途的植被將會受到如上圖般的破壞。

3.1.2.1 為防治山火，政府應加設防火措施，向遊客宣傳防火意識。政府應在吊車沿途增設火設施，如防火拍及山火瞭望台等，亦應在墓地旁設置隔火路，並於清明節及重陽節加強巡邏，以及早發現山火，並在其漫延之前盡早撲滅。另外，亦應向遊客加強宣傳山火危害，提高遊人防火意識。加設防火措施能為一旦發生山火作出準備，而向遊客宣傳防火意識則能防患於未然。

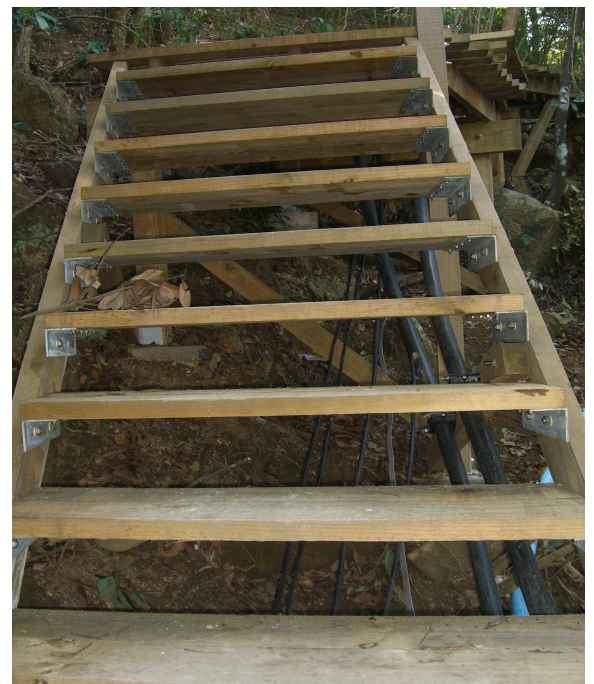
8.7.1 Use of Tanalith Oxide Treated Timber - The timber used for construction of emergency rescue trails is copper chromium arsenic (CCA) treated timber. According to overseas experience, CCA treated timber is widely used for outdoor structures. The risk of any toxicology impact on the local environment is minimal so long as MTRCL conducts proper maintenance to the timber trails.

2.1.8.1 由東涌至昂平的行人通道使用有毒物料，危害環境。由東涌至昂平的行人通道上的木材使用了不少使用外地引入的木材(詳見附圖六)。由該段行人通道使用了化學物 Tanalith oxide 作為木材防腐劑。然而 Tanalith oxide 是有毒而且含有 20% 的 Arsenic(砷，即砒霜)，對昂平的動植物均有害。Tanalith oxide 會隨著雨水流入山邊土壤及溪流，會污染環境，對溪中和沿溪的動植物構成傷害，極有可能造成生態災難。

附圖六：東涌至昂平沿途均有木製的行人通道，該等木材被塗上含有砒霜成份的防腐劑，對附近生態環境構成嚴重威脅。

3.1.5.1 在昂平這珍貴的生態環境中，地鐵應使用不含毒素的物料，以免對環境造成損害。化學物 Tanalith oxide 作為木材防腐劑，可溶於水中，有可能污染環境，並毒害包括盧文氏樹蛙等珍貴動植物。故此在興建行人通道時，應使用對環境無害不含毒素的物料，作為東涌至昂平的行人通道，以免污染環境，保護瀕危的動植物。

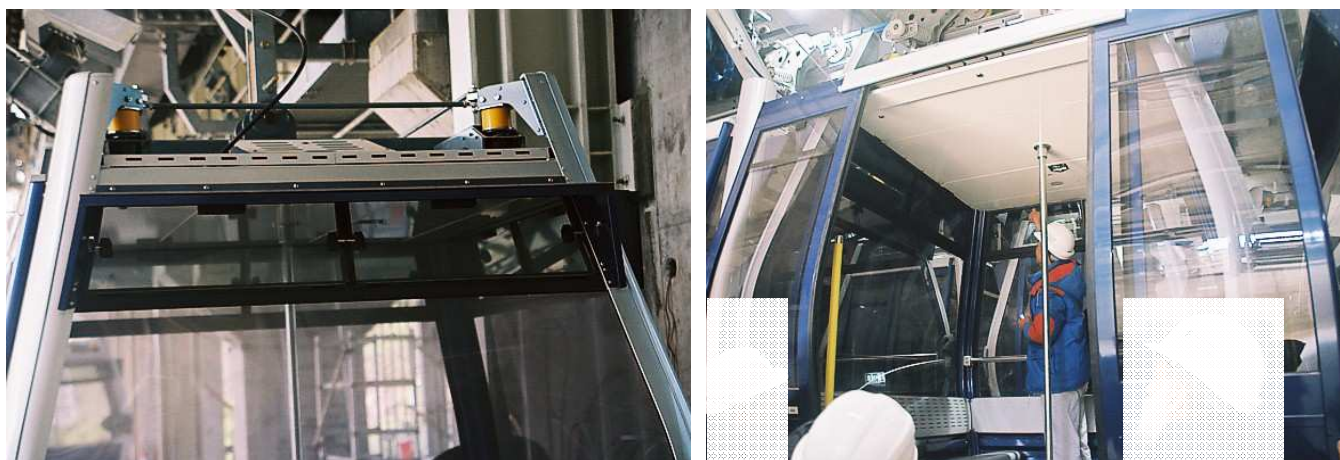
2.1.6.2 據悉現時東涌吊車的車箱內，設有多個可以任由遊客開啟的窗戶。由於窗戶容易開啟，部份遊客可以輕易地從車箱的窗戶拋出煙蒂(見附圖七)。由於吊車所經過的地方多是空曠、風力強勁的山坡，因此遊客由車廂拋出的煙蒂，有可能會引發大規模的山火。基於上述原因，現時車廂的窗戶設計將會增加引發山火的風險，對東涌吊車沿途的植被帶來威脅。

附圖七：乘客可輕易地打開東涌吊車車箱的窗戶，並可輕易地從窗戶拋下煙蒂，增加發生山火的機會。

2.1.6.3 鑒於現時東涌吊車車箱內的窗戶存在容易開啟的問題，東涌吊車經營者應考慮改善窗戶的設計，使乘客不能輕易地把未熄滅的煙蒂拋出窗外，政府及東涌吊車的經營者亦應加強執法，嚴懲在車廂內吸煙的乘客。

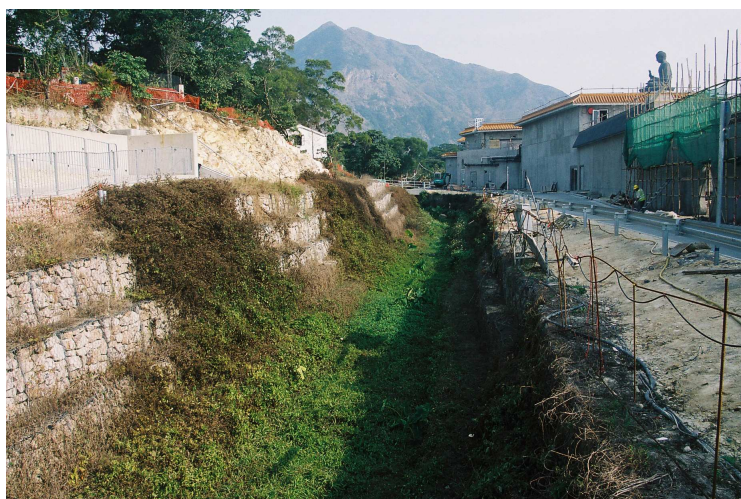
8.2.6 Inadequate Protection Against Mikania Micratha - Whilst *Mikania micratha* was once found in the diverted stream course, it has already been removed by MTRCL.

2.10.2 在人造溪流落成後不久，該人造溪流即被大量薇金菊覆蓋，薇金菊更攀附在人造溪流兩旁，用於固定石塊的鐵絲網上(詳見附圖八)。據悉，該等植物為薇金菊(*Mikania micrantha*)。薇甘菊會藉攀附其他植物至樹冠以攝取更多陽光，從而有助生長。與此同時，被薇甘菊厚密的葉和莖所覆蓋的植物，最終可能會因為光照不足而窒礙生長。薇甘菊亦能進行有性或無性繁殖，於春夏兩季生長迅速，故此被人冠以「一分鐘蔓延一英里的雜草」(“Mile-a-minute weed”)之稱號。承建商在興建人造溪流時，沒有採取措施防止薇金菊在河道內繁殖，最終使人造溪流被薇金菊覆蓋。薇金菊大量繁殖，使其他本土植物不能於人造溪流生長，因而不能為各種動物及昆蟲提供適當的食物，而薇金菊覆蓋河流表面，也會阻礙陽光照射河流低部，使河床的植物因為缺乏陽光，不能進行光合作用而大量死亡。薇金菊覆蓋人造溪流的表面，更會減弱人造溪流的排洪能力，增加上游泛濫的風險。

附圖八：人造溪流被大量薇金菊覆蓋，薇金菊更攀附在人造溪流兩旁，用於固定石塊的鐵絲網上，嚴重影響溪流的生態環境。

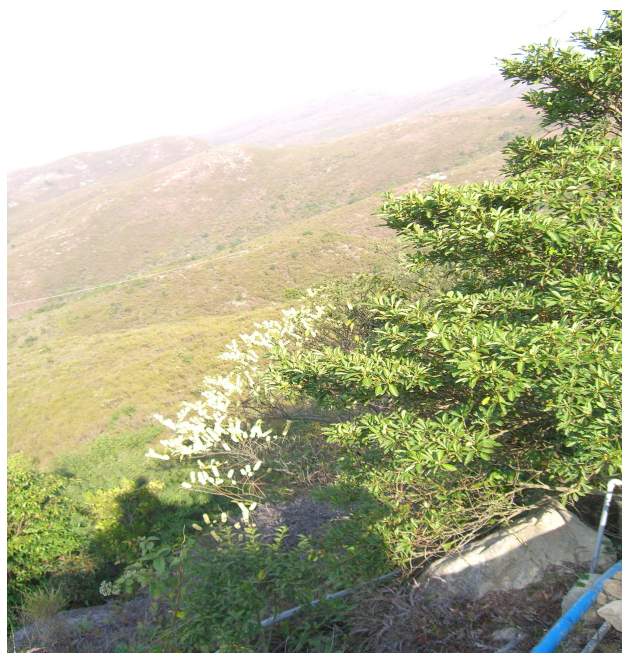
2.1.9.1 吊車工程沿途缺乏綠化，破壞昂平優美的景觀。於工程展開後，沿途樹木和植被受到傷害，變成處處泥地，如彌勒山的山頂被毀。吊車沿途均缺乏綠化，計劃引入的都是外地樹木品種。這將損害原有生態環境平衡，令優美珍貴的昂平自然景觀受到破壞。(詳見附圖九)

附圖九：由於政府對東涌吊車途經的植被沒有提供足夠的保護，使附近山頭的植被飽受山火破壞，僅餘下荒涼的山頭，破壞東涌吊車沿途的景色。

3.1.4.1 承建商應於吊車沿途加強綠化，美化景觀，並種植本地樹木。一方面有利大嶼山北的旅遊業的發展，另一方面亦需要復原因吊車工程而受損的植被。為了生態環境的平衡，在推展綠化計劃時，應根據當區生態環境，盡量多種本地樹木，及盡量避免破壞原有正在生長的植物。惟有加強綠化和種植本土樹木，才能使本地的生態環境不會因不恰當的綠化計劃而受到永久的破壞。
