**Legislative Council Panel on Transport
Subcommittee on Matters Relating Railways**

Investigations into West Rail Incident on 14 February 2007

**Report of the Incident Review Panel
on the Train Fire inside
West Rail Tai Lam Tunnel
on 14 February 2007**

This report is prepared by the Technical Review Panel on the result of investigation into the root cause of the Voltage Transformer (VT) on-fire incident in West Rail on 14 February 2007, the measures for monitoring and assuring the running integrity of the VT fleet, and the long-term solution.

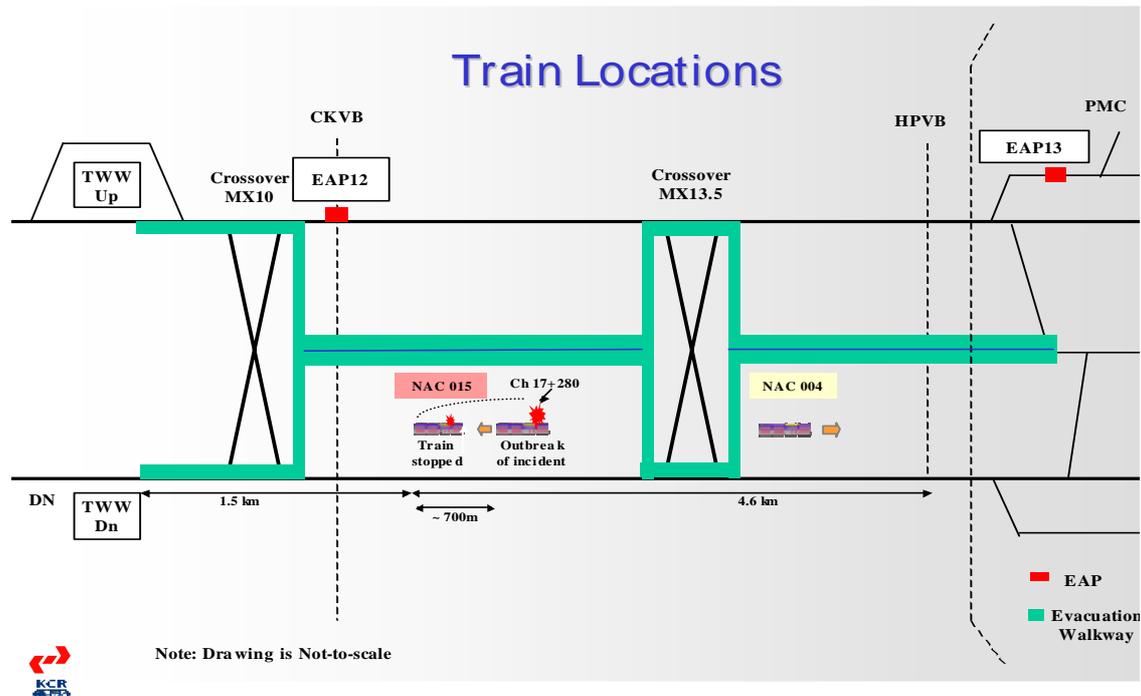
2.5. The TC immediately executed a System Hold command to stop all trains at station platforms. The train that followed the incident train, NAC004, which had departed Kam Sheung Road (KSR) station and was entering into the tunnel, was instructed by OCC to stop immediately.

The train came to halt at a position about 100 m from the mid tunnel crossover MX13.5. The train driver closed the dampers in view of smoke coming from the front to prevent the ingress of smoke into the train saloon. A sketch of the locations of trains inside TLT at the time of the incident is shown below -
