# West Rail Fire Incident

**Legislative Council – Panel on Transport  
Subcommittee on Matters Relating to Railways  
4 May 2007**

# Forensic Examination of the Failed Transformer

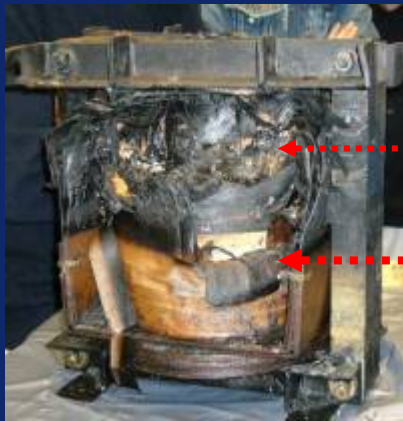
Upper Coil burnt seriously with signs indicating its insulation was firstly damaged by voltage surge

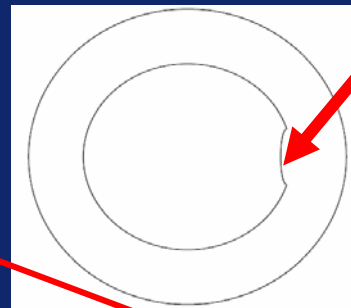
Bulging

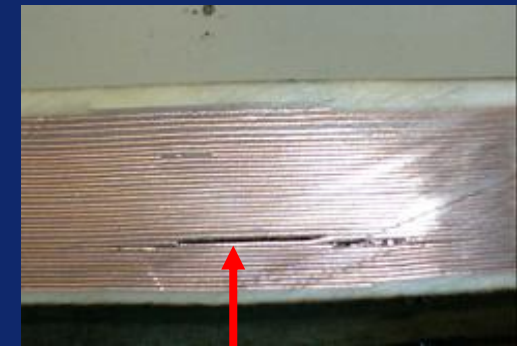
Separation of coil and resin

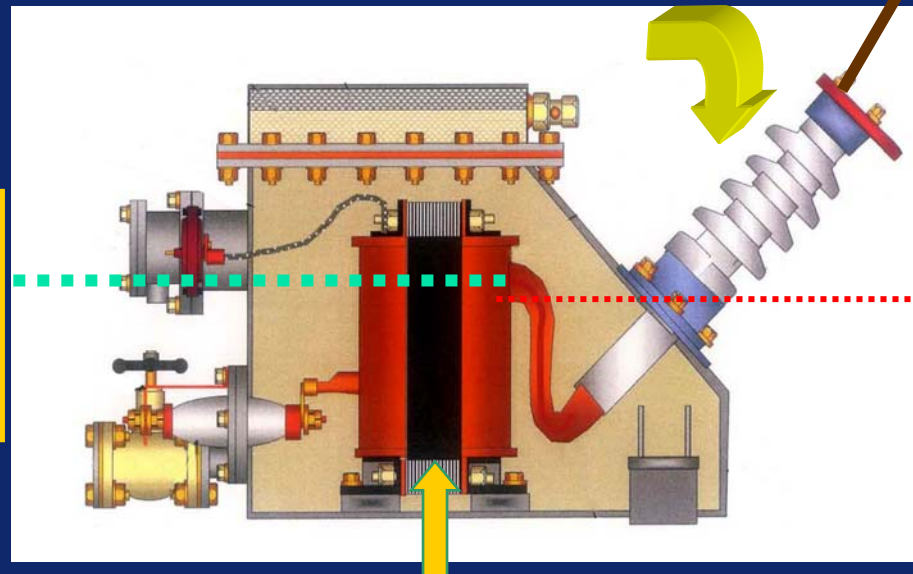
A hidden imperfection of insulation alone would not lead to equipment failure

A hidden imperfection of insulation encountering voltage surge as an attributing factor then triggered the fault
