#### **Follow-up to the meeting on 27 February 2012 “Breakdown of Ngong Ping 360 ropeway occurring in December 2011 and January 2012”**

**Ngong Ping 360 Ropeway**  
**Incident occurred on 25 January 2012**  
**Report of Investigation**

**Electrical and Mechanical Services Department**  
**3 April 2012**

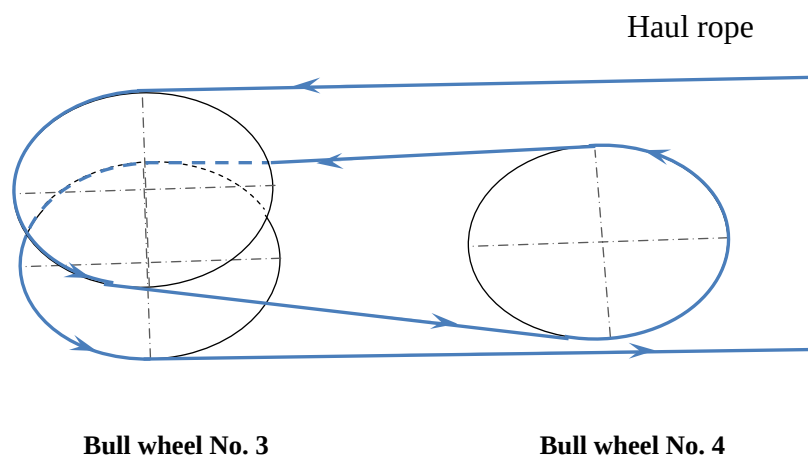
5.6 According to the statements provided by the Competent Person, vigorous vibration of the haul rope between bull wheels No. 3 and No. 4 (see configuration of the haul rope at Figure 3) was observed along with the abnormal noise before triggering of the position sensor of bull wheel No. 4. The triggering of the position sensor was attributed to the vigorous vibration of the bull wheel No. 4.

Figure 3 : Haul rope winding between the bull wheel No. 3 and bull wheel No. 4

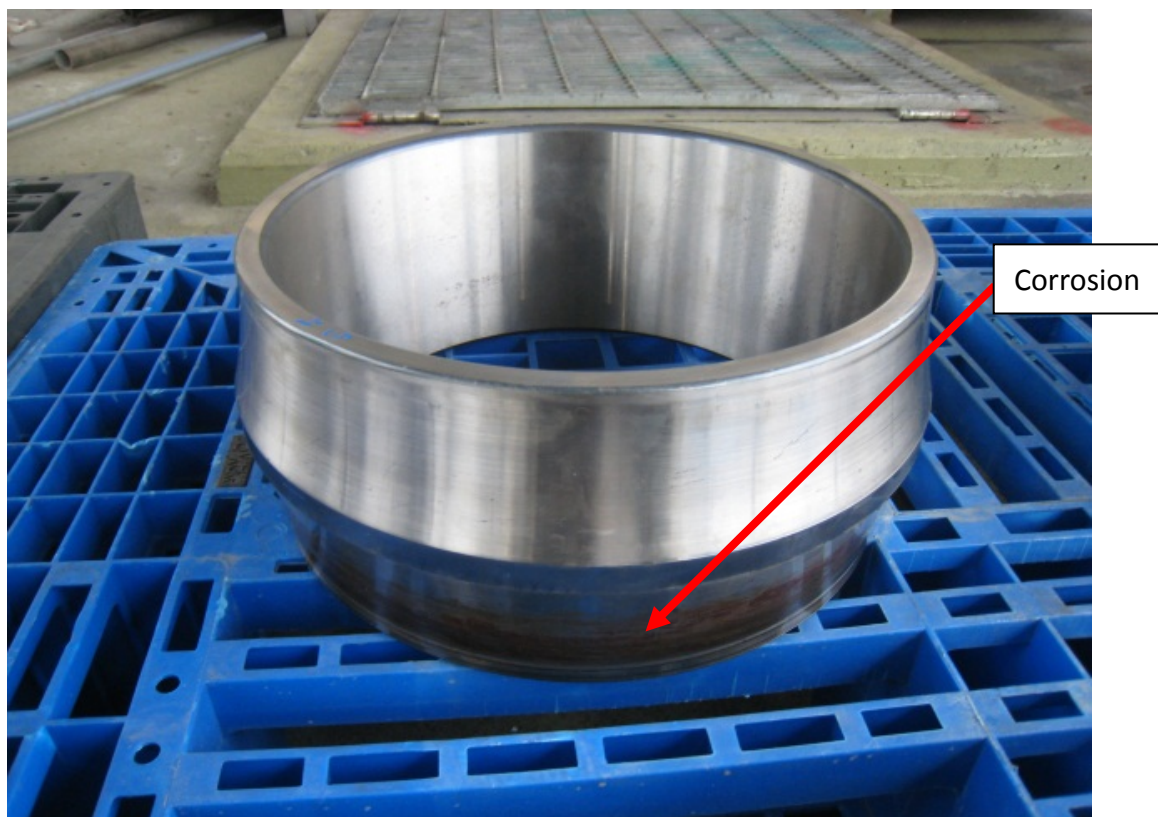
- (i) The spalling only occurred in the upper bearing ;
- (ii) For the inner ring of the upper bearing, brown staining from corrosion was found at the bottom raceway at the low loaded side (see Figure 6) while heavy spalling was found at the top raceway at the high loaded side (see Figure 5) ;
- (iii) In addition to spalling, heavy denting was found on the upper rollers of the upper bearing, as might be expected with the spalled metal fragments and the denting on the upper race (see Figure 7) ; and
- (iv) Corrosion/rust was also observed on the outer ring between the upper and lower rollers (see Figure 8).

Figure 6: Corrosion in the bottom raceway of the inner ring of the upper bearing
