**Legislative Council Panel on Transport
Subcommittee on Matters Relating to Railways**

**Follow-ups on the Service Suspension of Tseung Kwan O Line and
Part of Kwun Tong Line on 16 December 2013, and
Report on Subsequent Major Incidents on East Rail Line and
Light Rail**

**Service Suspension of Tseung Kwan O Line and Part of Kwun Tong Line
on 16 December 2013**

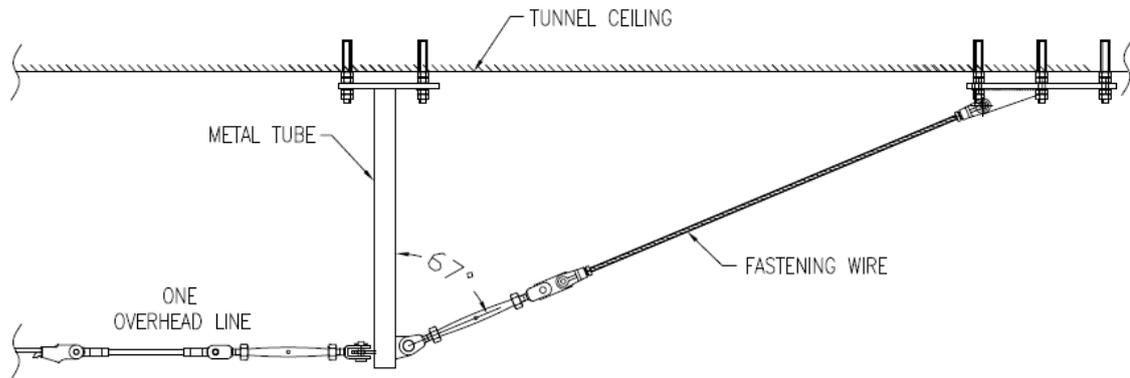
Typical configuration of the triangular support bracket

- (a) the support bracket was holding two overhead line wires instead of the typical configuration of one bracket holding one overhead line wire; and
- (b) the angle of the fastening wire from the metal holding tube was at 38° rather than the 67° shown in the typical configuration drawing as below.

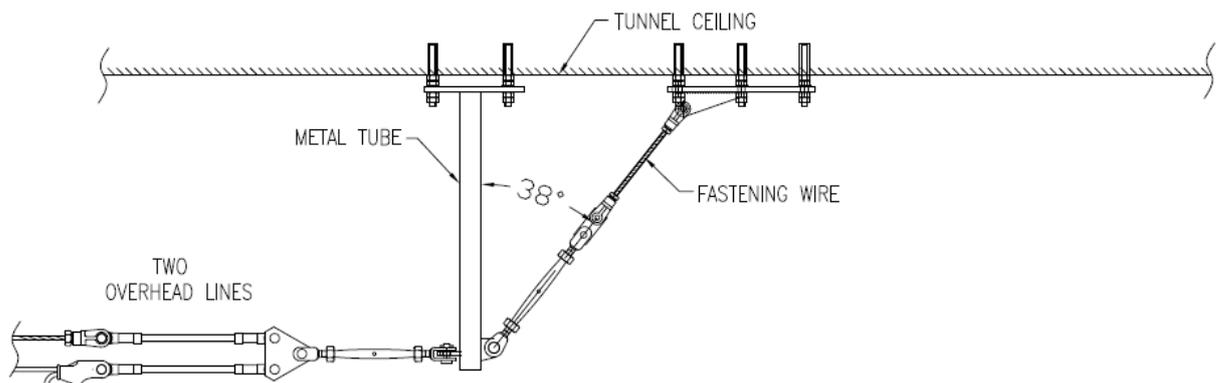
Configuration of the incident triangular support bracket

2. To determine the cause of the breakage, the wire was sent to an independent laboratory for testing and analysis. It was found that the materials of the fastening wire were sound. The breakage was due to excessive load which caused the wire to reach its ultimate strain limit over time. However, the elongation was gradual and not obvious through regular inspection. When the wire broke, the bracket dangled loose, slackening tension in the two overhead lines it was holding and causing them to droop.

3. After reviewing the design drawings of the concerned triangular-shaped support bracket from when Tseung Kwan O Line was built, the independent laboratory considered that the excessive load and ultimate breakage of the wire were due to the following two factors:

4. As a result, the tensile load on the concerned fastening wire was three times that of the typical configuration.
5. Further mechanical testing was performed on a fastening wire affixed according to the typical configuration. Results showed that either one of the contributing factors would not have led to the breakage even after a long period of time.
6. The concerned support bracket was installed during the construction of Tseung Kwan O Line and has been in place since project completion in 2002. There is no documentation showing why a non-typical configuration was used at the time of installation, nor can record be retrieved of any changes to the design or installation method.

- (a) at the incident location, two support brackets have been installed to each hold ONE overhead line wire instead of the original scenario of one bracket holding two overhead line wires. In addition, a second fastening wire has been added to provide greater support. The modifications were completed in January 2014;
- (b) the other two overhead line support brackets of the same type installed in Tseung Kwan O Line were fitted with a second fastening wire in January 2014; and
- (c) since the concerned triangular-shaped support bracket was designed and installed by the Tseung Kwan O Line overhead line contractor before the rail line was commissioned, MTRCL has taken action to seek information from the contractor on the design and installation method of the concerned bracket.
