Comments on Replacement of Fire Alarm System and Manual Toll Collection System in the Aberdeen Tunnel, and Traffic and Control Surveillance Systems in the Eastern Harbour Crossing and the Kai Tak Tunnel for Legco's Panel on Transport

by J Kwong 2016 04 13

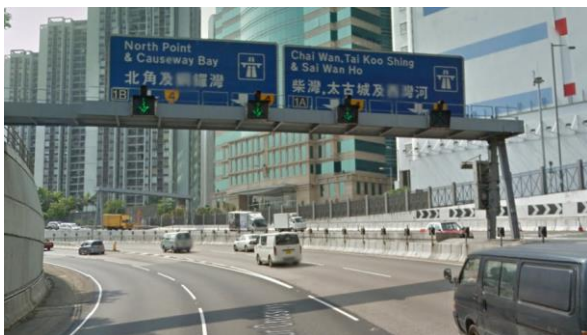
Contrary to the sign display, only the outmost right lane leads to "Tai Koo Shing & Sai Wan Ho" whereas only the second right lane leads to "Chai Wan" via Route 4. Misleading signage on high speed roads is a significant safety problem.

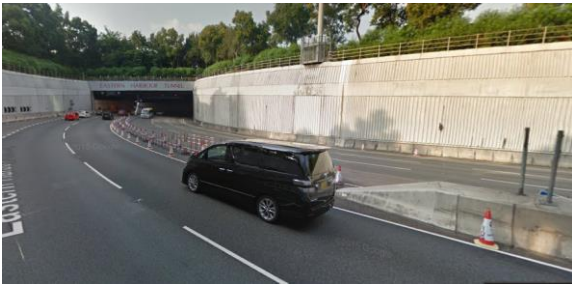
The median opening at the Quarry Bay tunnel entrance entails the risk of head-on collision if a vehicle loses control on the tight bend.

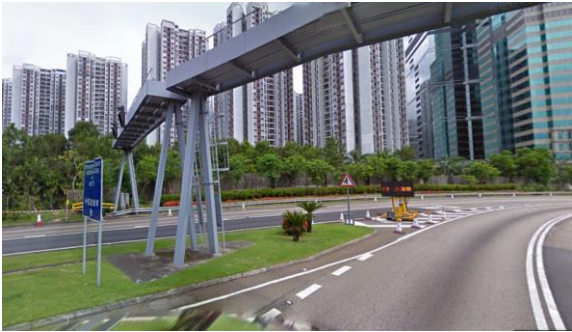
Unguarded support posts for traffic control system equipment are safety hazards.

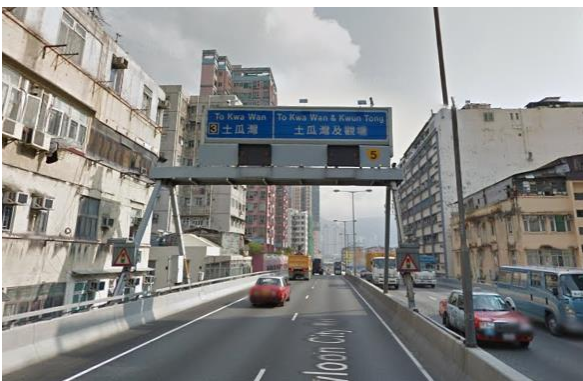
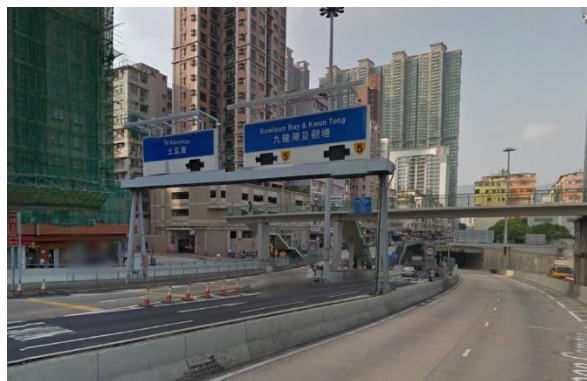
Contrary to the sign display, right lane traffic cannot access "To Kwa Wan" whereas left lane traffic can also access "Kwun Tong". Information on the upstream sign is also inconsistent with that on the downstream sign. Misleading signage on high speed roads is a significant safety problem.

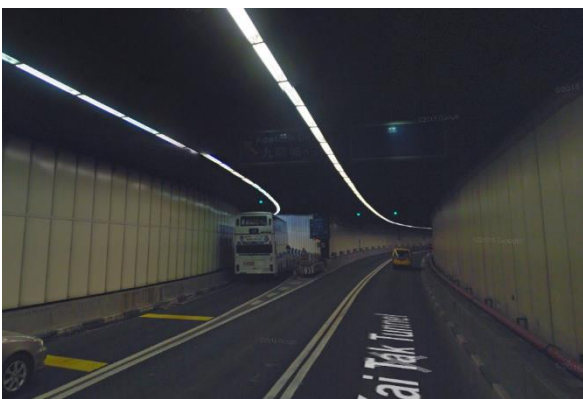
Current directional sign towards "Kowloon City" is inconspicuous and too late. Advanced direction signs are missing.

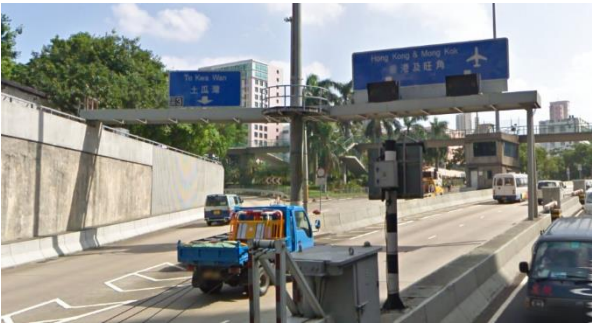
Guidance to "To Kwa Wan" on westbound tunnel tube is too late. Advance direction signs for the exit are missing.

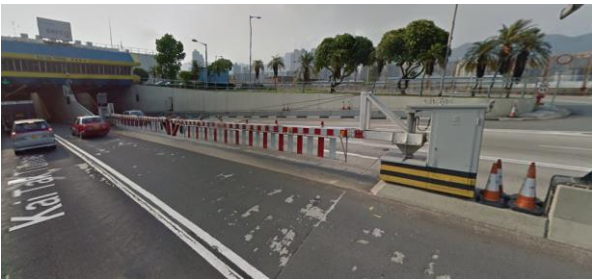
Existing movable barrier gates at the tunnel entrances could incur severe injuries if an errant vehicle collides with the equipment. The Project should specify passive safety requirements to contemporary standard for the replacement.

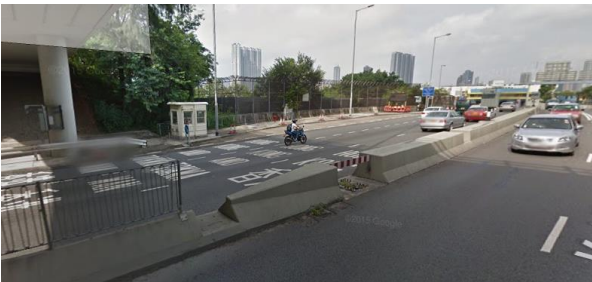
Unprotected kiosk for operational staff and hazardous discontinuity of the median barrier.

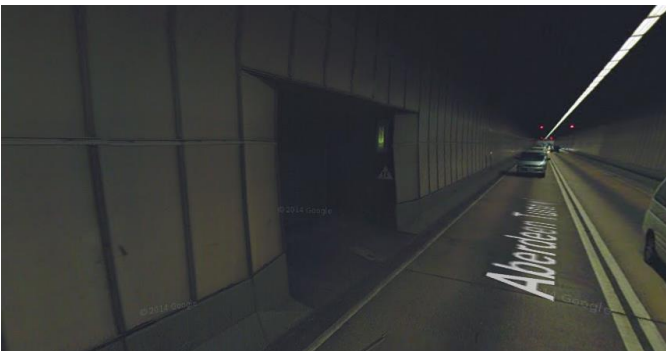
- The Project only features the replacement of the fire alarm system.
- Current tunnel design standard specifies emergency pedestrian cross-passage at 100m interval.
- There are only three vehicle cross-passages at approximately 450m interval.
- Suitability and ease of use of the vehicle cross passages for pedestrian evacuation in a fire needs verification.
- Signage for emergency evacuation is aging and not conspicuous
- Overall rationale of fire evacuation requires a review in light of the lack of cross-passages
- Toll collectors are vulnerable to impact by an errant vehicle mounting the toll islands

A vehicle cross-passage in the tunnel at 450m interval. Their operation and adequacy of signage should be reviewed in the Project.
