**Occupational Safety Condition of
 Hong Kong – Zhuhai – Macao Bridge (“HZMB”) Projects**

Labour Department
Concise Investigation Report for the
Fatal Accident in Hong Kong-Zhuhai-Macao Bridge Project
on 29 March 2017

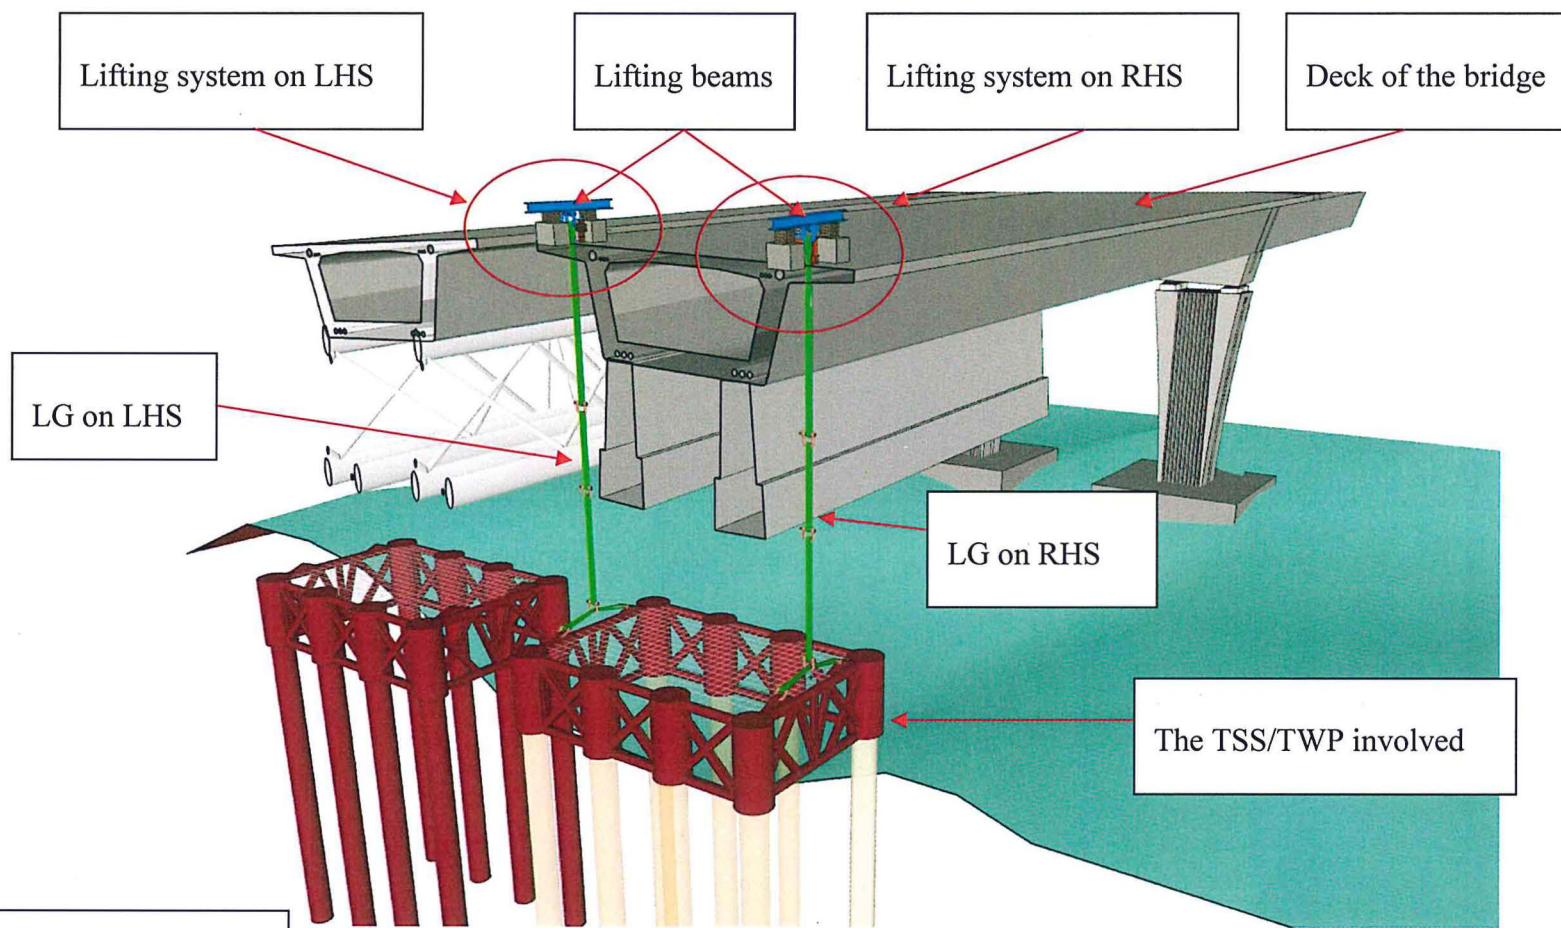
Figure 1 – Schematic diagram showing the TSS/TWP and the two lifting systems involved

2.3.3 One day before the accident (i.e. on 28 March 2017), the bottom parts of all eight sea piles of the TSS involved had been removed. Without support by these bottom parts, the TSS involved (including the upper parts of the sea piles, the TWP and the upper structures) had since been suspended by two sets of lifting systems, with one on the right hand side (“RHS”) and the other on the left hand side (“LHS”), which were set up on the deck of the bridge (Figure 1).

Bottom part of the sea piles (i.e. see light beige colour line) of the TSS/TWP involved had been removed, and the TSS had since been suspended by the lifting system

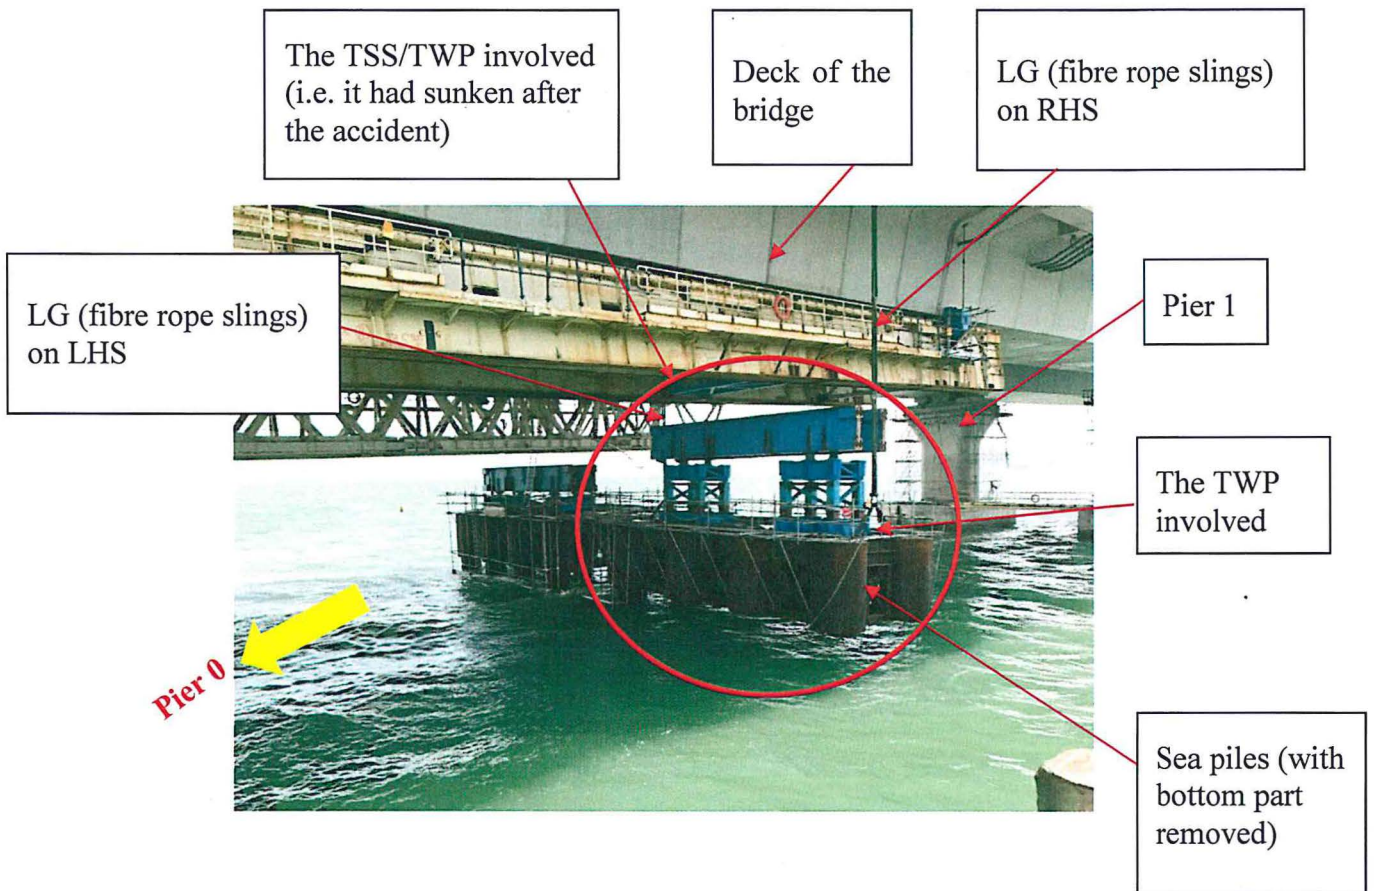
2.3.1 Two TSSs were erected above the sea surface between Pier 0 to Pier 1 to provide support for the installation of pre-cast bridge segments to form the bridge surface (Photo 1 - taken by ARUP prior to the accident on 28 March 2017). Each TSS was supported by eight sea piles as footing.

**Photo 1 – Overall view of the place of the accident
between Pier 0 and Pier 1
(Photo taken before the accident on 28 March 2017)**

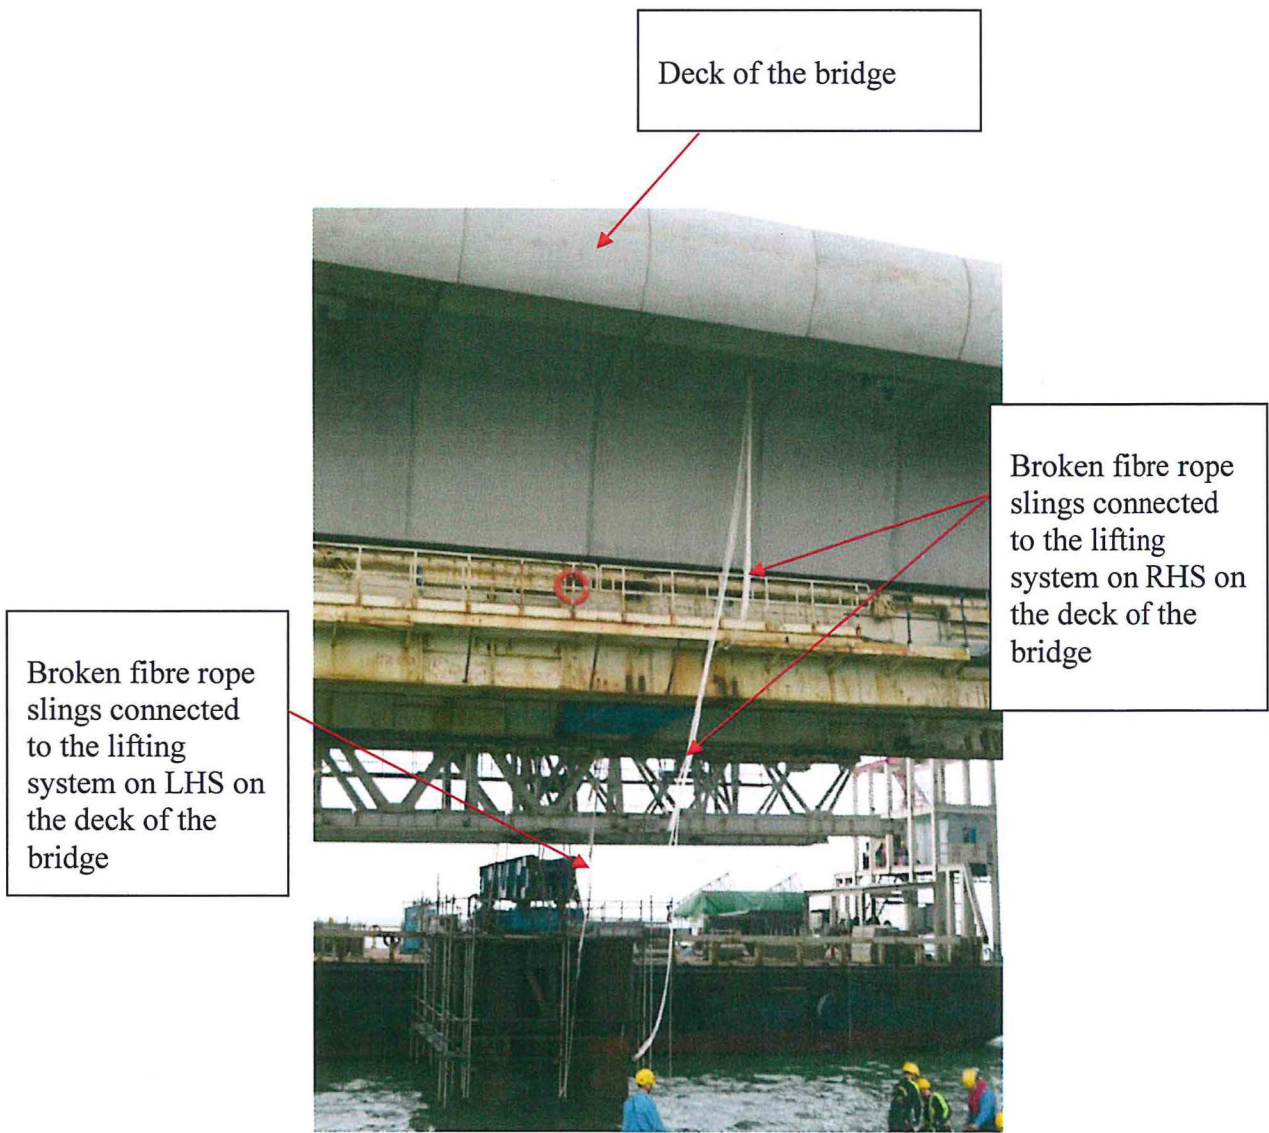
- 5.2.1 Two broken fibre rope slings suspending in the mid-air were found underneath the bridge deck after the accident (Photo 2).
- 5.2.2 Two sets of the lifting systems for lifting up the TWP were found on the bridge deck. The lifting system on the RHS was found collapsed (Photo 4), with the lifting beam, hydraulic jacks and their supports scattered on the deck of the bridge, whilst the lifting system on the LHS was found remained intact (Photo 3).
- 5.2.3 The support for the jacks was made up of some makeshift metal blocks. LD's investigation revealed that their integrity as jack support had not been assessed. In particular, the strength of each block under various loading conditions was not known. Also, when stacked together, the overall stability was not assessed.
- 5.2.4 There was no temporary works design certificate issued for the lifting system.

Photo 2 – Showing broken fibre rope slings beneath the deck of the bridge after the accident

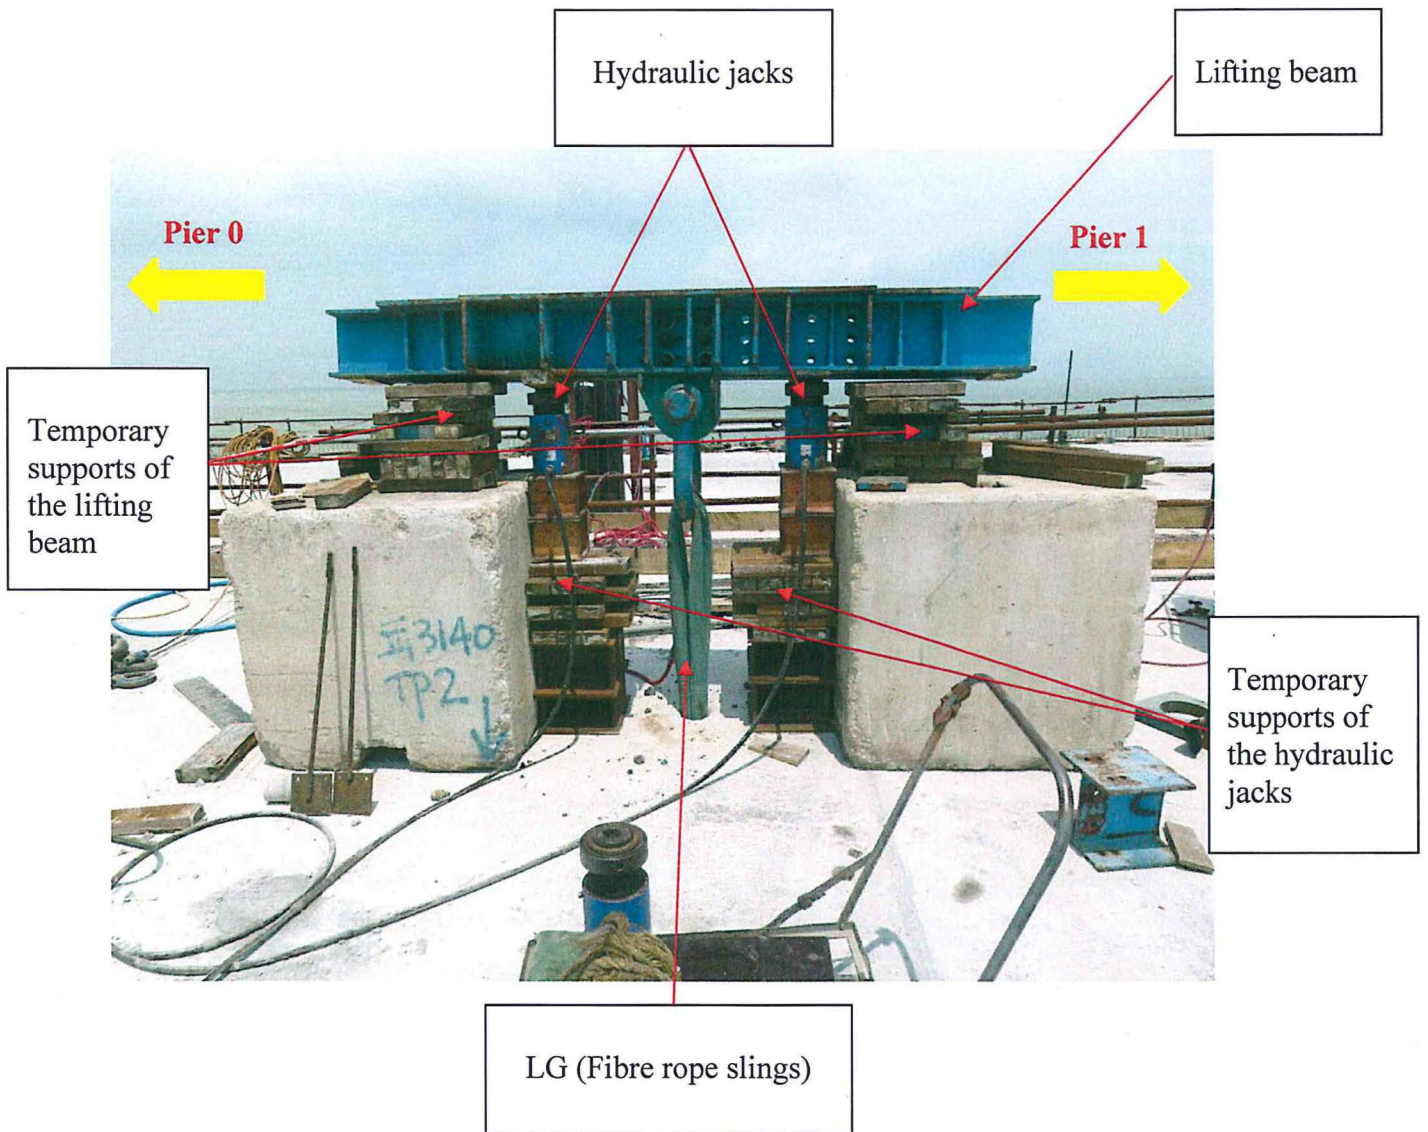
Photo 3 – No collapse of the lifting system on LHS on the deck of the bridge under construction

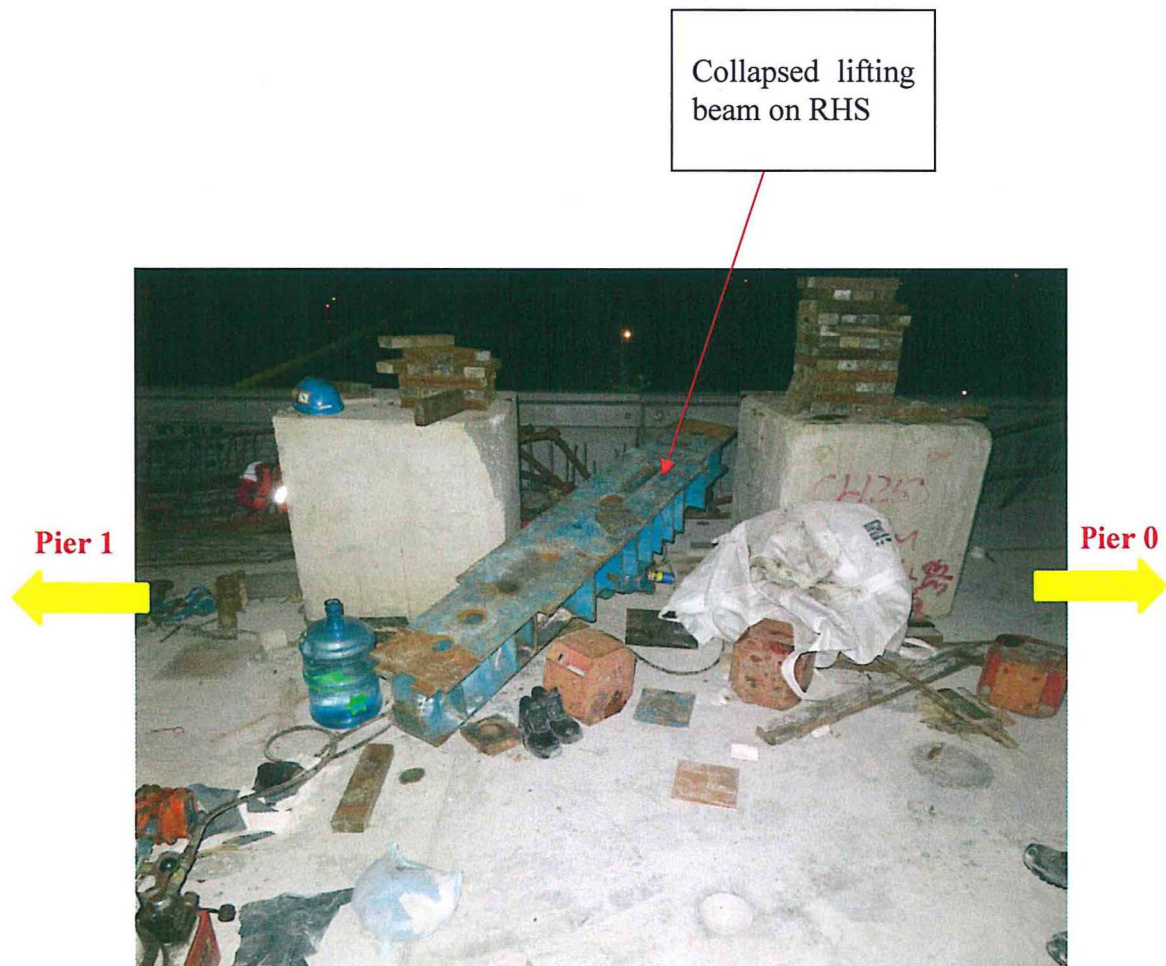
- 3.3 During the lifting, the lifting beam on RHS on the bridge deck collapsed, causing breakage of two fibre rope slings which constituted the two sets of LG suspending the TWP on both sides (Photo 4). Given the failure of the LG, the TWP plunged into the water. D/P(1), D/P(2) and I/P(2) were dismantling a metal scaffold erected around the TWP concerned during the lifting. Whilst their safety harnesses were anchored to the guard-rail of the TWP, the three workers were dragged into the sea together with the collapsed TWP. At the same time, the collapsed lifting beam hit I/P(1) and I/P(3) who were working on the bridge deck. They were injured with bone fractures on their right legs.

- 5.4.1 It is suspected that the accident was mainly attributable to the unstable temporary supports of the hydraulic jacks at the RHS lifting system which fell, resulting in the collapse of the lifting beam.
- 5.4.2 The jerking force, that resulted from the collapse of the lifting beam and exerted to the LG, caused the breakage of two fibre rope slings. Eventually, the TWP suspended by the slings plunged into the sea.
- 5.4.3 At the material time of the accident, D/P(1), D/P(2) and I/P(2) were dismantling the metal scaffold erected around

Photo 4 – The collapsed lifting beam on RHS on the deck of the bridge under construction
