立法會交通事務委員會  
鐵路事宜小組委員會

廣深港高速鐵路香港段  
石崗列車停放處維修車庫列車車輪偏離路軌事件

**Investigation Results on**

**Shek Kong Stabling Sidings**  
**Running Maintenance Shed Track No. 4**  
**Wheel Shift Incident**  
**of Guangzhou-Shenzhen-Hong Kong**  
**Express Rail Link (Hong Kong Section)**  
**on 3 April 2018**

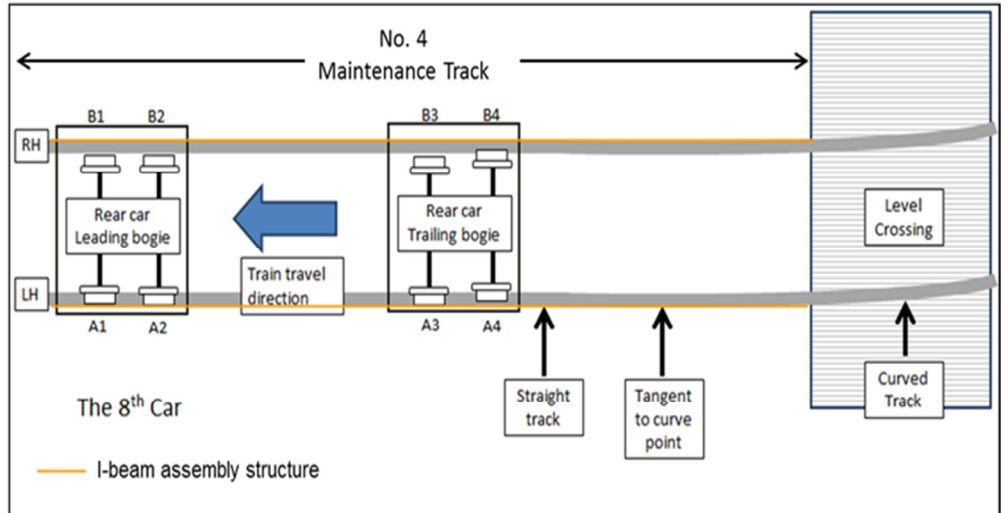
Diagram Showing the position of the train wheels

1.2 The train wheels position immediately after the incident took place is shown diagrammatically in **Annex 1**.

standard dimension of 1,435mm with +8mm/-6mm tolerance), causing the wheels shifted out of position. The location of the wheel drop point on the right-hand side rail at 1.65m from the tangent to the 180m radius curve was identified. Slacking of the I-beam in the elevated track section for the left-hand side rail was found.

3.2 The results of the technical investigation revealed that track gauges of 1,436-1,525mm, exceeding the 1,435mm +8mm/-6mm tolerance, were found at the incident track location on the elevated track support section of RMS Track No. 4. With the measured dimensions of the wheelsets all within their specifications and maintenance standards as confirmed by the experts from Sifang after the incident, the conditions of the track gauges explained how the four wheels of the incident

train had shifted out of position. The rail fastenings of RMS Track No. 4 were found to be securely in contact with the rail foot of both rails after the incident. The evidence on site indicated that the I-beams supporting the running rails above had been displaced and were slightly deformed.

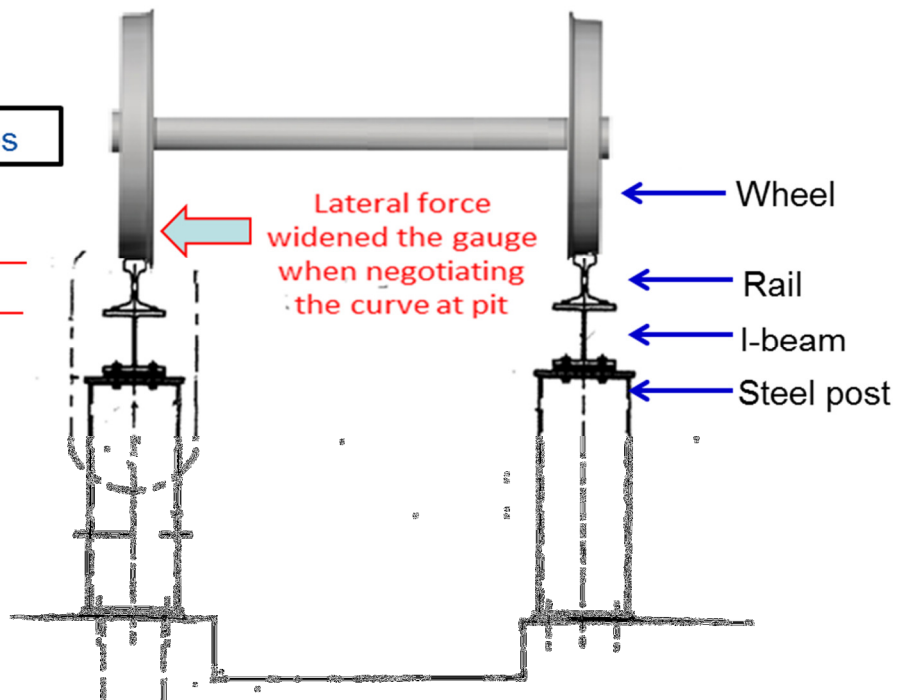
## Interface Parties

3.1 The RMS tracks involve two design parties. The running rail and rail fastenings were designed (and built) by the contractor responsible for the trackworks (P-Way). A separate Detailed Design Consultant, ARUP, was responsible for the design of the I-beam and supporting structure below the rail in the SSS. (See **Annex 1**).

3.4 The Panel has interviewed the detailed design consultant responsible for the design of the I-beam assembly structure supporting the maintenance tracks at RMS. It was identified that the consultant had assumed the lateral forces imposed on the short curved section of RMS Track No.4 would be insignificantly small and therefore adopted the same design for the I-beam assembly structure for all of the four maintenance tracks at RMS.

3.5 The actual lateral forces exerted by the train wheels at RMS Track No. 4 have exceeded the original design assumptions used by the detailed design consultant and this is considered to be the root cause of this incident. With repeated running of trains over that section since April 2017, the track support assembly eventually succumbed during the passage of the incident train on 3 April 2018.

5.1 To prevent recurrence, the Corporation is now working on an improvement measure to strengthen the track support assembly on this curved section of RMS Track No. 4 so as to re-open RMS Track No. 4 for use. It is proposed to enhance the track support assembly at the curved section, by replacing the section of I beams and vertical supports with two reinforced concrete walls under the rails. With this enhancement, the structure can withstand the actual lateral forces while still allowing maintenance works to be carried out underneath the train. Formal submission of the design proposal will be submitted to relevant Government bureaus/ departments for their review before implementation.
