Legislative Council Panel on Transport

Recent Incidents of Water Leakage and Smoke Emission from the Pillar Box at the Basement of the Passenger Clearance Building of the Hong Kong-Zhuhai-Macao Bridge Hong Kong Port

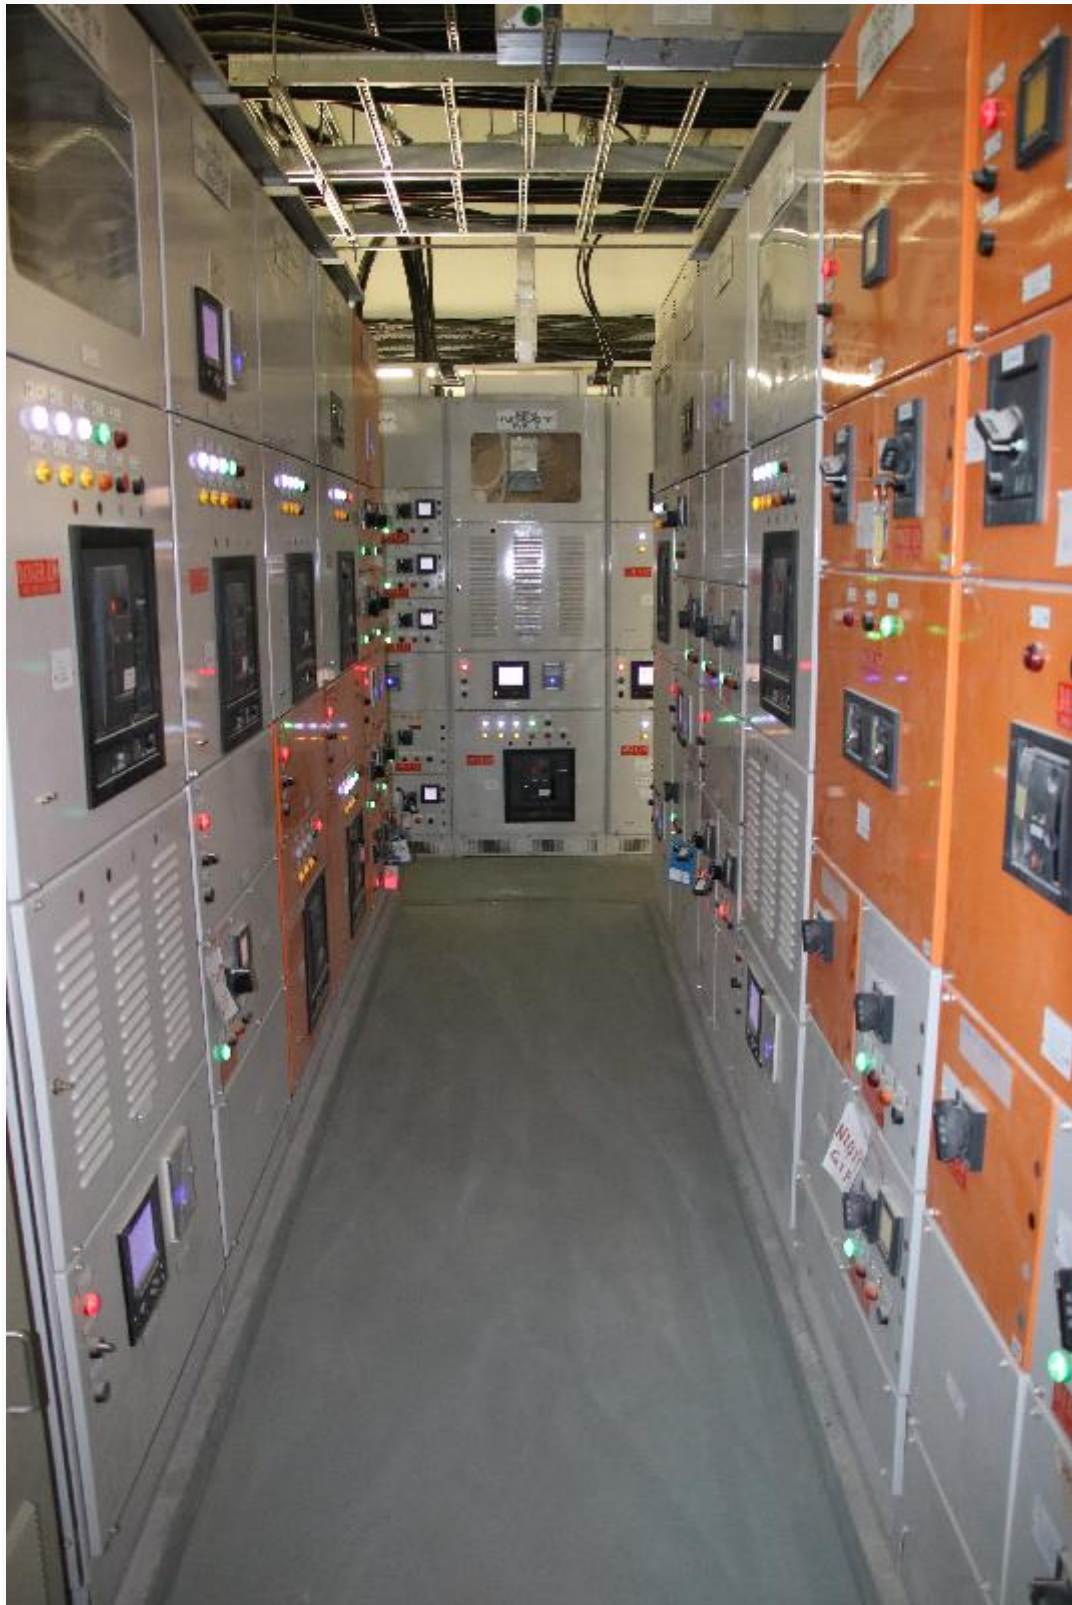
6. According to the records kept by the resident site staff (RSS) of the consultant commissioned by HyD, upon completion of structural and fitting-out works at the PCB, final installation of the E&M equipment as well as its testing and commissioning were underway. On 15 April 2018, rainwater entered into some unsealed underground cable ducts through the draw-pits due to the cable ducts being not sealed up in a timely manner after cables laying. This caused the rainwater to leak into a low voltage switchroom (the voltage of which is 380V and not 11kV as reported by the media) in the west wing of the basement through the draw-pits and cable ducts. The Contractor and the RSS tackled the issue promptly, after finding out the leakage problem, and have the concerned equipment thoroughly checked and the affected parts replaced. The concerned cable ducts have also been sealed up and the other E&M facilities of the PCB are unaffected.

Regarding the water leakage incident at the Passenger Clearance Building of Hong Kong-Zhuhai-Macao Bridge Hong Kong Port, photo (taken on July 3, 2018) shows the present condition of the location of the April 15, 2018 water leakage incident.

11. After the incident of water leakage, HyD had demanded the Contractor to seal up all unsealed underground cable ducts to avoid recurrence of similar incident. The Contractor has completely sealed up the cable ducts in the draw-pits surrounding the PCB. In the recent severe rainfall events, HyD no longer found any water leakage at cable ducts.

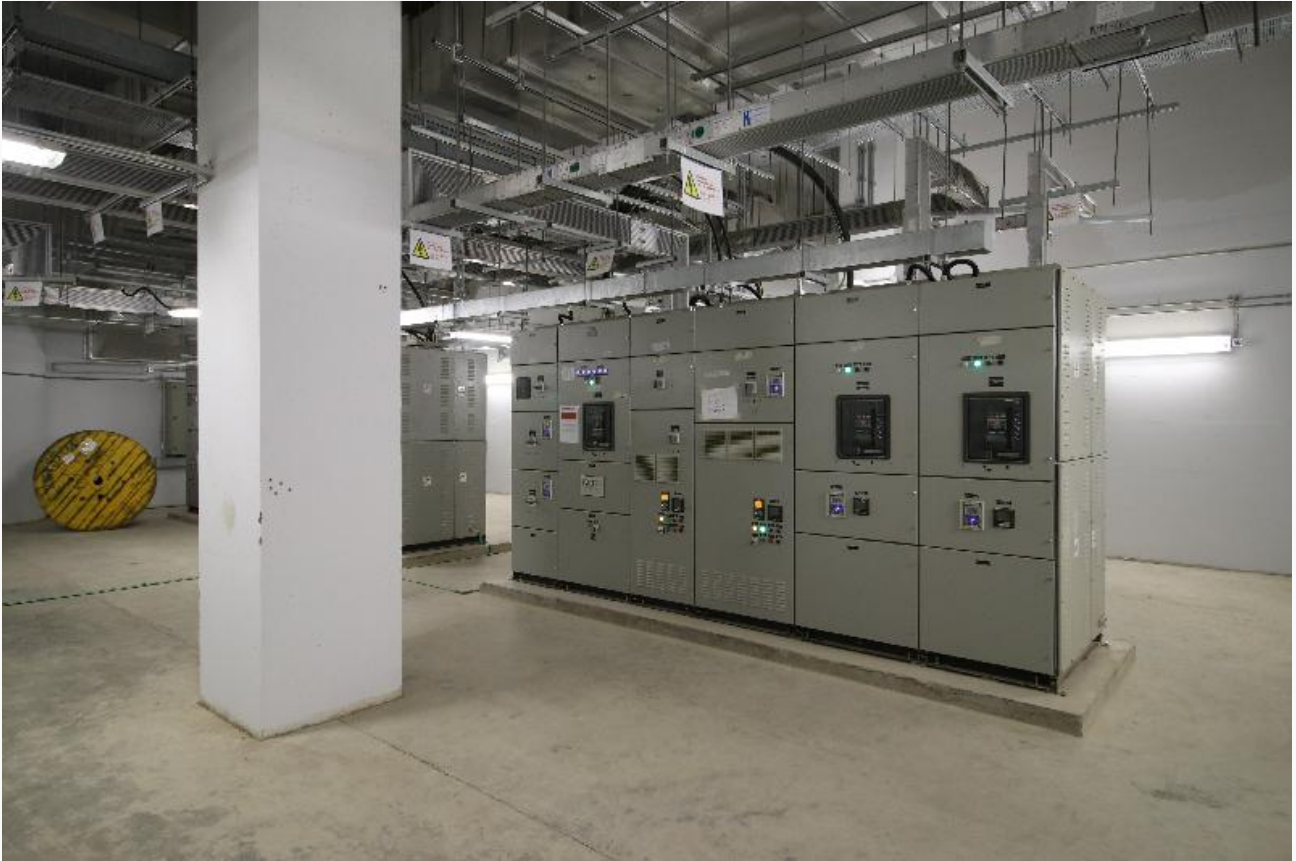
7. Regarding the media report about the smoke emission from a pillar box of the air conditioning system at the basement of the PCB, the incident happened on 20 June 2018 with reference to the record of the RSS of the consultant commissioned by HyD. The RSS found that there was smoke emitted from one of the pillar boxes at the control centre of the district cooling system located at the east wing of the basement in PCB. After investigation, it was revealed that the harmonic filter of a chilled water pump inside the

pillar box of district cooling system was out of order leading to over-heating and smoke emission. The Contractor has completed the rectification works for the malfunctioned component and the pillar box is currently in normal operation.

Regarding the water leakage incident at the Passenger Clearance Building of Hong Kong-Zhuhai-Macao Bridge Hong Kong Port, photo (taken on July 3, 2018) shows the present condition of the location of the June 20, 2018 smoke emission incident.

12. With regard to the smoke emission incident at the pillar box of air conditioning system at the basement of the PCB, HyD had demanded the Contractor to check all the pillar boxes of the air conditioning system and to conduct relevant testing, so as to enhance monitoring for ensuring smooth operation of the system. Currently, there are regular security patrols in the PCB round-the clock. Any issue found will be reported immediately and be dealt with in a timely manner.

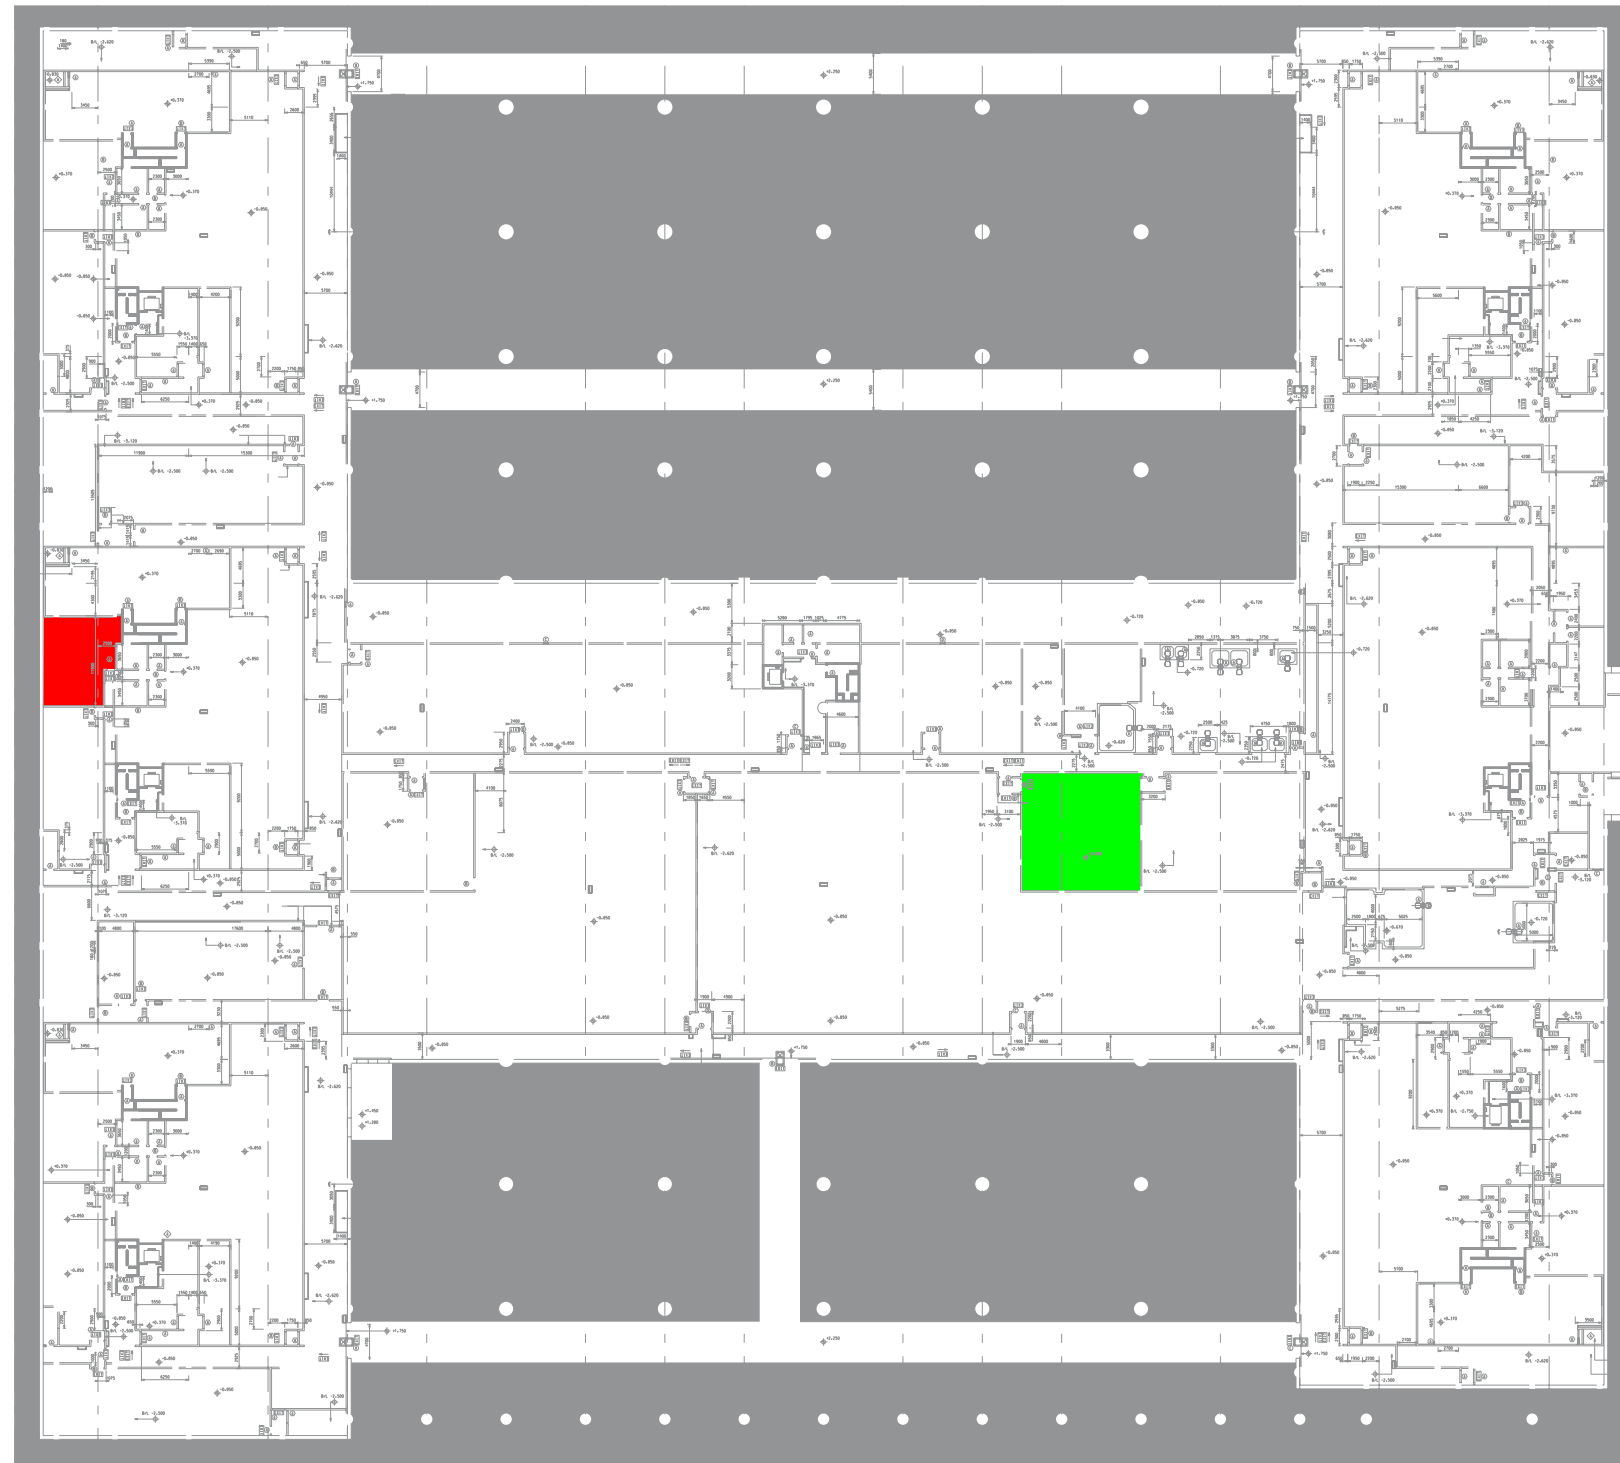
旅檢大樓地庫的平面圖 — 發生漏水事件的低壓電掣房及發生冒煙事件的區域供冷系統控制中心的位置
Basement Floor Plan of Passenger Clearance Building -
Location of the Low Voltage Switch Room with Water Leakage Incident
and the Control Centre of District Cooling System with Smoke Emission Incident

發生漏水事件的低壓電掣房
The Low Voltage Switch Room
with Water Leakage Incident
-

發生冒煙事件的區域供冷系統控制中心
The Control Centre of
District Cooling System with
Smoke Emission Incident
