**For discussion  
on 31 August 2018**

**Legislative Council Panel on Transport  
Incident Relating to Construction of the Platform Slab of  
Hung Hom Station Extension Works  
under the Shatin to Central Link Project**

This paper reports to Members on the incident relating to construction of the platform slab of Hung Hom Station (“HUH”) Extension works under the Shatin to Central Link (“SCL”) project and the follow-up actions taken by the Government.

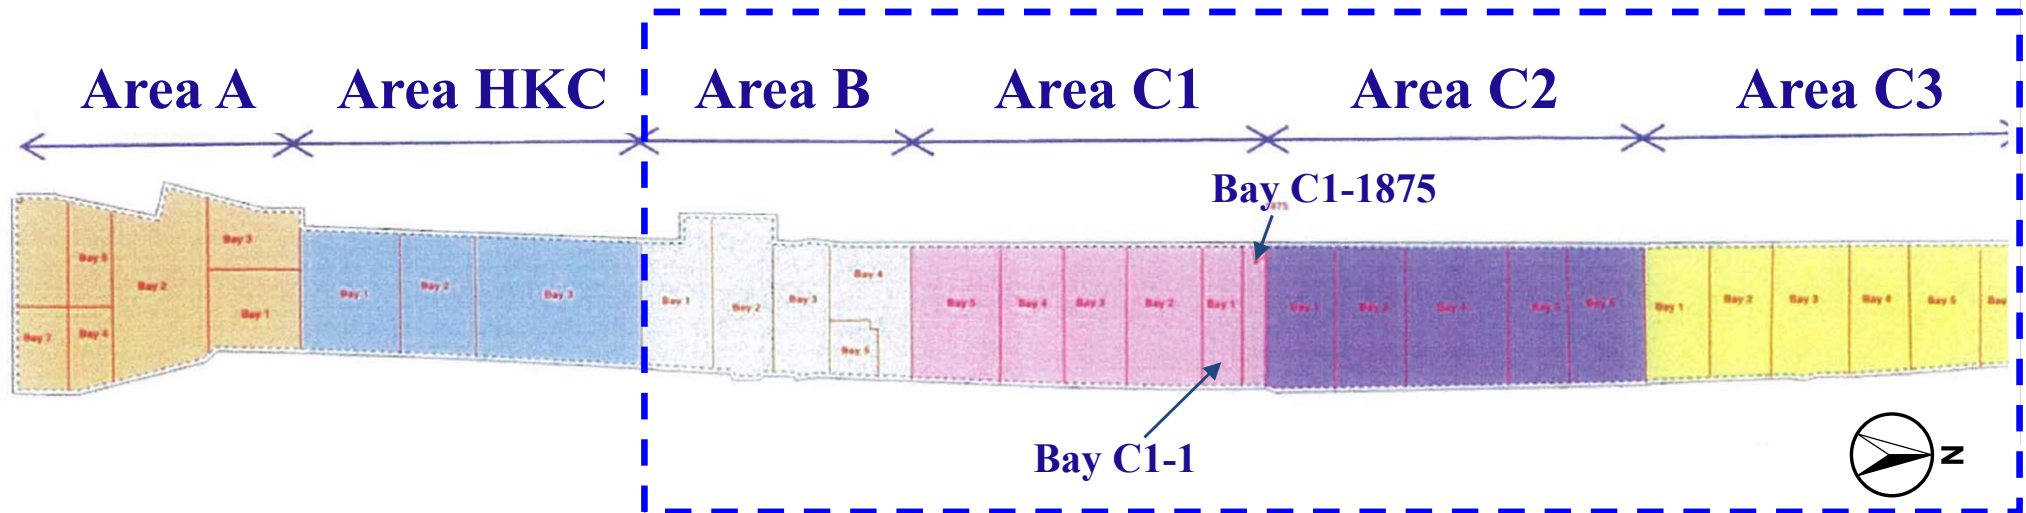
## East West Corridor (“EWC”) platform slab concrete pour plan

- Total 32 concrete pours for the entire EWC slab
- Incident relating to construction of the platform slab involves Areas B, C1, C2 and C3 (22 bays in total)

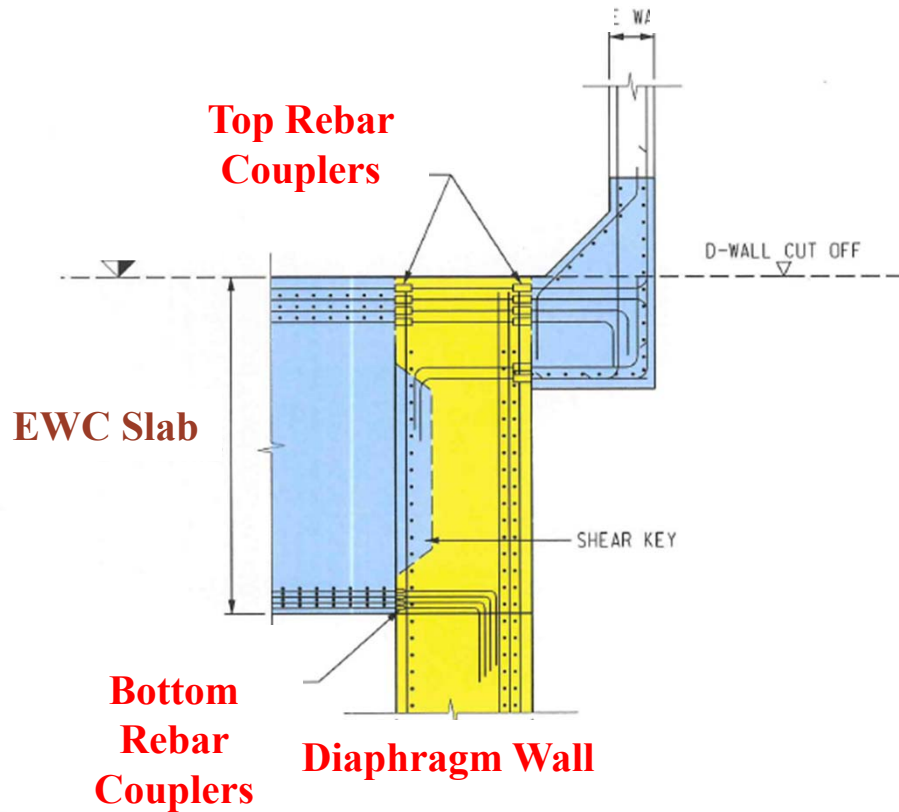
**EWC Slab and Diaphragm Wall (East) Connection Detail (1)**  
**(For bays C1-1 and C1-1875 only)**

14. In the course of the Government's follow-up of the incident, MTRCL submitted supplementary information to HyD on 13 July 2018. According to the EWC platform layout plan (**Annex 3**) and the connection details between the diaphragm walls and platform slab (**Annex 4**) as shown in the submitted supplementary information, with the exception of two concrete pour bays (i.e. Bay C1-1 and Bay C1-1875) of the EWC platform slab, couplers had no longer been used in the top layers of reinforcement in the connection of the platform slab with the eastern diaphragm wall in the remaining 20 concrete pour bays of platform slab in Areas B, C1, C2 and

C3. After careful study by the HyD and the BD, these details were found to be inconsistent with the drawings already agreed by BD, and hence brought about the following serious problems –

- (i) The connection details as shown in the supplementary information submitted by the MTRCL on 13 July 2018 did not correspond to those shown in the MTRCL's report submitted on 15 June 2018, and were also inconsistent with the design agreed by BD;
- (ii) The connection details as shown in the supplementary information submitted by the MTRCL on 13 July 2018 indicated that the number of couplers used was about 2,000 less than that stated in MTRCL's report submitted on 15 June 2018; and
- (iii) MTRCL has provided information to HyD demonstrating that 23,500 couplers had been used in the connection of the diaphragm walls and EWC platform slab. If the connection details as shown in the supplementary information submitted by the MTRCL on 13 July 2018 were correct, the government departments would cast doubts about the relevant information submitted earlier.
