**Legislative Council Transport Panel
Sub-Committee on Matters Relating to Railways
14 April 2020**

**Derailment Incident at Hung Hom Station on East Rail Line on
17 September 2019
and
Incident happened near Lai King Station on Tsuen Wan Line on
6 October 2019**

Part I: Derailment incident happened near HUH on EAL on 17 September 2019

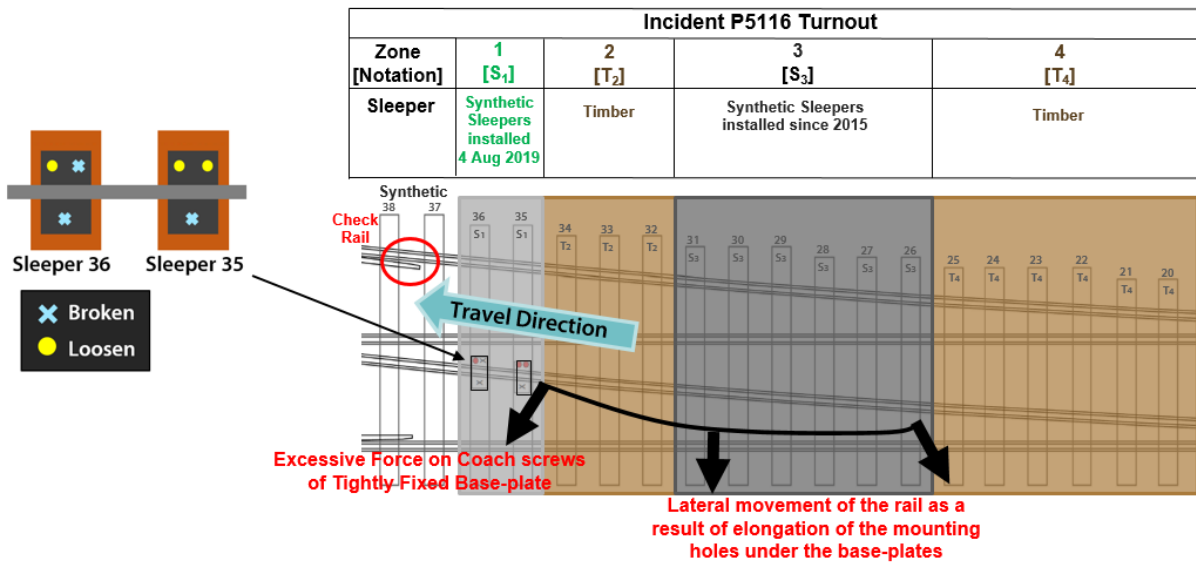
Illustration of Sleeper Arrangement at Incident Turnout P5116

Timber sleeper (2 nos.) replacement at Zone 1 on 3rd August 2019 to correct the track gauge had resulted in developing excessive force breaking the coach screws.

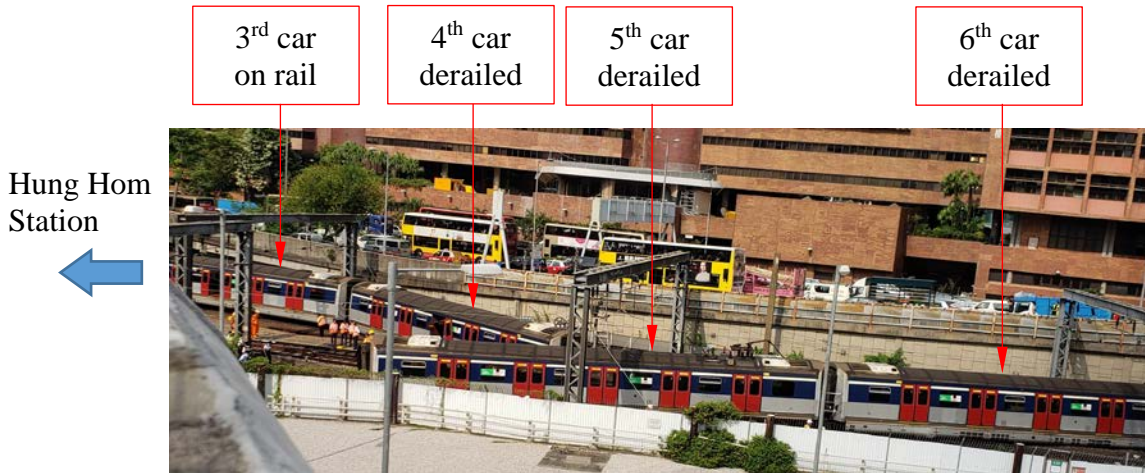
Figure 1 : Status of the incident train immediately after derailment

2.2 At the time of the incident, the train was entering Platform 1 of Hung Hom Station. The 4th to 6th cars derailed, and the coupler connecting the 4th and 5th cars was disconnected. Eight passengers were injured. **Figure 1** shows the status of the train immediately after derailment.

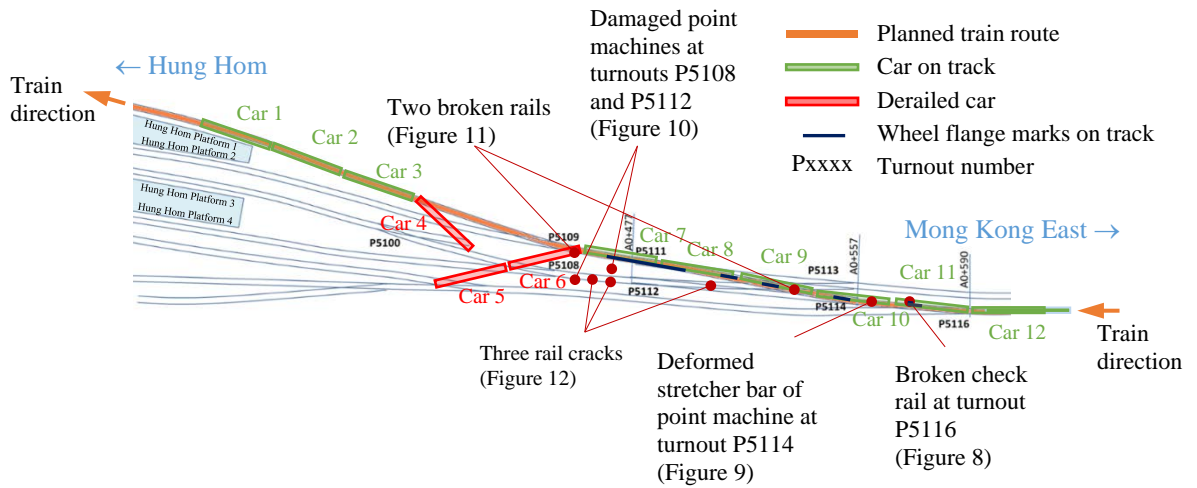
Figure 7 : Status of incident train after derailment and damage to nearby railway facilities

- (a) The incident train was scheduled to enter Platform 1 of Hung Hom Station. During the incident, the 4th to 6th cars derailed, and the coupler connecting the 4th and 5th cars was disconnected. The first three cars and the last six cars remained on the track rail. There were eight turnouts at the incident location to control train movement to and from different platforms at Hung Hom Station. The status of the incident train after derailment and the damage to the nearby railway facilities are shown in **Figure 7**. Photos of wheel flange marks, broken rails, rail cracks, and damaged point machines are shown at **Appendix I**.

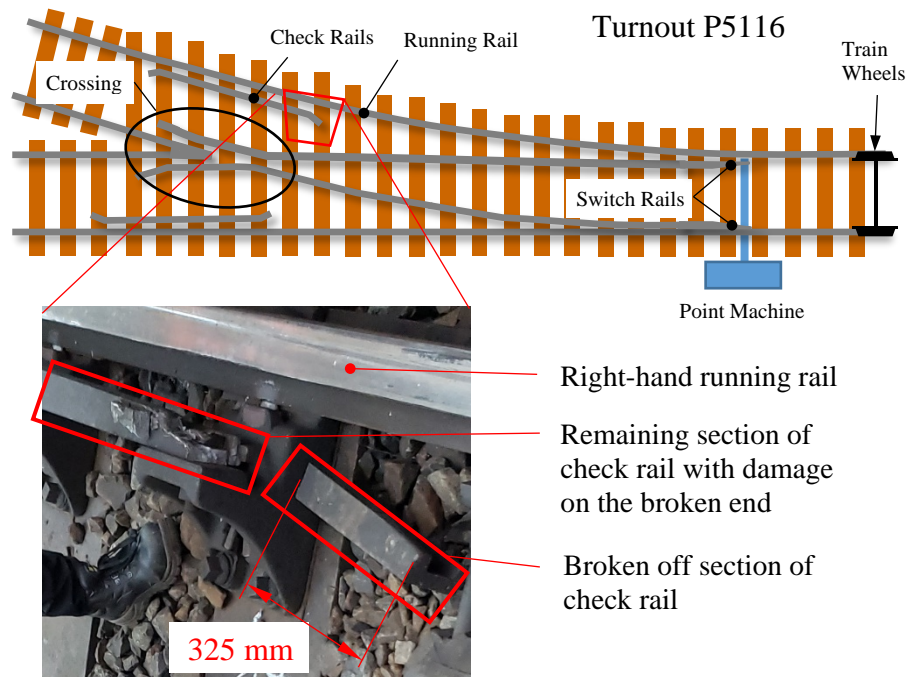
Figure 8 : Broken check rail at turnout P5116

- (b) The check rail at turnout P5116 towards Hung Hom Station was found broken (see **Figure 8**). The length of the broken section was measured to be 325 mm.

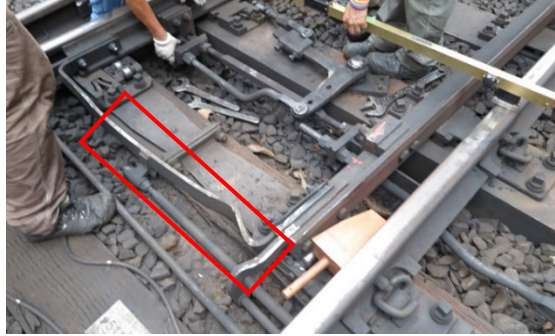
Figure 9 : Deformed stretcher bar of point machine at turnout P5114

- (c) At turnout P5114, the components of the point machine¹⁹ were deformed and damaged as shown in **Figure 9**. The motor drive of point machines of turnouts P5108 and P5112 were also damaged as shown in **Figure 10**.

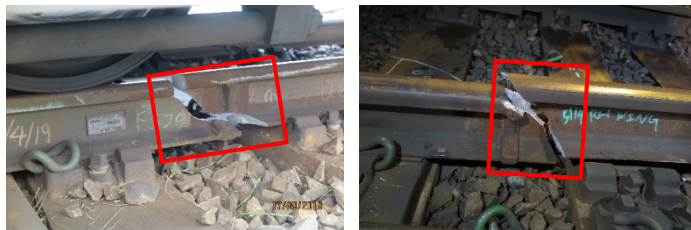
Figure 11 : Two broken rails

- (d) Two broken rails (see **Figure 11**) and three rail cracks (see **Figure 12**) were found at the incident location.

Two broken rails and three rail cracks were found at five different locations around the incident location. All points of fracture were located at welded joints. All broken points and cracks were recent fracture, instead of fatigue failure. It was evident that these fractures and cracks were caused by the derailed wheel flange striking the protruding part of the weld collar (see **Figure 24**), which were not uncommon in train derailment incidents.

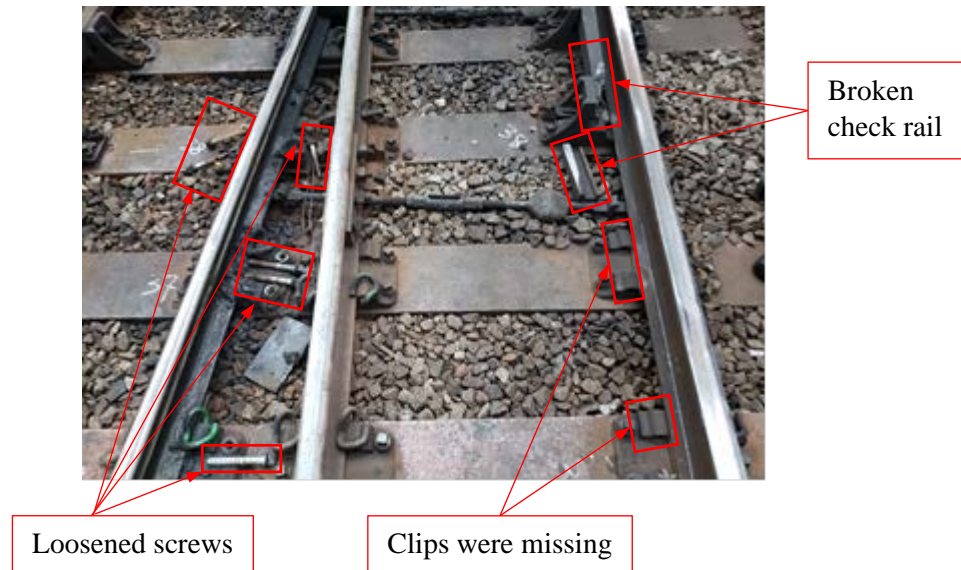
Figure 13 : Loosened fastening screws, missing clips, and broken check rail at turnout P5116

- (e) During investigation at turnout P5116, some fastening screws for fixing the baseplates to the sleepers were found to have been taken out and put aside. MTRCL confirmed that these fastening screws were found loosened and removed by their staff without the use of any tools after the incident (see **Figure 13**). Some clips for retaining the rail on the baseplates at the inside of the right-hand rail near the broken check rail were missing.

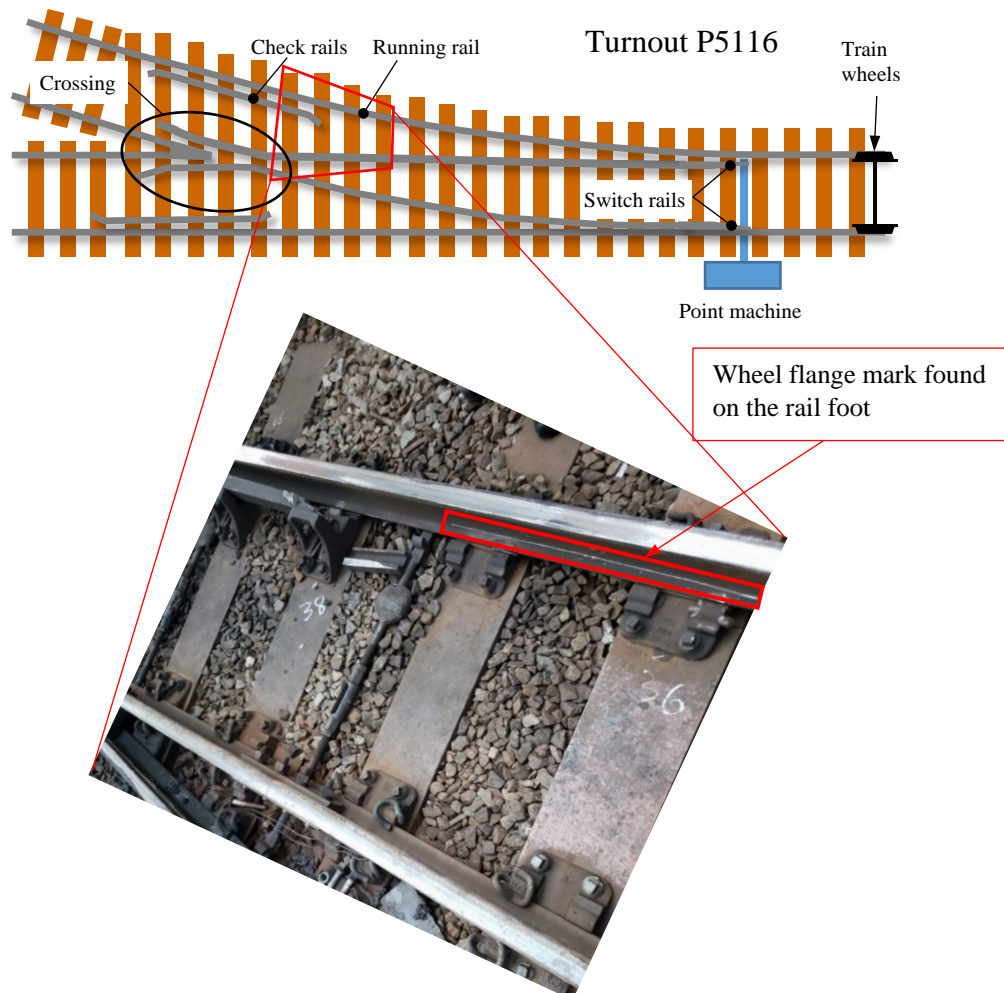
Figure 14 : Wheel flange marks on the rail foot

- (f) Wheel flange marks, as caused by the wheel flanges²⁰, were observed on rail foot and sleepers along the tracks at the incident location. An example of wheel flange mark found on the running rail near 36th sleeper of turnout P5116 is shown in **Figure 14**.
- (g) The track gauge of the running rails at turnout P5116 was measured after the incident and found exceeding the Safety Intervention Limit of 1,455 mm.
- (h) The train operation log showed the train speed was 39 km/h at the time of derailment.
- (i) No external object that was not part of the railway system was found at the incident location and nearby areas during site investigation with the Hong Kong Police Force.

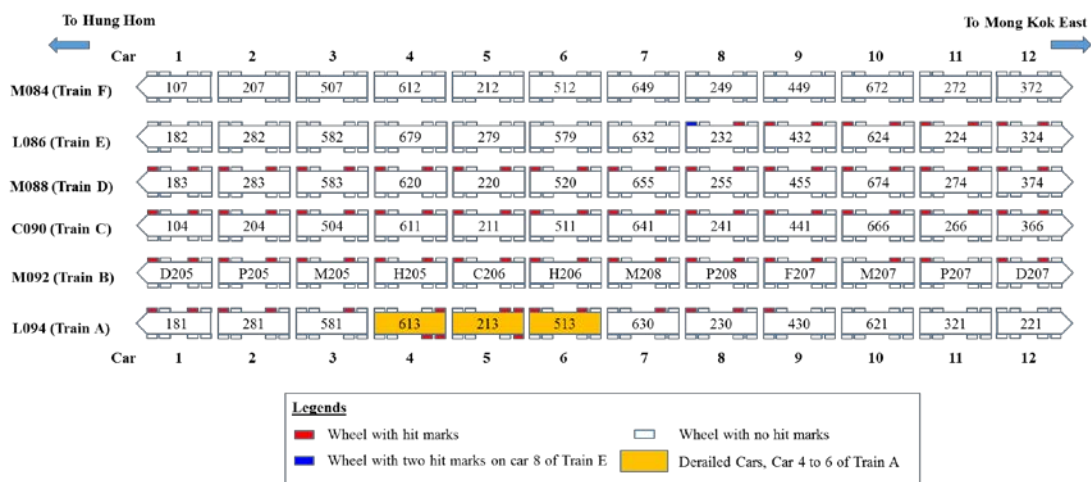
Figure 15 : Record of hit marks found on wheels of Train A to Train F

Schedule of arrival at Hung Hom Station *	Train No.	Ref. No.	Platform	Hit mark on wheels	Remarks
08:12	M084	Train F	4	No	
08:14	L086	Train E	1	Yes	First hit mark observed on 8 th car
08:17	M088	Train D	4	Yes	
08:19	C090	Train C	1	Yes	
08:22	M092	Train B	4	Yes	
08:24	L094	Train A	1	Yes	Incident train

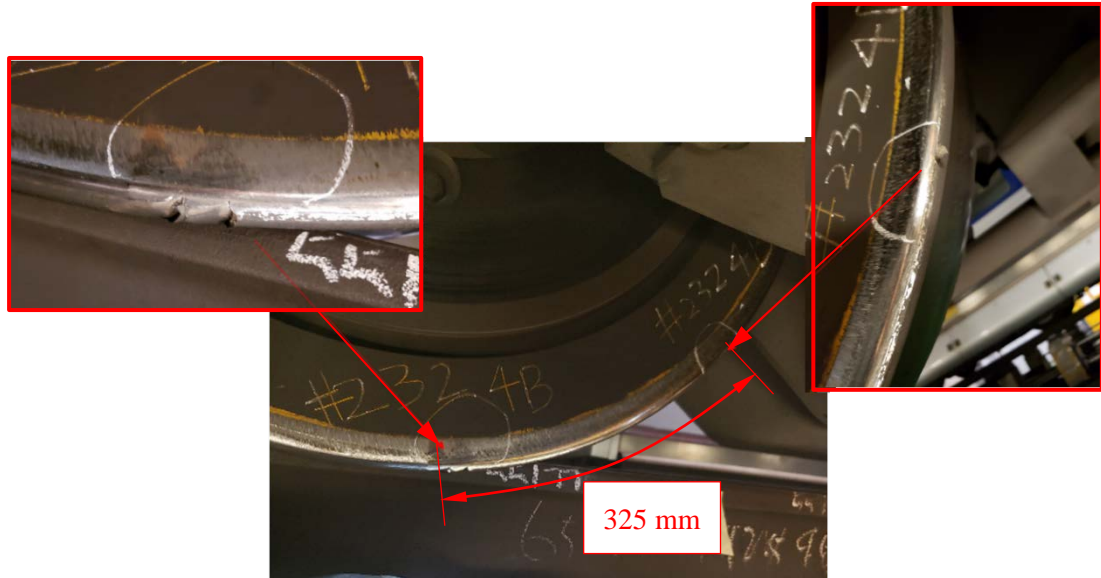
Figure 16 : Two hit marks separated by 325 mm on the first right-hand wheel of the 8th car of Train E

4.3.2 EMSD examined and found two hit marks with a separation of 325 mm (see **Figure 16**) on the first right-hand wheel on the first bogie of the 8th car of Train E. The separation distance of these two hit marks matched with the

length of the broken check rail at turnout P5116. As no hit mark was found on the wheels of the 1st to 7th cars of Train E, it was evident that the 8th car was the first to have hit and broken the front end of the check rail of turnout P5116.

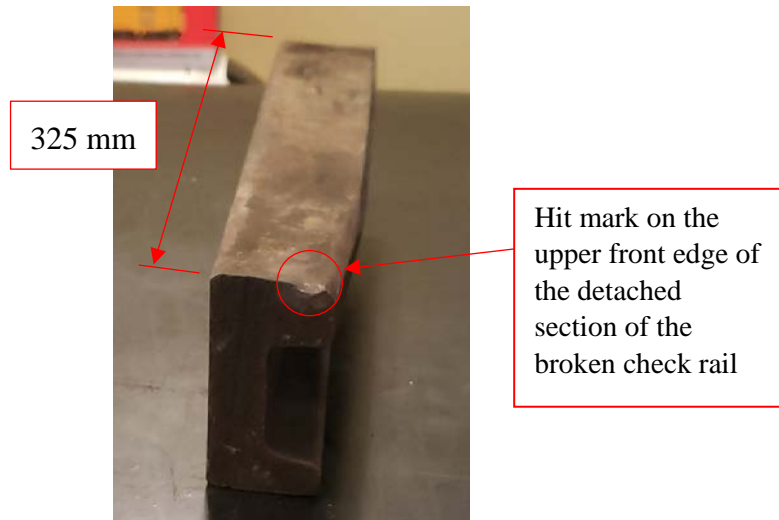
Figure 17 : Front view of detached section of broken check rail

The check rail of turnout P5116 towards Hung Hom Station was found broken. The purpose of the check rail was to restrict lateral movement of wheels to ensure that trains take the correct route through the crossing. The detached

section of the broken check rail was of length 325 mm (see **Figure 17**). From the hit mark at the upper front edge of the check rail and the hit marks on the wheels of the 8th car of Train E, it was evident that the breakage was due to fracture failure from collision with the wheel of the 8th car of Train E, instead of material fatigue.

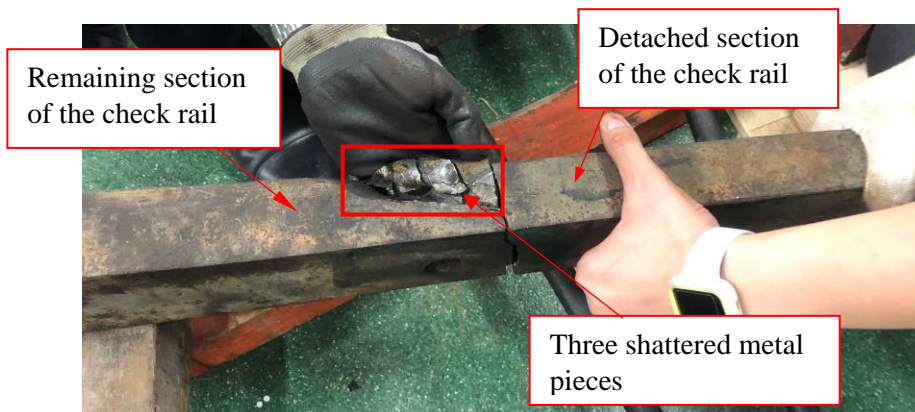
Figure 18 : Broken check rail and shattered metal pieces

Three smaller pieces of broken metal were found near the broken check rail on the track. The shape of the metal pieces, when putting together, matched with that of the fractured surface of the remaining section of the broken check rail (see **Figure 18**). It was evident that these metal pieces were shattered off from the fractured surface as a result of being hit by wheels of subsequent Train E to Train A.

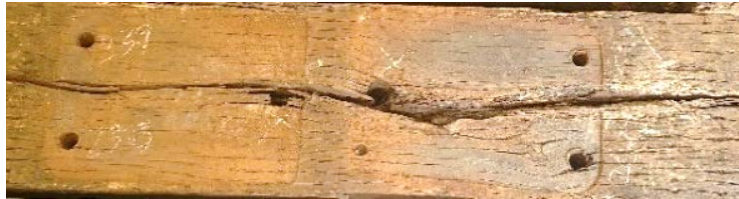
Figure 19 : Rotten timber sleeper

Both timber and synthetic sleepers were used at the incident location. Some of the timber sleepers were found to have rotted (see **Figure 19**). EMSD seized some sleepers from the derailment location.

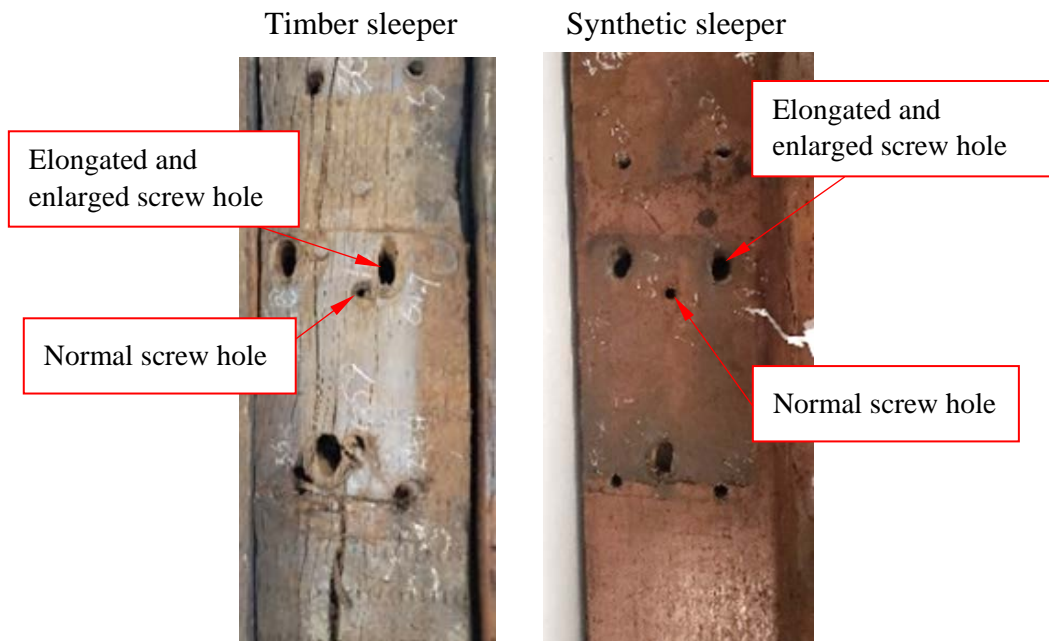
Figure 20 : Sleepers with elongated and enlarged screw holes

Elongated and enlarged screw holes were found on all the seized sleepers (**Figure 20**). These screw holes would not have been able to secure the positions of baseplates on the sleepers, thus failing to maintain the standard track gauge.

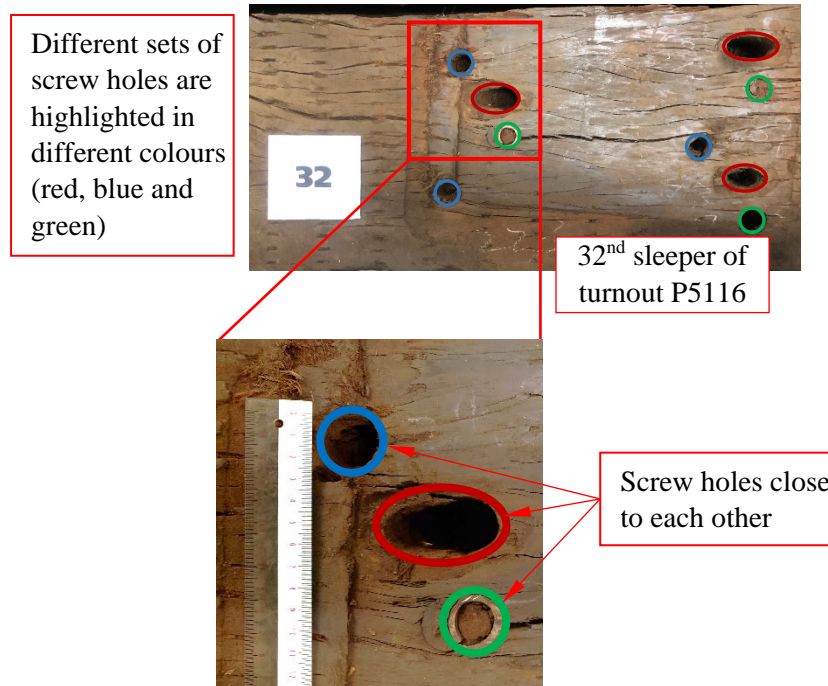
Figure 21 : Screw holes underneath the baseplate of left hand rail of the incident route on the 32nd sleeper of turnout P5116

More than one set of screw holes underneath the baseplate were observed on some seized sleepers. During track maintenance, a loosened baseplate may be fixed by shifting and re-orientating the baseplate and mounting it with a new set of screw holes on the existing sleeper. The new screw hole should be separated from existing screw holes with

sufficient distance to ensure the integrity of the new screw hole. Three sets of screw holes were found underneath the baseplate of left hand rail of the incident route on the 32nd sleepers of turnout P5116 (see **Figure 21 and Figure 22**). Some screw holes were very close to each other, which would weaken the timber and its restraint of the baseplate.

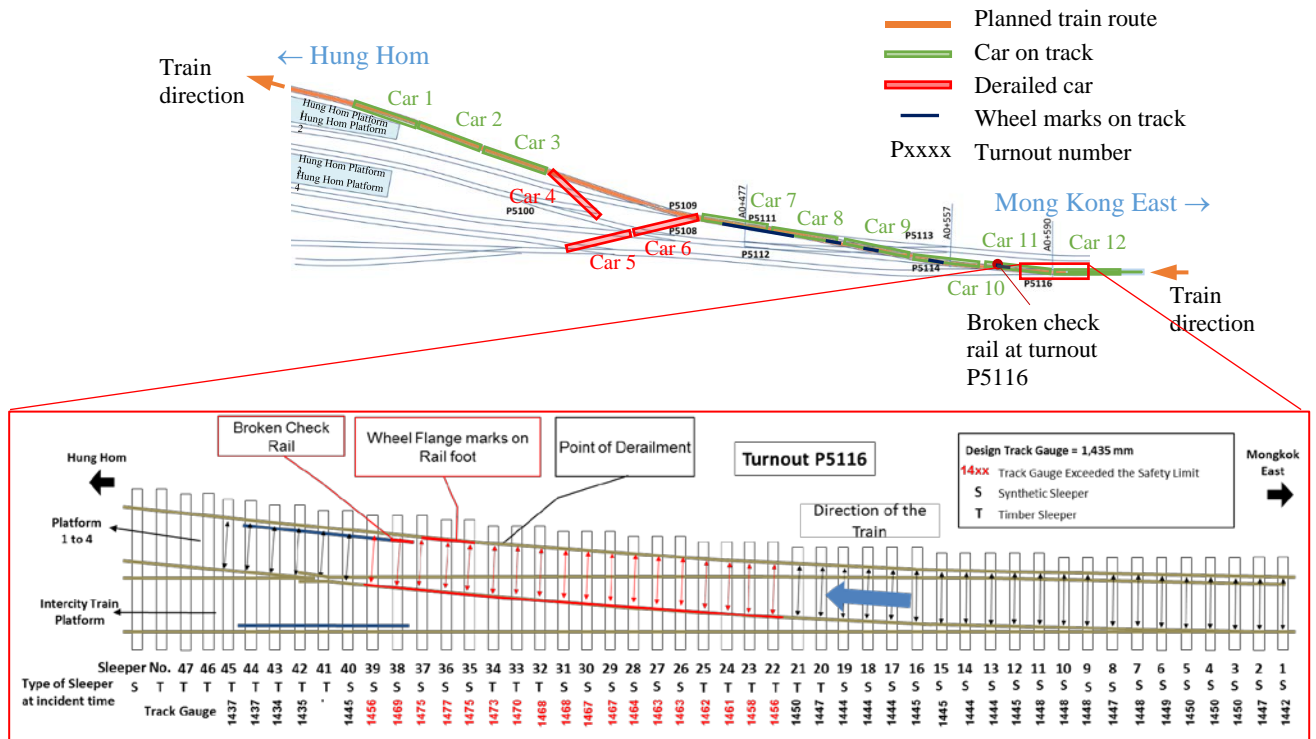
Figure 22 : Point of derailment and track gauge at turnout P5116

EMSD’s investigation team, including the appointed experts, conducted detailed inspections at the incident location to determine the point of derailment. Given the travelling direction of trains, the investigation team found that the wheel flange mark first appeared on the rail foot between the 35th and 36th sleepers of turnout P5116. Considering the train speed and the time taken for the wheel to fall and touch the rail foot, it was evident that the point of derailment was between the 33rd and 34th sleepers of turnout P5116. **Figure 22** shows the location of the point of derailment at turnout P5116.

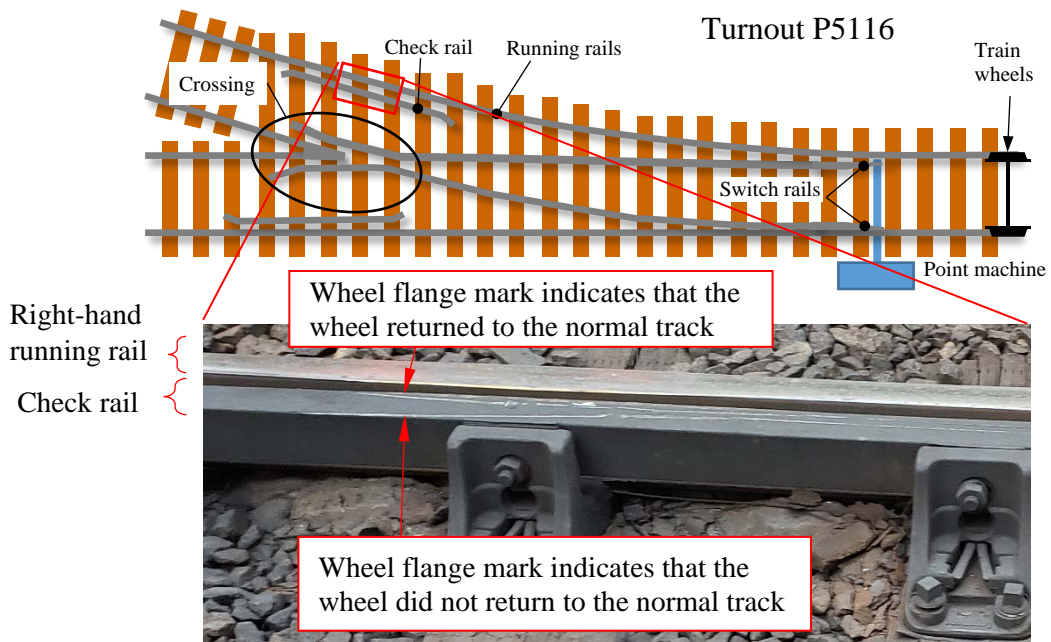
Figure 23 : Wheel flange marks on top of the check rail

Wheel flange marks were found on the top of the check rail at turnout P5116 (**Figure 23**). It was evident that some wheels of Train A to Train E had hit the check rail and climbed onto the top of the check rail.

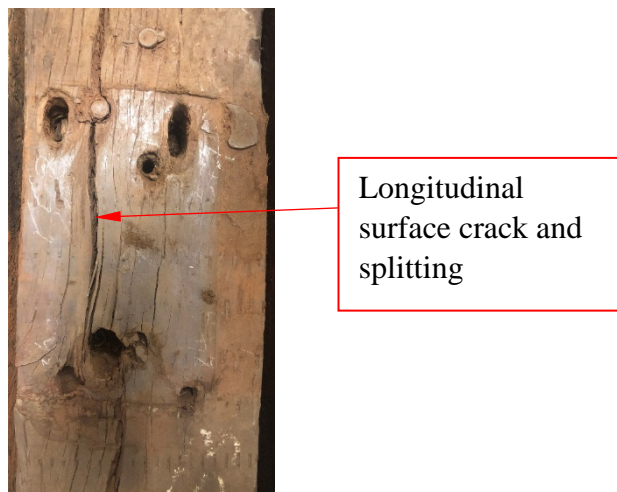
Figure 25 : Rotten timber sleeper

The investigation team examined the sleepers that were seized from site at or near the point of derailment. Many of the timber sleepers were found to have rotted internally. Longitudinal surface cracks and splitting were noted on some timber sleepers. The type of surface cracks present was evidence of internal rotting of timber. Deterioration of the integrity of the timber due to rotting reduces the ability of the screws to hold the baseplate firmly in place on the sleeper, resulting in gauge widening. **Figure 25** shows the condition of a rotten timber sleeper with longitudinal surface crack and splitting.
