Information note on Derailment Incident at Hung Hom Station on East Rail Line on 17 September 2019 and Incident near Lai King Station on Tsuen Wan Line on 6 October 2019

Derailment Incident at Hung Hom Station on East Rail Line on 17 September 2019

PR018/20
3 March 2020**MTR Implements Improvement Measures as Investigation Panel Concludes Dynamic Track Gauge Widening Caused East Rail Line Derailment Incident**

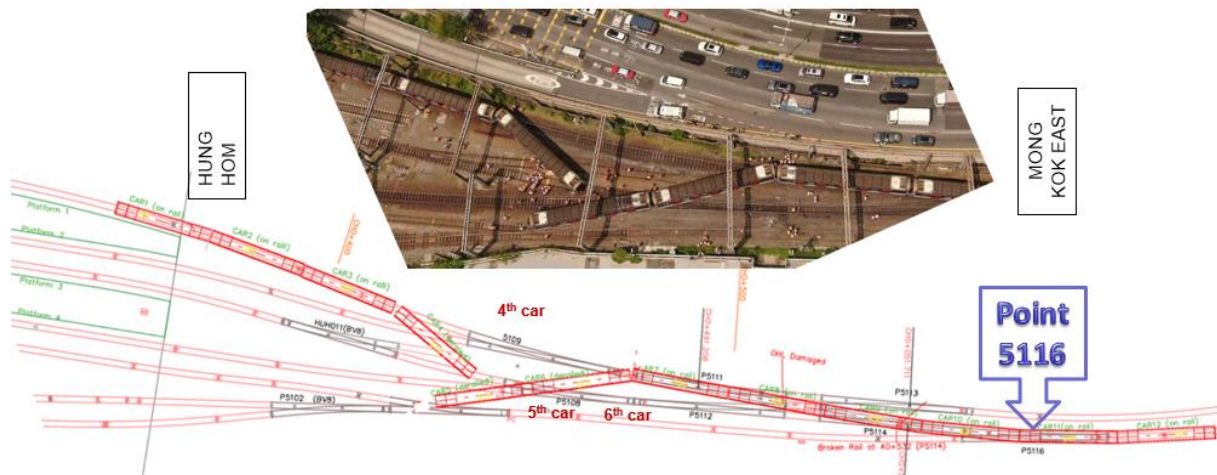
Incident Site at North of Hung Hom Station (East Rail Line)

On 17 September 2019 at 08:29 hours, the train L094 [“Train 1”] approaching Hung Hom Station (HUH) Platform 1 derailed at turnout P5116 north of the station. Three cars (4th, 5th and 6th car) derailed and the train was divided between the 4th and 5th car.

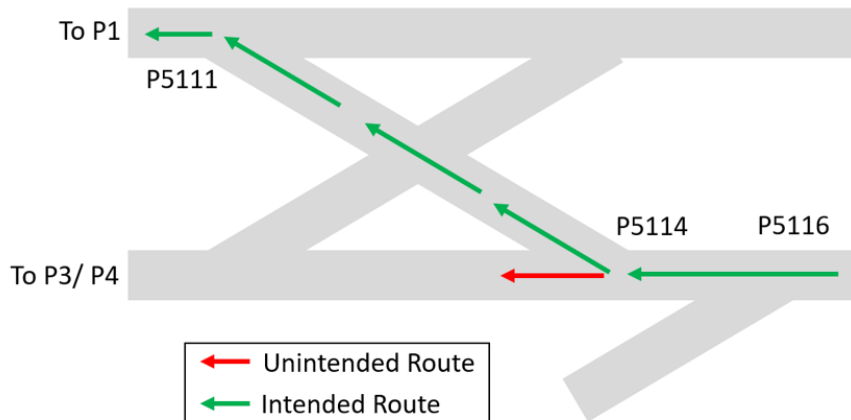
Annex 2

- 4.1 Prior to the incident, at about 08:18 hours on 17 September 2019, the leading wheelset on the 8th car of Train number L086 [hereafter “Train 5”] hit the check rail of turnout P5116 and damaged it as shown in Annex 2. A check rail is laid parallel to a running rail to guide wheels through the rail crossing of all turnouts. The wheels of 3 subsequent trains [namely “Trains 4, 3 and 2”] hit and progressively further damaged the check rail but still took the

- 4.2 At about 08:29 hours, the leading wheelset of the 5th car of Train 1 rode up on the remainder of the damaged check rail of turnout P5116 and took an unintended route towards Platforms 3 and 4 at turnout P5114 as shown in Annex 2, completely derailing the 4th, 5th and 6th cars and dividing the train between the 4th and 5th cars at a speed of around 39km/h.

Illustration of Train Route (Intended/ Unintended) of Train 1

The Incident train, Train 1 travelled on diverged route at turnout P5114.

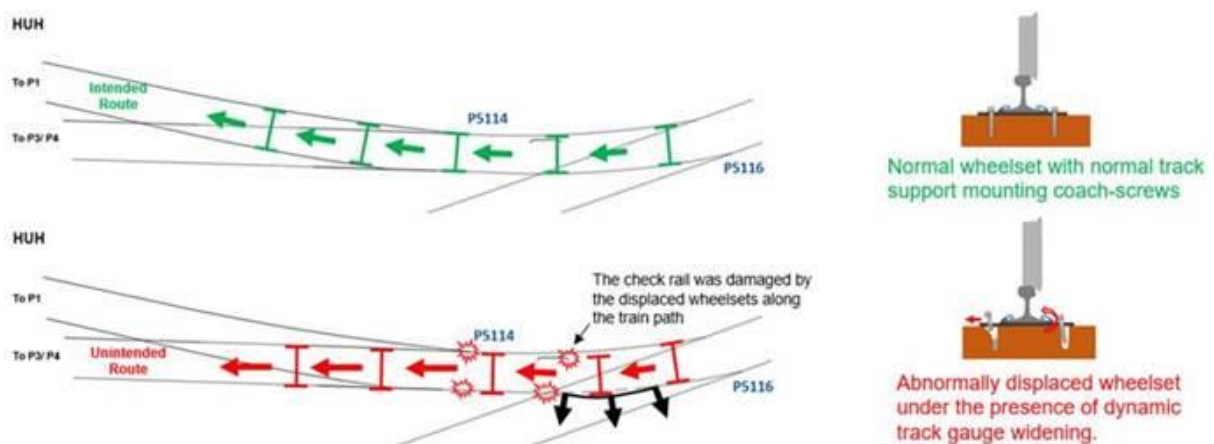
The immediate cause of the derailment was due to dynamic track gauge# widening at turnout P5116.

(#the distance between the rails under the load of a train)
