26 June 2023

# Incident of a 275-kV Fault in HK Electric's Power System on 19 April 2023

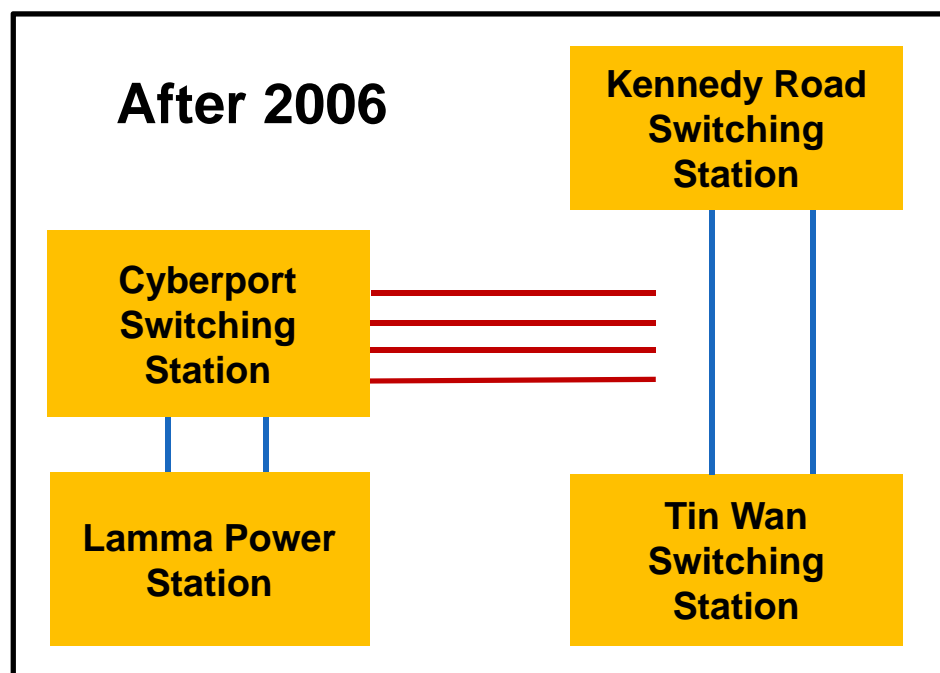
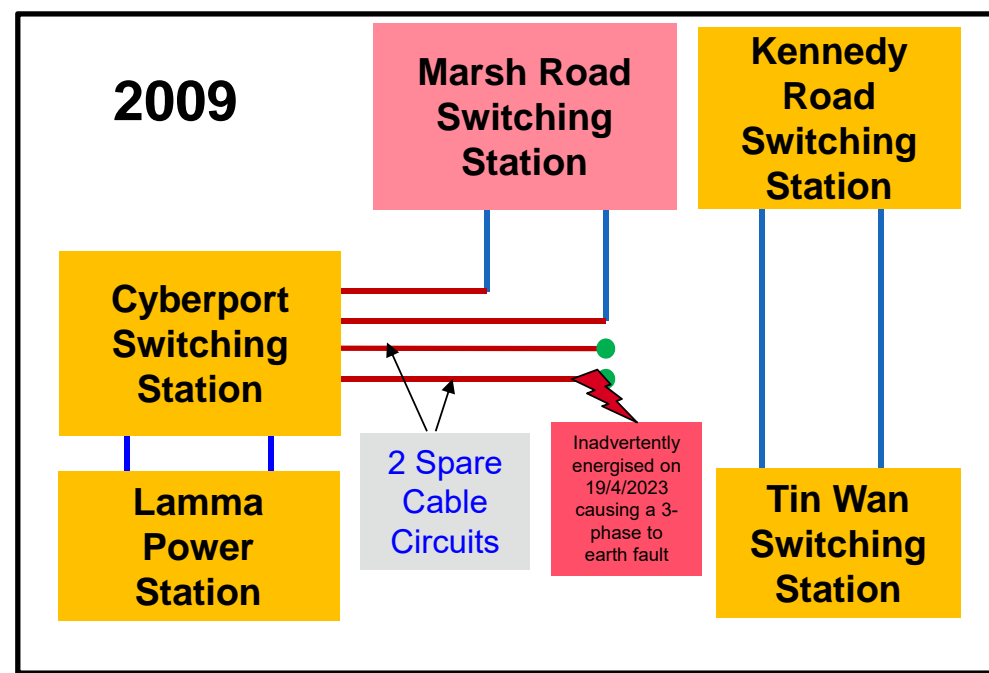
- To reinforce the power supply to HK Island North, two of the four spare 275-kV cable circuits were extended to Marsh Road Switching Station in 2009. The other two cable circuits remain as spare
- These two spare cable circuits have been connected to the switchgear at Cyberport Switching Station since first commissioning. One of the circuits was inadvertently energised during switchgear commissioning after refurbishment work on 19/4/2023, causing a 275-kV 3-phase to earth fault.

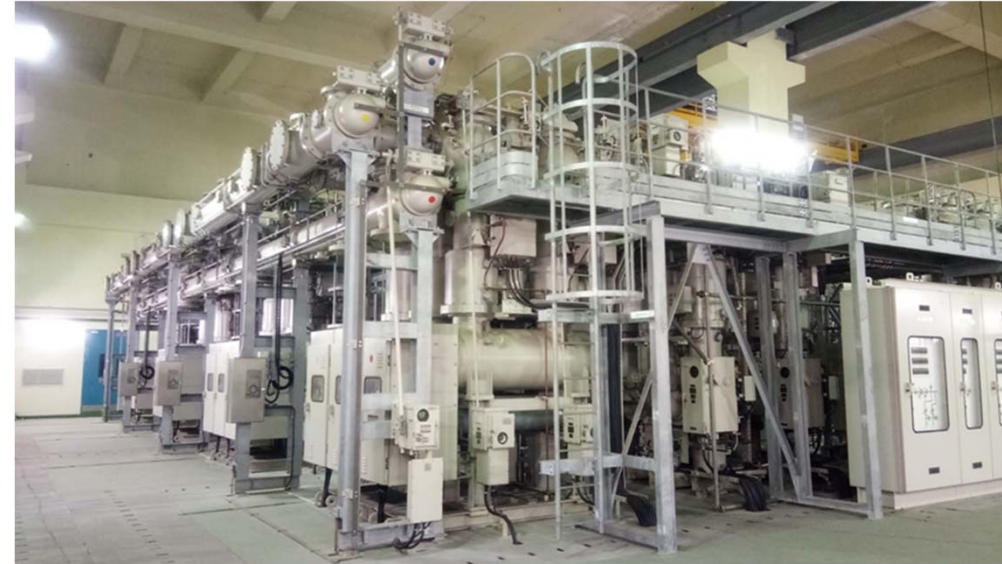
1. The refurbishment of the concerned gas-insulated switchgear (GIS) of Cyberport 275-kV GIS was just completed at the time of incident
2. GIS refurbishment is scheduled to be carried out around every 20 years by in-house experienced technicians under the immediate supervision of personnel of the switchgear OEM
3. Before the refurbishment, the switchgear isolators of spare GIS bays had been locked open to avoid inadvertent operation
4. Refurbishment involves inspection of all parts of the GIS and replacement of worn-out parts. The scope of inspection also includes the concerned spare GIS bay.

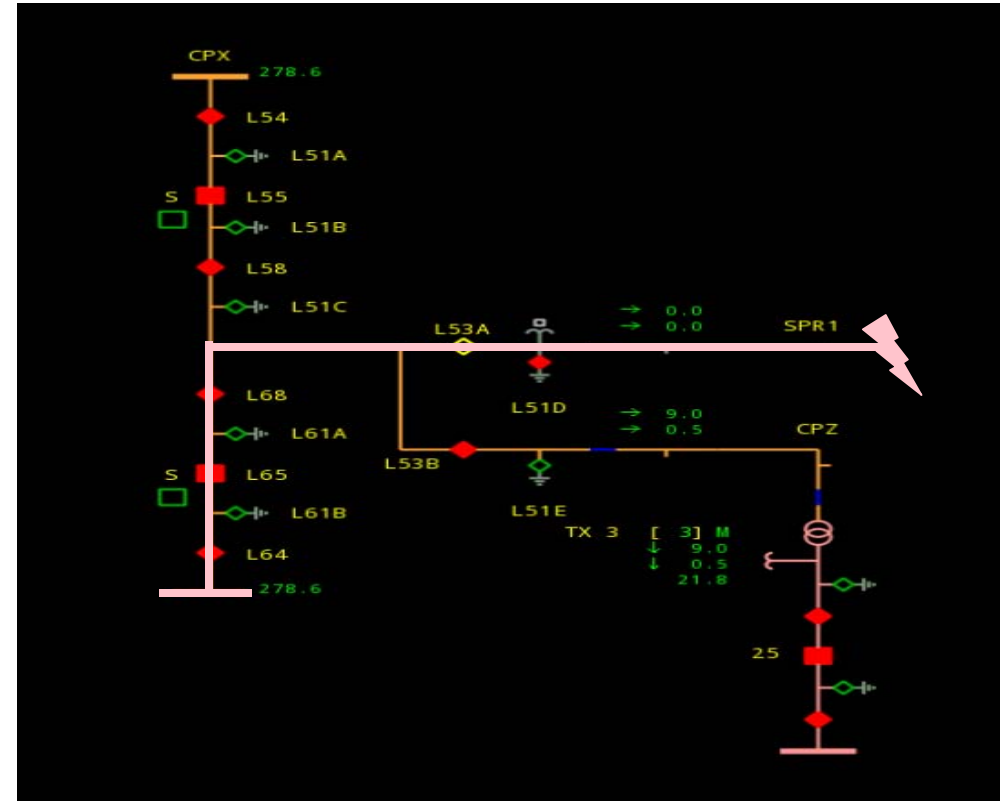
5. To ensure quality of work, all refurbished GIS portions have to undergo recommissioning
6. To minimize the impact of unforeseeable events on our customers, all recommissioning works are required to be carried out in mid-night
7. In the course of GIS recommissioning, the spare cable circuit was inadvertently energised causing a 3-phase fault.

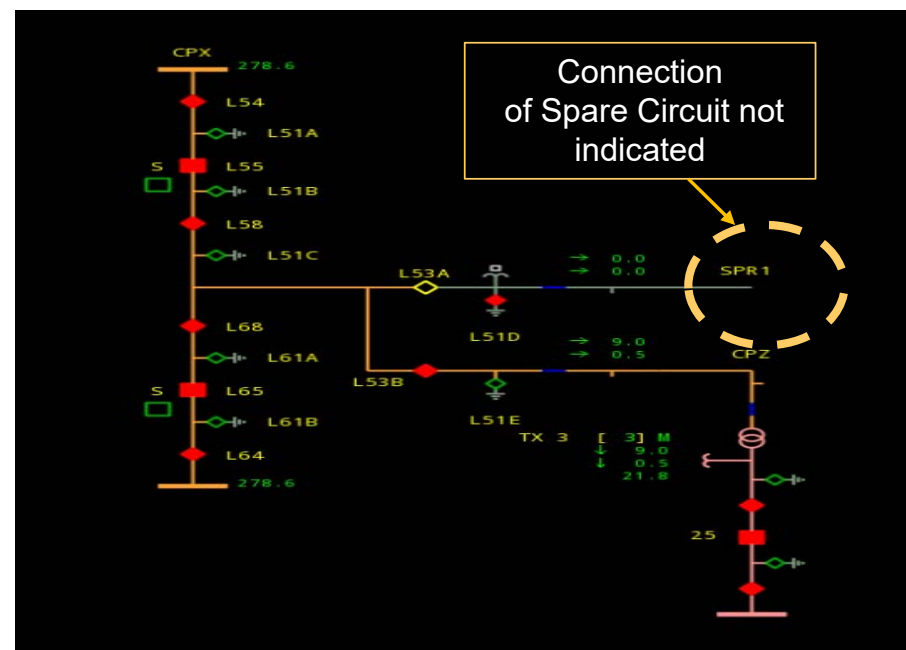
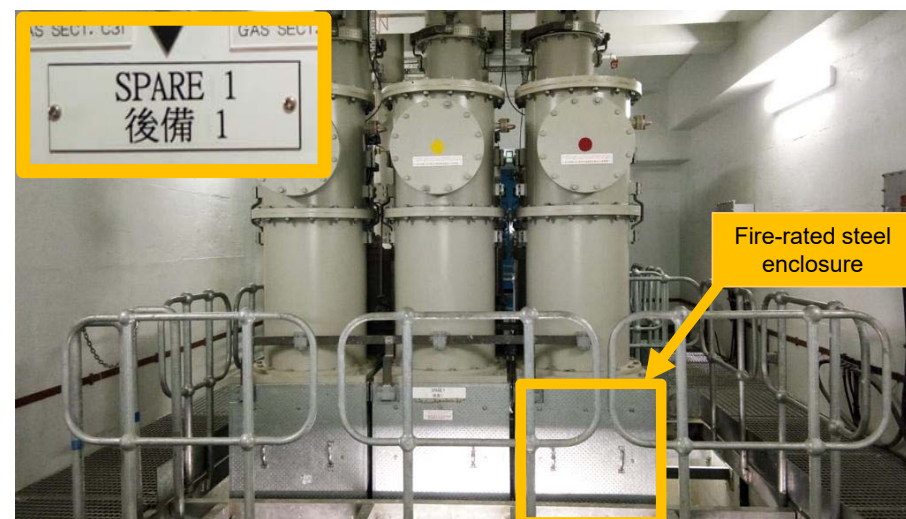
1. The transmission network diagram had already been updated in 2009 after network change. However, the EMS diagram used for commissioning only includes in-service cables rather than all cables and this caused a 3-phase fault during commissioning
2. On-site labels were insufficient to indicate whether a spare cable circuit is connected to the switchgear
3. The engineer in charge was unable to identify whether the concerned GIS was connected to a spare cable circuit in his on-site inspection
4. No compulsory counter-check requirement for commissioning of refurbished GIS
5. Consequential voltage dip and power disturbance affected two generating units in Lamma Power Station.
