**Legislative Council
Panel on Environmental Affairs**

**Power Supply Incident in Some Areas on Hong Kong Island
of The Hongkong Electric Company, Limited on 19 April 2023**

**Incident of a 275-kV Fault in HK Electric's Power System
on 19 April 2023**

INCIDENT INVESTIGATION REPORT

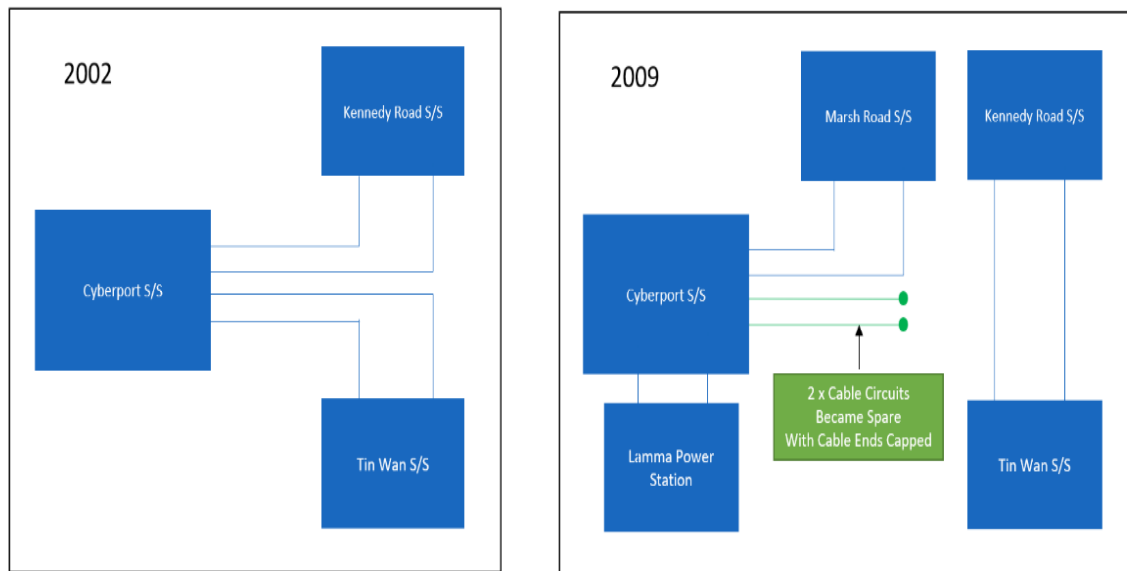
Illustration 1. Network Change at CPX in 2002 and 2009

- 2.1.3 Following the installation and commissioning of the two Lamma Power Station to Cyberport 275-kV submarine cable circuits in 2006, the two 275-kV cable circuits which were used to supply CPX in 2002 were restored to their original configuration. Two of the four CPX cable circuits were then extended and connected to Marsh Road 275-kV Switching Station in Wanchai in 2009 for delivering power to the northern part of Hong Kong Island while the remaining two have since become spare cable circuits. One end of these two spare cable circuits was capped inside Kai Lung Wan cable tunnel portal while the other end remained connected to the 275-kV switchgear of CPX.

- 2.1.4 As these two spare cable circuits were laid in a common trench with the other two extension cable circuits to Marsh Road 275-kV Switching Station, they were designed to be reserved for future use such as possible emergency repair of the extension cable circuits as well as for possible future network reinforcement/expansion. While these spare cable circuits were connected to CPX, considerable amount of works including cable jointing and testing would be required before they could be put into service. The two cable isolators at CPX connecting to these two spare cable circuits were opened and locked by unique lock to ensure these spare cable circuits were securely separated from our in-service transmission network. Details of the network change mentioned in 2.1.3 and 2.1.4 are shown in Illustration 1.

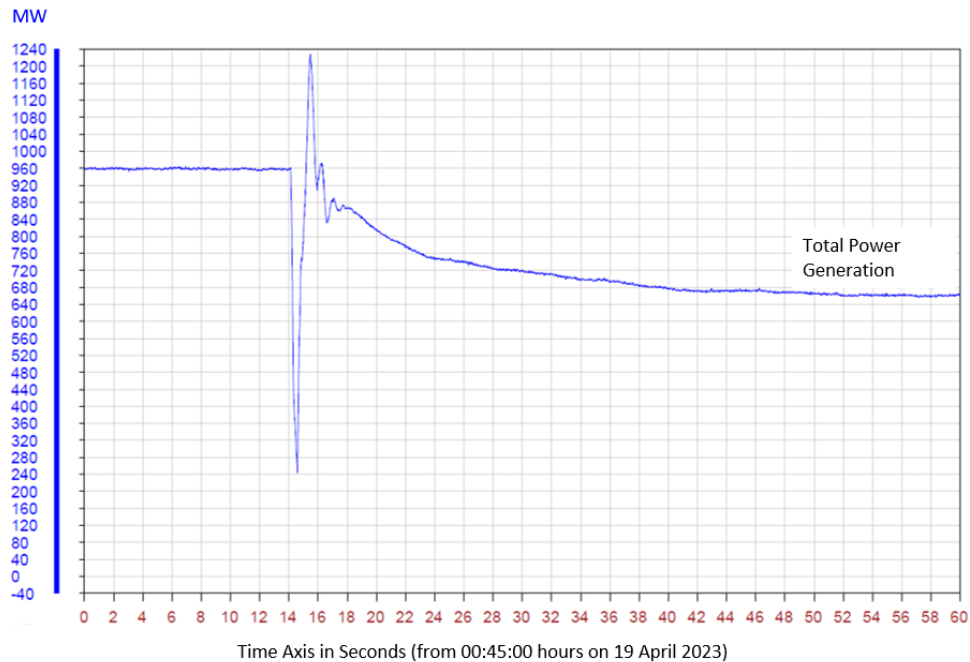
Illustration 3. Total Power Generation of Lamma Power Station on 19 April 2023 at 00:45 Hours

It was the first time that a 275-kV three-phase fault occurred in HK Electric's system, which gave rise to a very severe disturbance to the power system. The fault also caused a severe voltage dip and the system voltage had collapsed to nearly zero for about half a second, which was a very rare incident and caused considerable adverse impacts on the whole power system.

All the generating units at Lamma Power Station and their auxiliary equipment were also seriously affected by this unprecedented power disturbance. The total power generation in Lamma Power Station fluctuated seriously in the first few seconds after the occurrence of the fault (refer to Illustration 3 below). The protection systems of the auxiliary and major equipment functioned to protect them from damage. For example, the lubricating oil pumps of some coal mills affected by the voltage dip were tripped by the undervoltage protection such that the cables and the motors of the pumps had been protected from overheating; and the moving parts of the coal mills had been protected from excessive wear by tripping the mills when the pressure of the lubricating oil dropped. These protection systems were designed for preventing damage of generating units during severe power disturbance rather than allowing them to ride through a system fault.

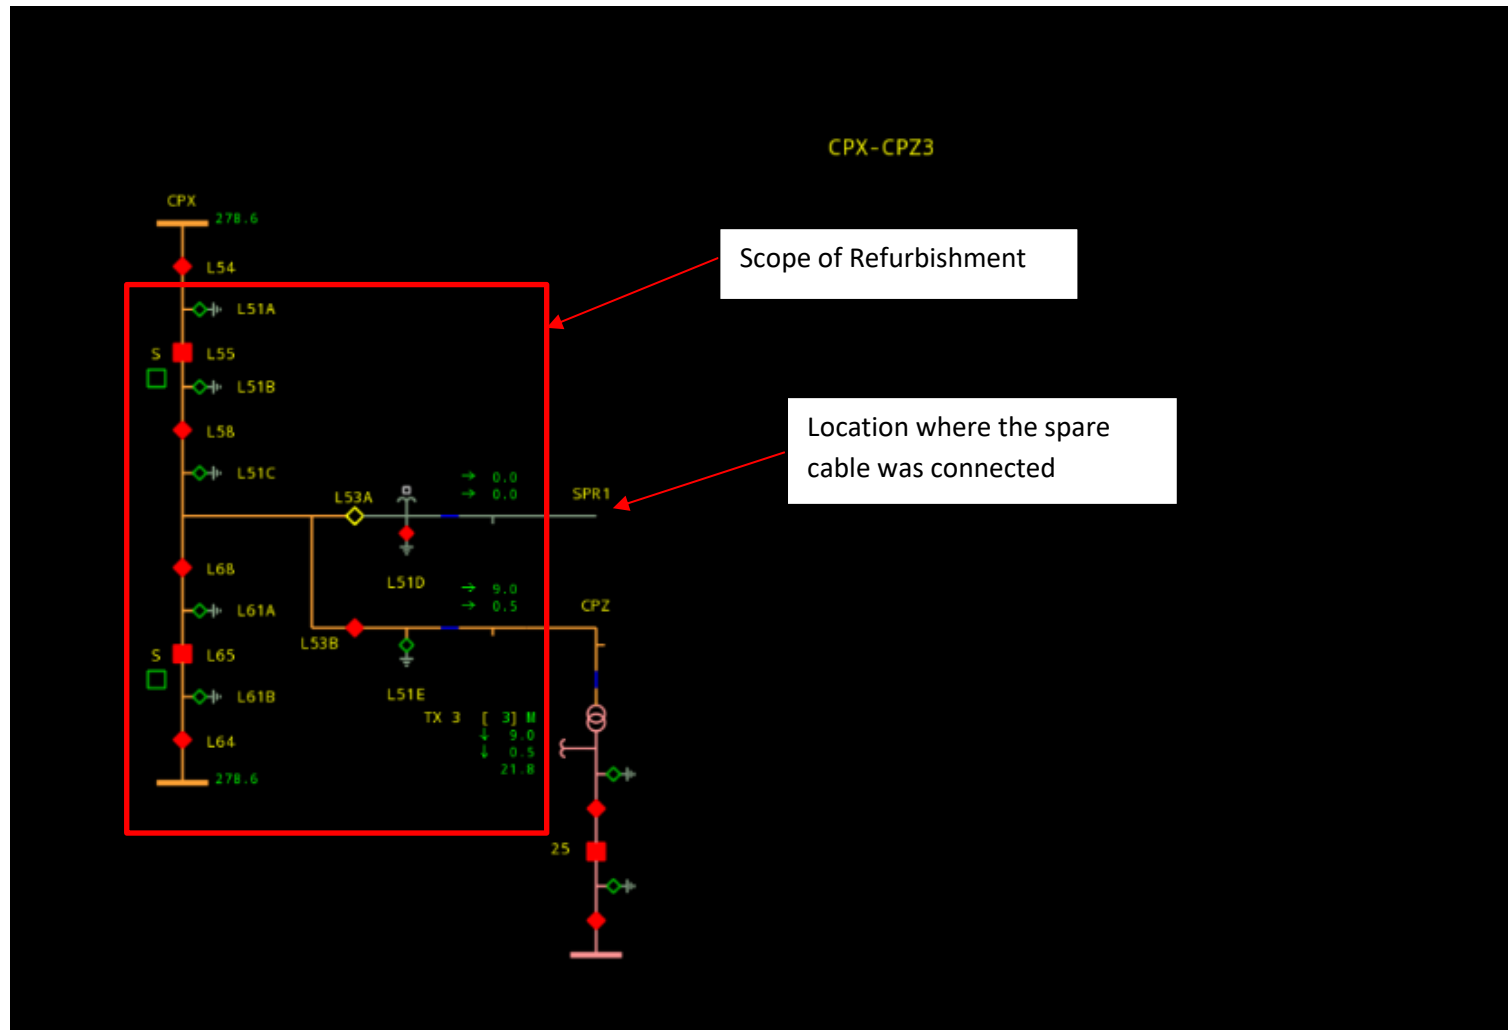
Figure 2. Scope of Refurbishment Work and EMS Circuit Diagram

- 4.3.5 In preparation for the refurbishment work, the engineer in charge performed a number of tasks, including among other things, 1) referred to the EMS circuit diagrams which was a customary practice for using it as reference by engineers to prepare the HV Permit-to-work (PTW); 2) confirmed the circuits connected to the GIS by checking on-site various labels on the GIS; and 3) visually checked external condition of the cable connection
