Legislative Council House Committee
Conservation of an Old Chinese Banyan Tree in Kowloon Park

Old Chinese Banyan Tree in Kowloon Park (No. LCSD YTM/97)

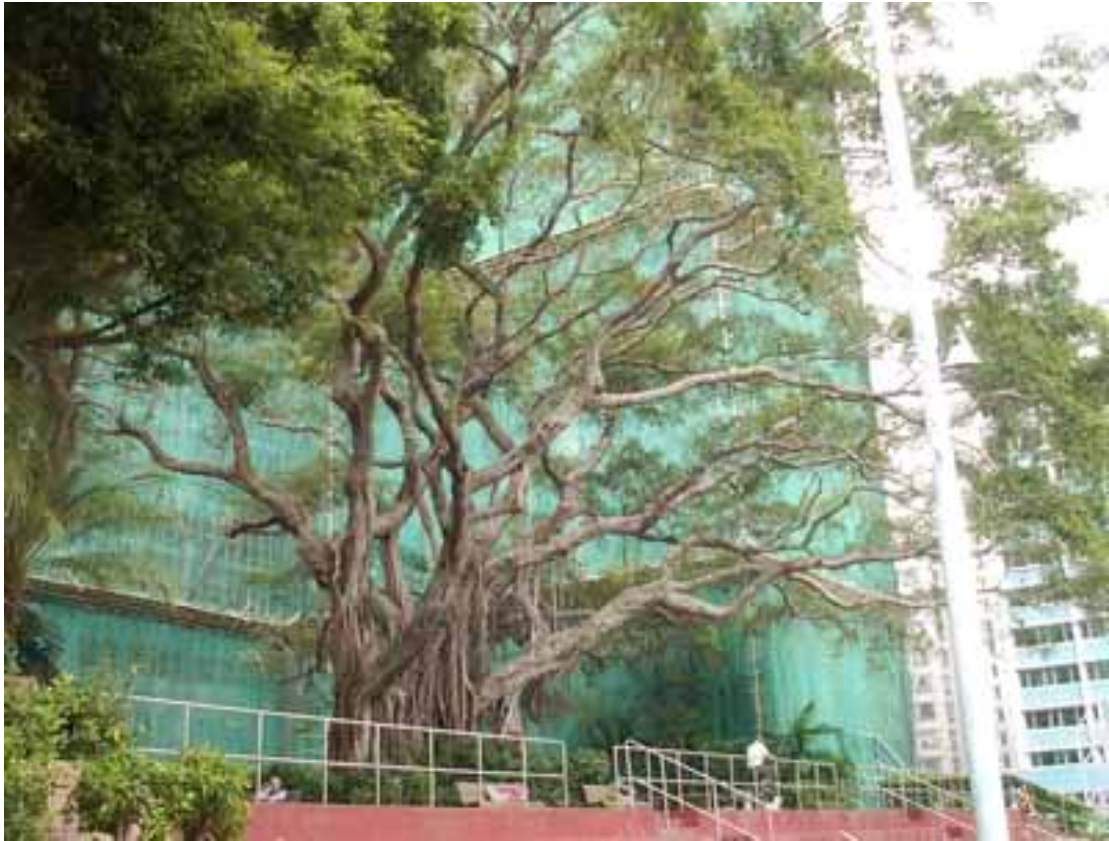
Photo taken on 9 November 2004

2. A Chinese banyan tree (*Ficus microcarpa*) located next to a mini-soccer pitch in Kowloon Park has been listed on the Register of Old and Valuable Trees with the Registration Number LCSD YTM/97. The Leisure and Cultural Services Department (LCSD) has been closely monitoring the health condition of the banyan tree and conducts regular inspections to observe its condition of growth. In late 2004, LCSD observed that the tree was suffering from abnormal defoliation (see [Annex 1](#)). It was believed to be caused by the damage to part of the root system of the banyan tree during the redevelopment of Kowloon Park in the 1980's. Moreover, the peripheral area of the tree base was paved with concrete slabs. When pedestrians passed by, they stepped on the slabs and caused soil compaction, thus hindering air and water infiltration into the soil layers. This had affected the respiration and development of its root system.

The tree was suffering from abnormal defoliation

3. In view of the rapid deterioration in the health and vigour of the tree, LCSD staff have taken the following measures with a view to improving the growing environment and rejuvenating the vigour of the tree –

- (a) to fence off the tree base to prevent unnecessary stepping and activities which will result in further soil compaction and hinder air and water infiltration into the soil layers;
- (b) to treat the fungal infections on the roots by applying

- (c) to facilitate application of fertilisers by inserting PVC tubes along the drip line of the tree;
- (d) to improve air and water permeability by removing other plants at the tree base;
- (e) to increase the soil area by removing boulders and concrete slabs near the tree base;
- (f) to improve soil permeability by turning over the soil;
- (g) to apply foliar feeding ;
- (h) to induce growth of new shoots by grafting seedlings onto the twigs;
- (i) to understand the levels of macronutrients and micronutrients by conducting soil and leaf analyses;
- (j) to remove withered twigs;
- (k) to conduct detailed inspections of the internal structure of the tree by utilising the PICUS Sonic Tomograph;
- (l) to cover the tree base with a layer of fine mulch; and
- (m) to develop aerial roots into supporting roots by employing the method of inserting the aerial roots into bamboo poles.

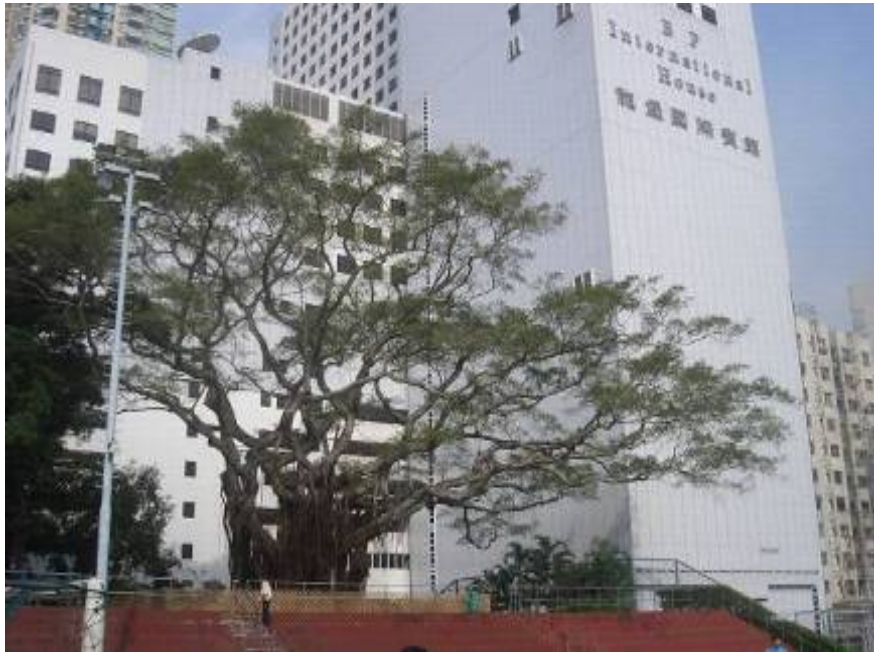
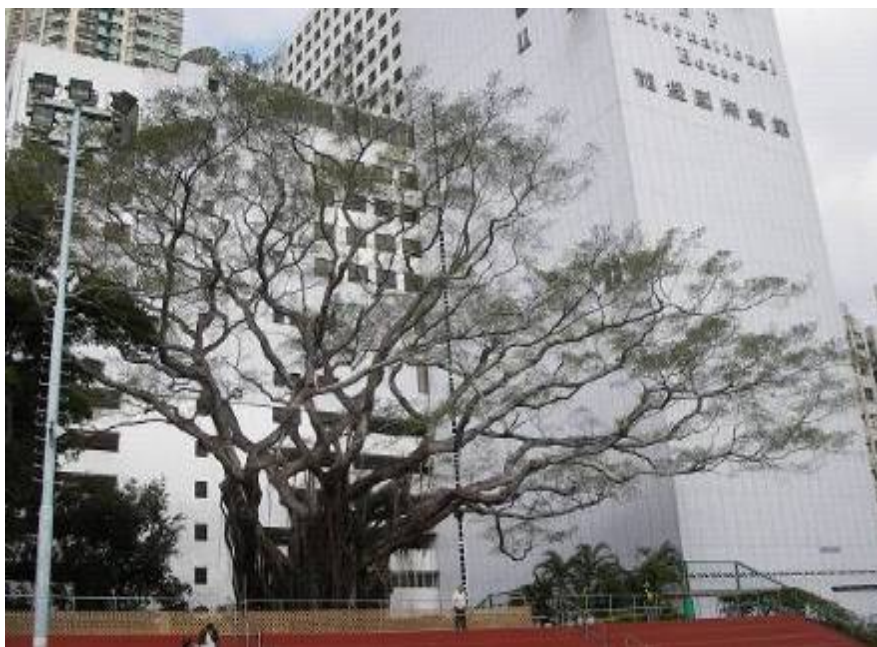
4. The health condition of the banyan tree had improved after the implementation of the above measures (see **Annex 2**). From 2006 to 2007, LCS D closely monitored the growth of the tree and continued to take appropriate improvement measures.

Compared to the condition in 2004, the health condition of the Chinese banyan tree had improved

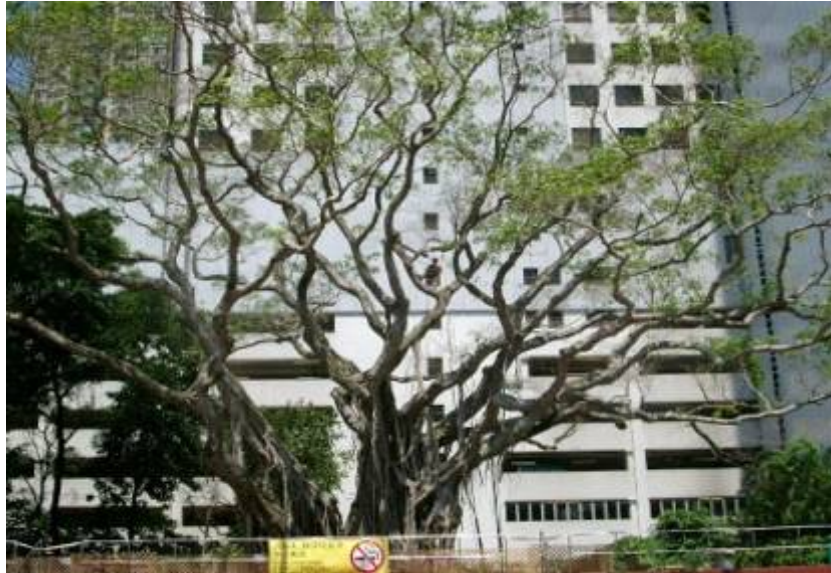
Photo taken on 20 June 2007

Condition before the collapse of a portion of its trunk

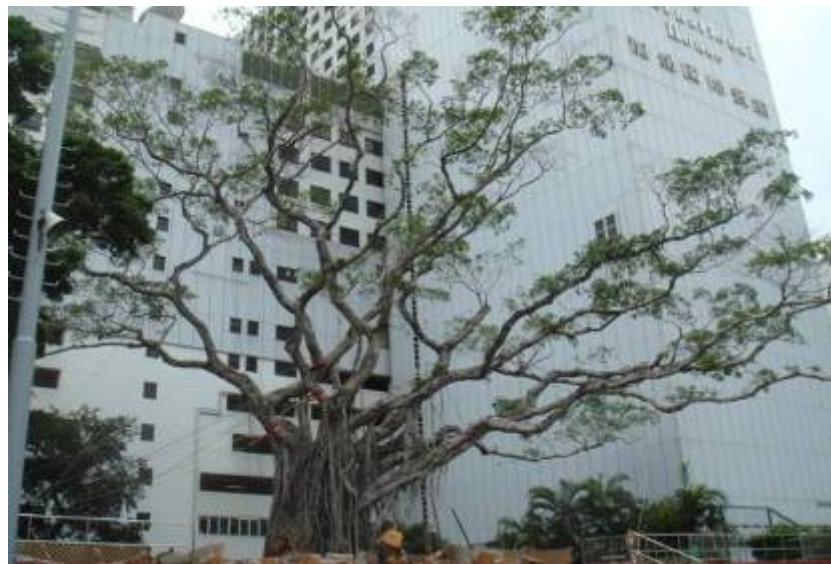
Photo taken on 21 August 2007

5. On 11 August 2007 after the passage of Severe Tropical Storm Pabuk, about one third of the main trunk of the tree split and fell due to the typhoon attack. LCS D tried its best to save the banyan tree and, based on the advice of its Tree Expert Group (TEG), took active measures to save the tree. After thorough study and discussion, TEG considered

Condition after the collapse of a portion of its trunk

that supporting structures could be used to stabilise the branches of the banyan tree and that the small banyan court where the tree was located should be closed to prevent park-goers from stepping on the soil there. Moreover, TEG also held the view that bamboo poles should continue to be used to facilitate the growth of aerial roots to the soil surface and their development into supporting roots. Please refer to **Annex 3** for the conditions of the tree before and after the collapse of a portion of its trunk. When LCSD attended a meeting of the Yau Tsim Mong District Council in September of the same year, the Department gave a detailed account of the possible causes of the collapse of a portion of the tree trunk and the feasible measures proposed by TEG to enhance the preservation and the saving of the tree. Members present at the meeting had a thorough discussion over the conservation of old trees.

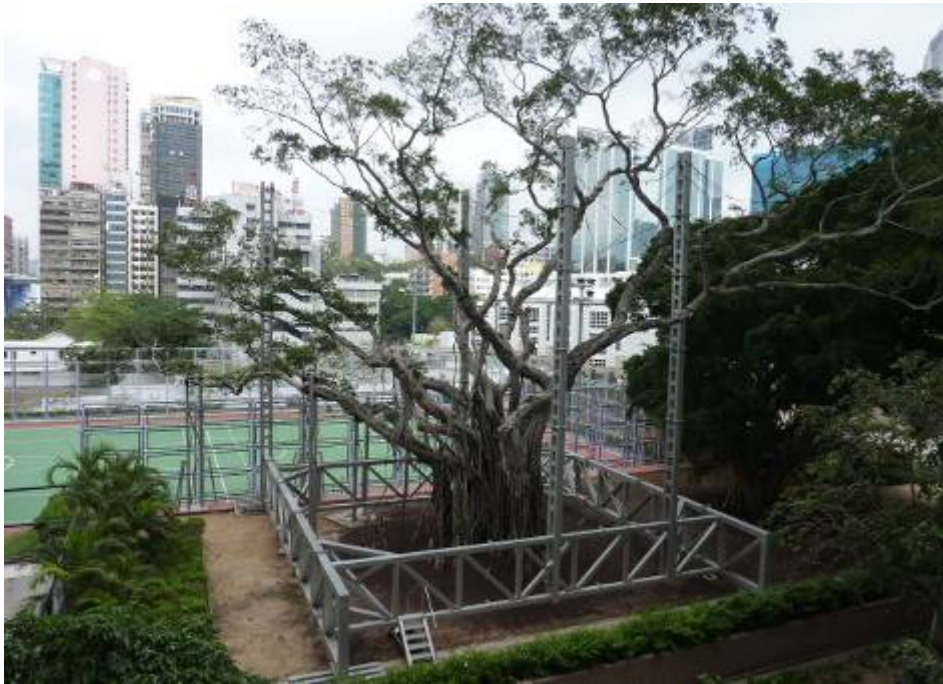
Photo taken on 10 May 2009

Condition after installation of metal props and metal base frame

6. After a comprehensive study of the input from TEG and the Architectural Services Department, LCSD has devised a long-term plan for stabilising the tree. Apart from putting up three sets of metal props to provide additional support to some of the major side branches, a metal base frame measuring approximately 18 metres in length and 11 metres in width has also been put up to surround the tree. The trusses of the entire metal base frame rest on the soil area like a bridge to avoid possible damage to the roots of the tree. Vertical props can also be added at suitable locations along the base frame when necessary with a view to stabilising the outward stretching branches in the form of a “hanging bridge” (see **Annex 4**). The cost of the whole project is about \$950,000.

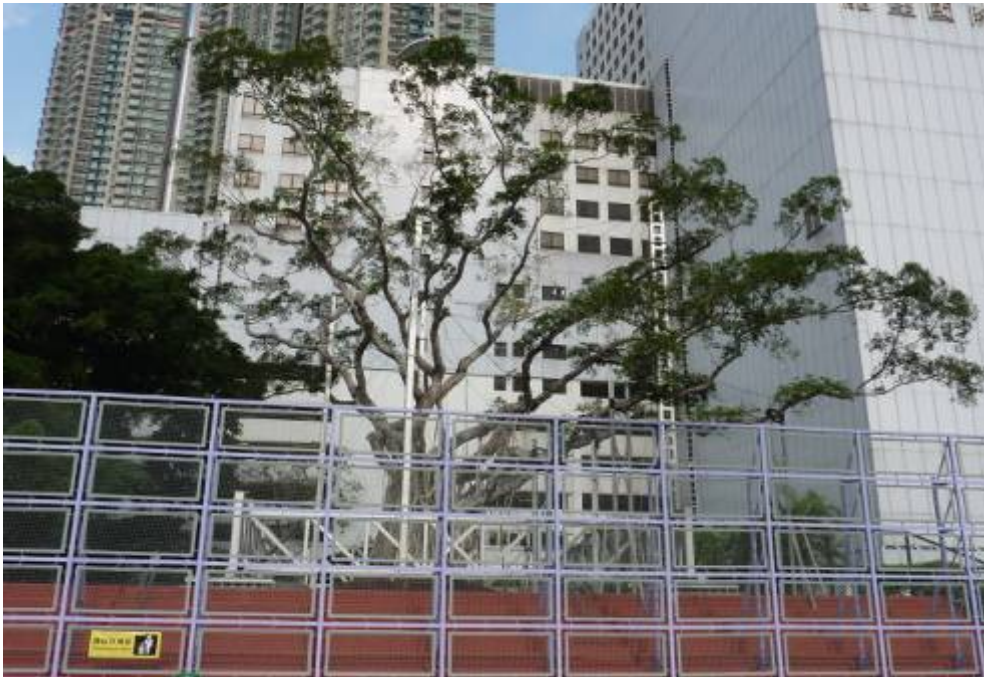
Photo taken on 11 May 2009

7. After the collapse of a portion of its trunk in August 2007, the banyan tree in Kowloon Park has remained firm and stable, notwithstanding several attacks by typhoons since then. This shows that the installation of new vertical props has achieved its desired effect in conserving the tree. The tree is now in its recovery stage. It is in stable condition, with no signs of risk of further collapse (see **Annex 5**). However, although new leaves and aerial roots are observed on the trees from time to time, the recovery will take time. LCSD will continue to implement the improvement measures mentioned in Paragraph 3 above as appropriate and carry out foliar feeding at ten-day intervals (see **Annex 6**). In addition, LCSD has also tried to use organic compost provided by the Environmental Protection Department to improve the soil structure and promote microbial activities in the soil. Meanwhile, a mechanism has also been put in place by LCSD to monitor and prevent termite infestation on the tree. Nonetheless, the tree needs to go through a relatively long

Condition in May 2009
