Legislative Council House Committee Conservation of an Old Chinese Banyan Tree in Kowloon Park

Old Chinese Banyan Tree in Kowloon Park (No. LCSD YTM/97)

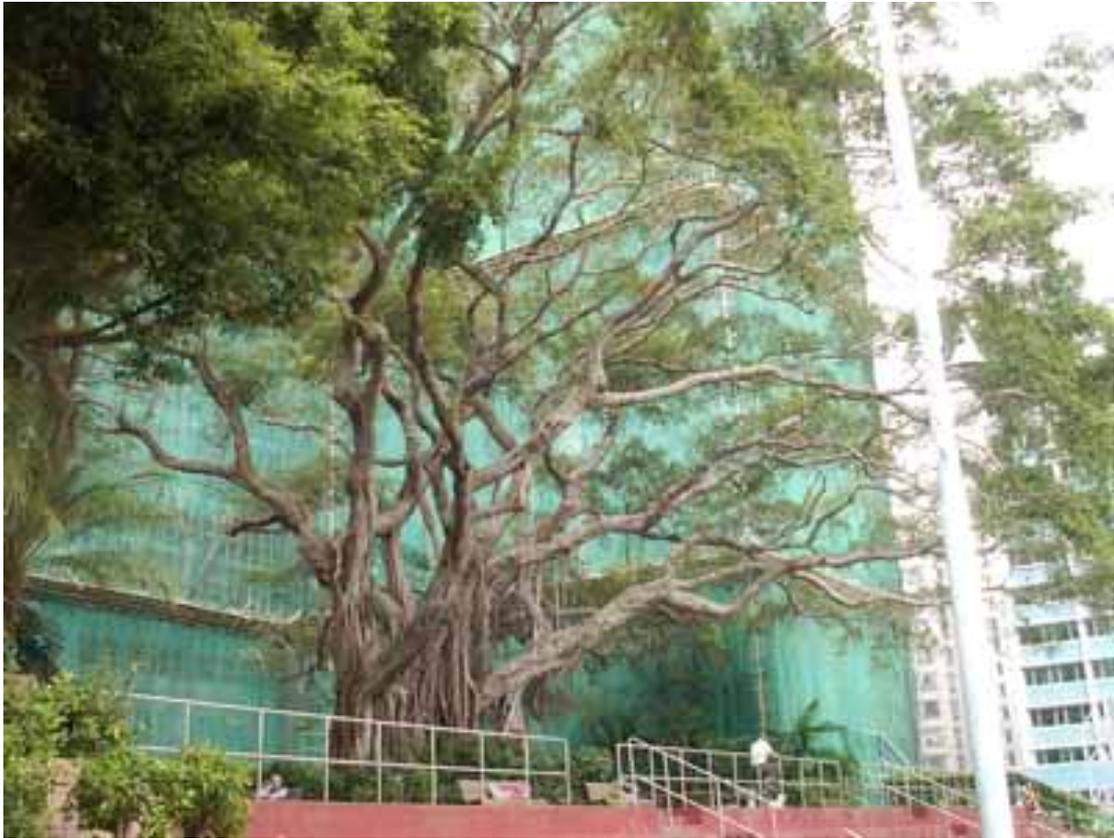
Photo taken on 9 November 2004

2. A Chinese banyan tree (*Ficus microcarpa*) located next to a mini-soccer pitch in Kowloon Park has been listed on the Register of Old and Valuable Trees with the Registration Number LCSD YTM/97. The Leisure and Cultural Services Department (LCSD) has been closely monitoring the health condition of the banyan tree and conducts regular inspections to observe its condition of growth. In late 2004, LCSD observed that the tree was suffering from abnormal defoliation (see [Annex 1](#)). It was believed to be caused by the damage to part of the root system of the banyan tree during the redevelopment of Kowloon Park in the 1980's. Moreover, the peripheral area of the tree base was paved with concrete slabs. When pedestrians passed by, they stepped on the slabs and caused soil compaction, thus hindering air and water infiltration into the soil layers. This had affected the respiration and development of its root system.

The tree was suffering from abnormal defoliation

3. In view of the rapid deterioration in the health and vigour of the tree, LCSD staff have taken the following measures with a view to improving the growing environment and rejuvenating the vigour of the tree –

- (a) to fence off the tree base to prevent unnecessary stepping and activities which will result in further soil compaction and hinder air and water infiltration into the soil layers;
- (b) to treat the fungal infections on the roots by applying

fungicides;

- (c) to facilitate application of fertilisers by inserting PVC tubes along the drip line of the tree;
- (d) to improve air and water permeability by removing other plants at the tree base;
- (e) to increase the soil area by removing boulders and concrete slabs near the tree base;
- (f) to improve soil permeability by turning over the soil;
- (g) to apply foliar feeding ;
- (h) to induce growth of new shoots by grafting seedlings onto the twigs;
- (i) to understand the levels of macronutrients and micronutrients by conducting soil and leaf analyses;
- (j) to remove withered twigs;
- (k) to conduct detailed inspections of the internal structure of the tree by utilising the PICUS Sonic Tomograph;
- (l) to cover the tree base with a layer of fine mulch; and
- (m) to develop aerial roots into supporting roots by employing the method of inserting the aerial roots into bamboo poles.

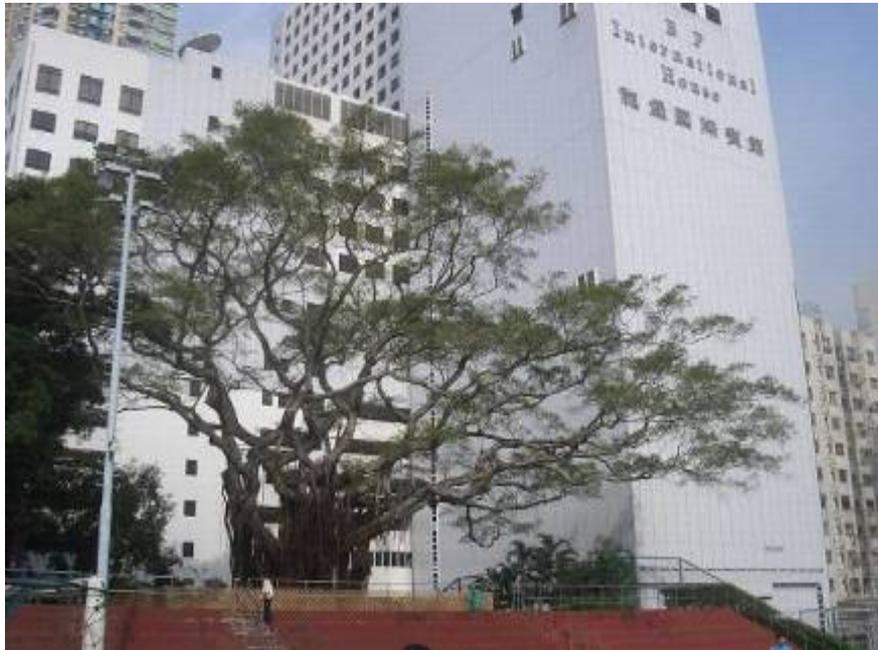
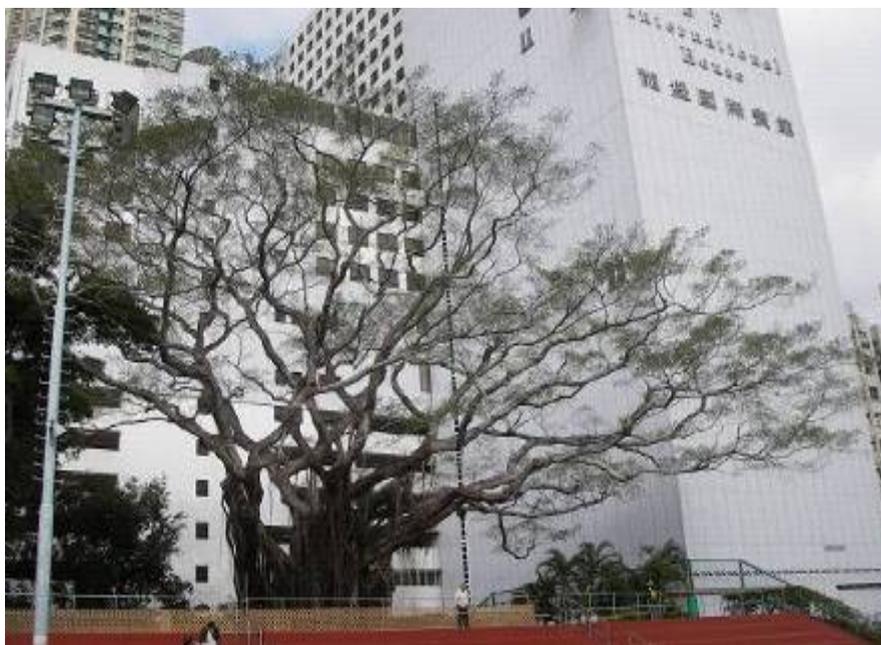
4. The health condition of the banyan tree had improved after the implementation of the above measures (see **Annex 2**). From 2006 to 2007, LCS D closely monitored the growth of the tree and continued to take appropriate improvement measures.

Compared to the condition in 2004, the health condition of the Chinese banyan tree had improved

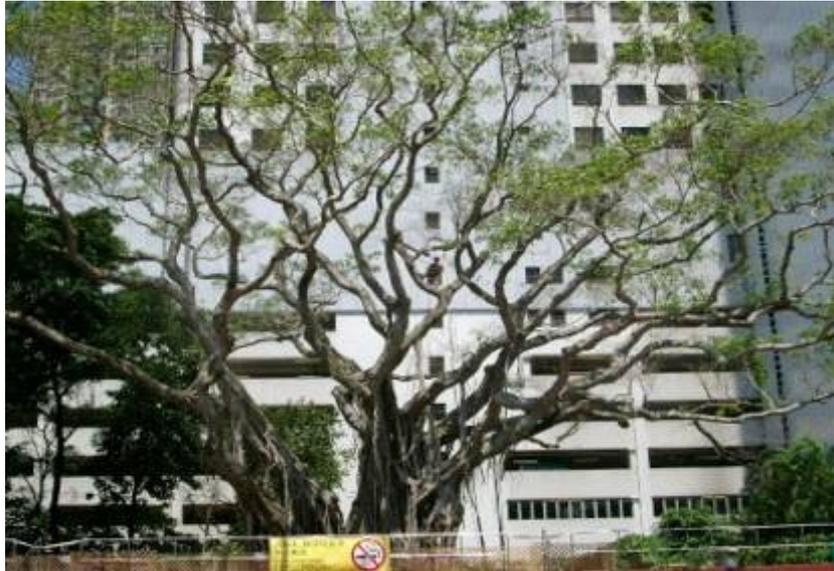
Photo taken on 20 June 2007

Condition before the collapse of a portion of its trunk

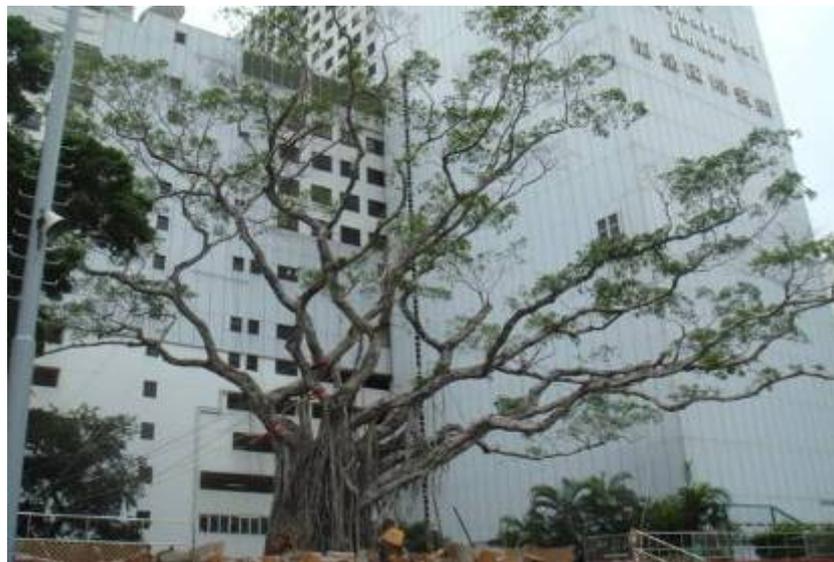
Photo taken on 21 August 2007

5. On 11 August 2007 after the passage of Severe Tropical Storm Pabuk, about one third of the main trunk of the tree split and fell due to the typhoon attack. LCS D tried its best to save the banyan tree and, based on the advice of its Tree Expert Group (TEG), took active measures to save the tree. After thorough study and discussion, TEG considered

Condition after the collapse of a portion of its trunk

that supporting structures could be used to stabilise the branches of the banyan tree and that the small banyan court where the tree was located should be closed to prevent park-goers from stepping on the soil there. Moreover, TEG also held the view that bamboo poles should continue to be used to facilitate the growth of aerial roots to the soil surface and their development into supporting roots. Please refer to **Annex 3** for the conditions of the tree before and after the collapse of a portion of its trunk. When LCSD attended a meeting of the Yau Tsim Mong District Council in September of the same year, the Department gave a detailed account of the possible causes of the collapse of a portion of the tree trunk and the feasible measures proposed by TEG to enhance the preservation and the saving of the tree. Members present at the meeting had a thorough discussion over the conservation of old trees.

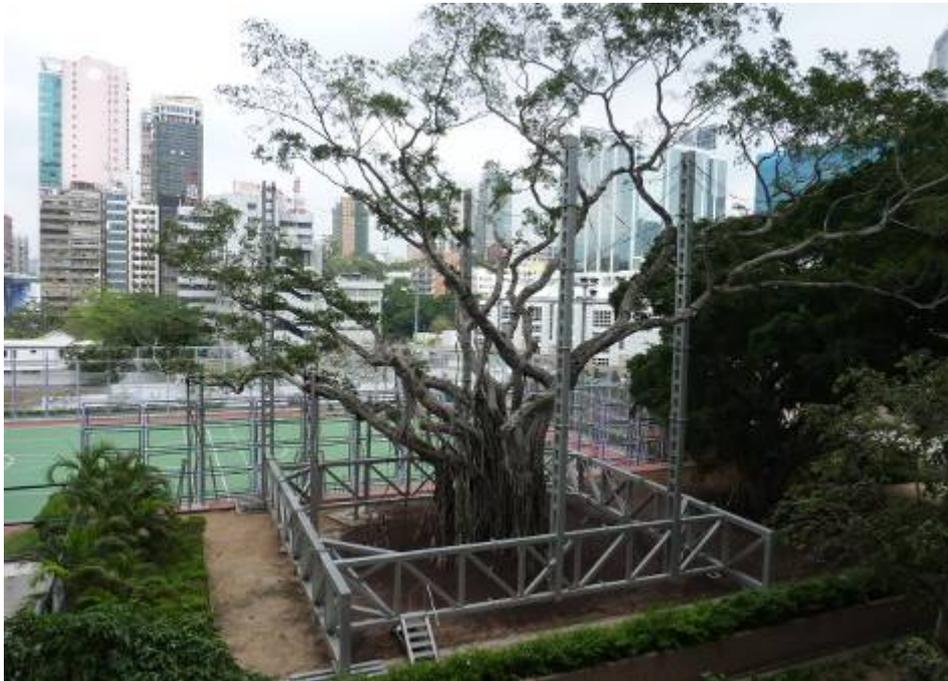
Photo taken on 10 May 2009

7. After the collapse of a portion of its trunk in August 2007, the banyan tree in Kowloon Park has remained firm and stable, notwithstanding several attacks by typhoons since then. This shows that the installation of new vertical props has achieved its desired effect in conserving the tree. The tree is now in its recovery stage. It is in stable condition, with no signs of risk of further collapse (see **Annex 5**). However, although new leaves and aerial roots are observed on the trees from time to time, the recovery will take time. LCSD will continue to implement the improvement measures mentioned in Paragraph 3 above as appropriate and carry out foliar feeding at ten-day intervals (see **Annex 6**). In addition, LCSD has also tried to use organic compost provided by the Environmental Protection Department to improve the soil structure and promote microbial activities in the soil. Meanwhile, a mechanism has also been put in place by LCSD to monitor and prevent termite infestation on the tree. Nonetheless, the tree needs to go through a relatively long

Condition after installation of metal props and metal base frame

6. After a comprehensive study of the input from TEG and the Architectural Services Department, LCSD has devised a long-term plan for stabilising the tree. Apart from putting up three sets of metal props to provide additional support to some of the major side branches, a metal base frame measuring approximately 18 metres in length and 11 metres in width has also been put up to surround the tree. The trusses of the entire metal base frame rest on the soil area like a bridge to avoid possible damage to the roots of the tree. Vertical props can also be added at suitable locations along the base frame when necessary with a view to stabilising the outward stretching branches in the form of a “hanging bridge” (see **Annex 4**). The cost of the whole project is about \$950,000.

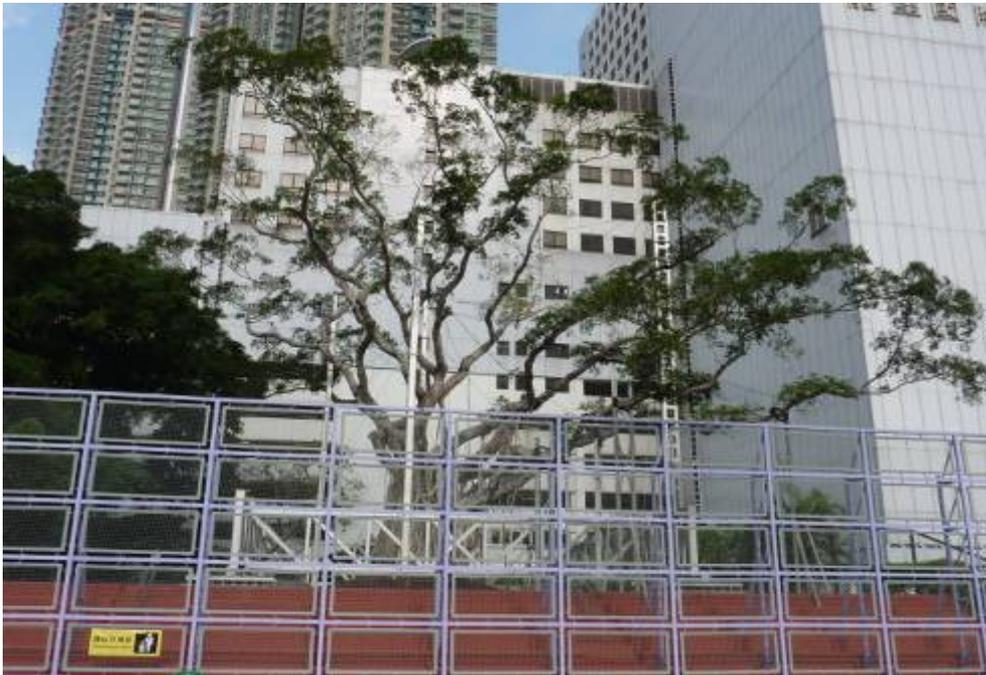
Photo taken on 11 May 2009

Condition in May 2009
