**Legislative Council
Panel on Environmental Affairs**

**Supplementary Information on
Odour Problem and Polluted Seabed at Tsuen Wan Water-front**

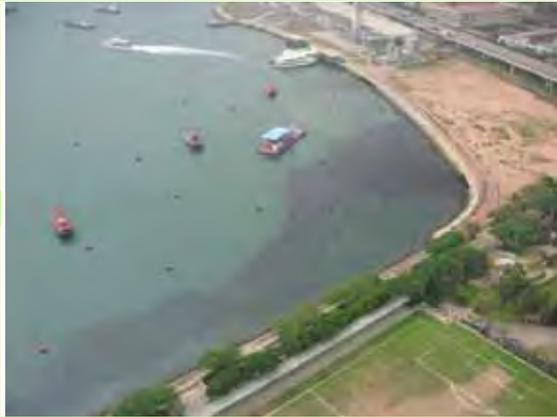
Before rectification in April 2005

Photos of Tsuen Wan Bay before (left) and after (right) the public sewer rectification

10. During the “Team Clean Campaign” from 2003 to 2005, the Administration further stepped up its efforts to identify and remove major building expedient connections in the Tsuen Wan area. An inter-departmental working group was organized to meet regularly to exchange information and to deal with the expedient connections and misconnections found in public and private sewers and the defects of public sewers and related problems. From 2006 to 2008, 21 building expedient connections in the area were found and rectified. As a result of joint departmental efforts, the number of related odour complaints was reduced from 71 in 2005 to 2 in 2008. A set of photographs of Tsuen Wan Bay before and after the public sewer rectification in 2005 is attached at **Annex 2** for reference.
