**Legislative Council Panel on Security
Daya Bay Nuclear Power Station Notification Mechanism**

**Operational Matter on 23 May 2010 at
the Guangdong Daya Bay Nuclear Power Station**

Information Paper

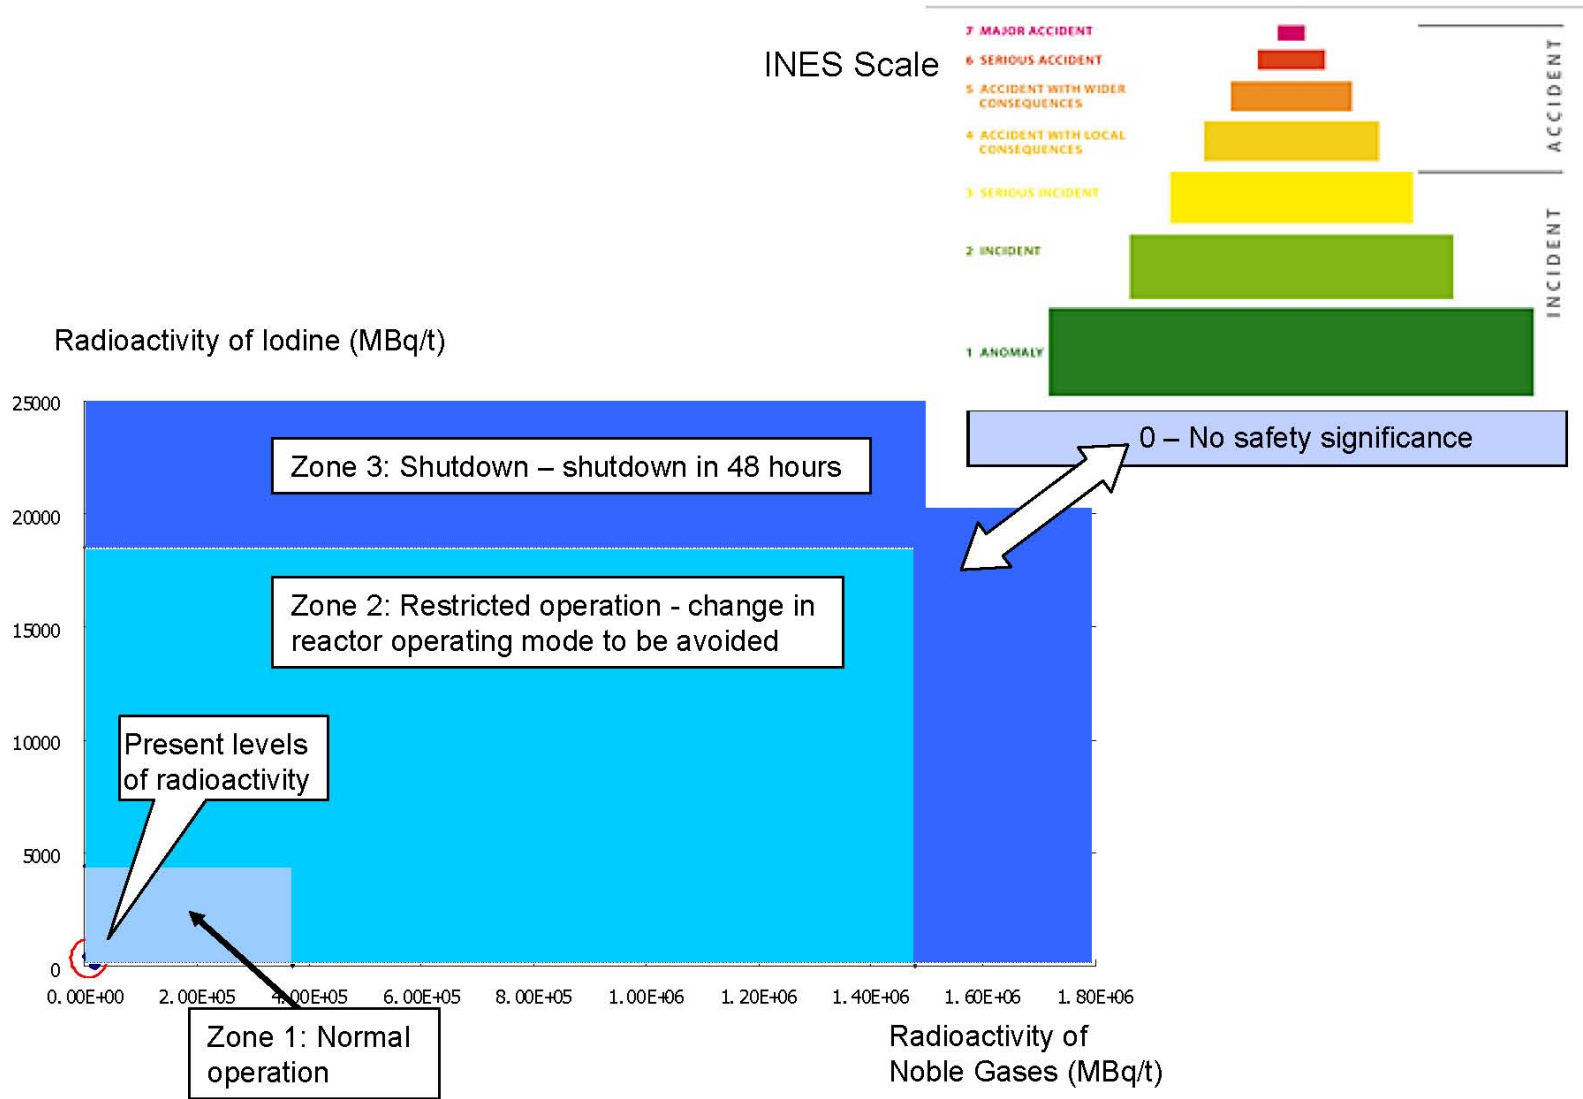
Figure 2 Operating limits due to radioactivity in the reactor cooling water of Daya Bay Unit 2

7. The preliminary assessment conducted at the plant indicates that the situation might be due to an imperfect sealing of a fuel rod in the reactor core of Unit 2. Each reactor has 41 448 fuel rods. All these fuel rods are made in France in compliance with the original specifications of the French reactor manufacturer.

mode is not changed or affected. Zone 3, when a higher radioactivity level concentration is found, the reactor is required by the technical specification to shut down within 48 hours, and the situation will be classified as a “Level 0” (also known as Below Scale) Licensing Operational Event on the INES. The current situation in which the reactor now operates is well within Zone 1 as depicted in Figure 2.

15. Daya Bay will include in its investigation the cause of the imperfect sealing of fuel rod. As the situation is well within the allowable operation zone and remains stable, replacement work will be carried out in the next planned refuelling outage where the affected fuel rod will be replaced. Preventive measures will be developed following the investigation.

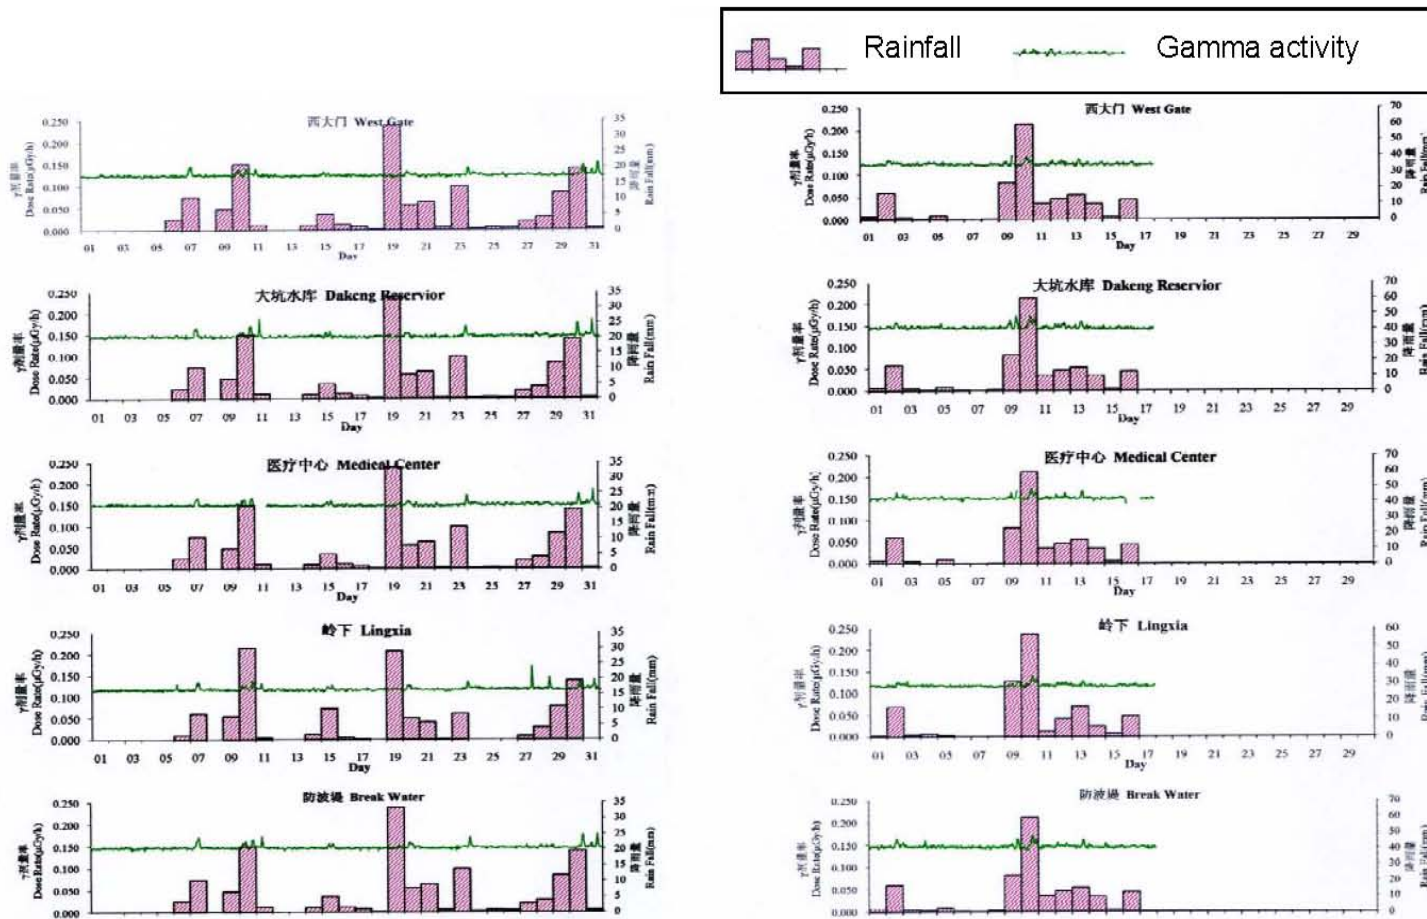
Figure 3 Gamma activity at Daya Bay on-site radiation monitoring stations (May and June 2010)

13. Daya Bay has 5 more external radiation monitoring stations which keep track of gamma radiation on a real time continuous basis. They are located at about 5 km from Daya Bay. Same as the 5 on-site monitoring stations, they also show no abnormal level of radiation.

Note: Gamma activity at a monitoring station is also affected by rainfall and may experience a slight and temporary increase.
