**Legislative Council Panel on Transport
Subcommittee on Matters Relating to Railways**

Progress on Upgrading Signalling System for Railway Lines

**Executive Review Panel Report
on the Signalling Failure on the Tsuen Wan, Island,
Kwun Tong and Tseung Kwan O Lines
on 16 October 2018**

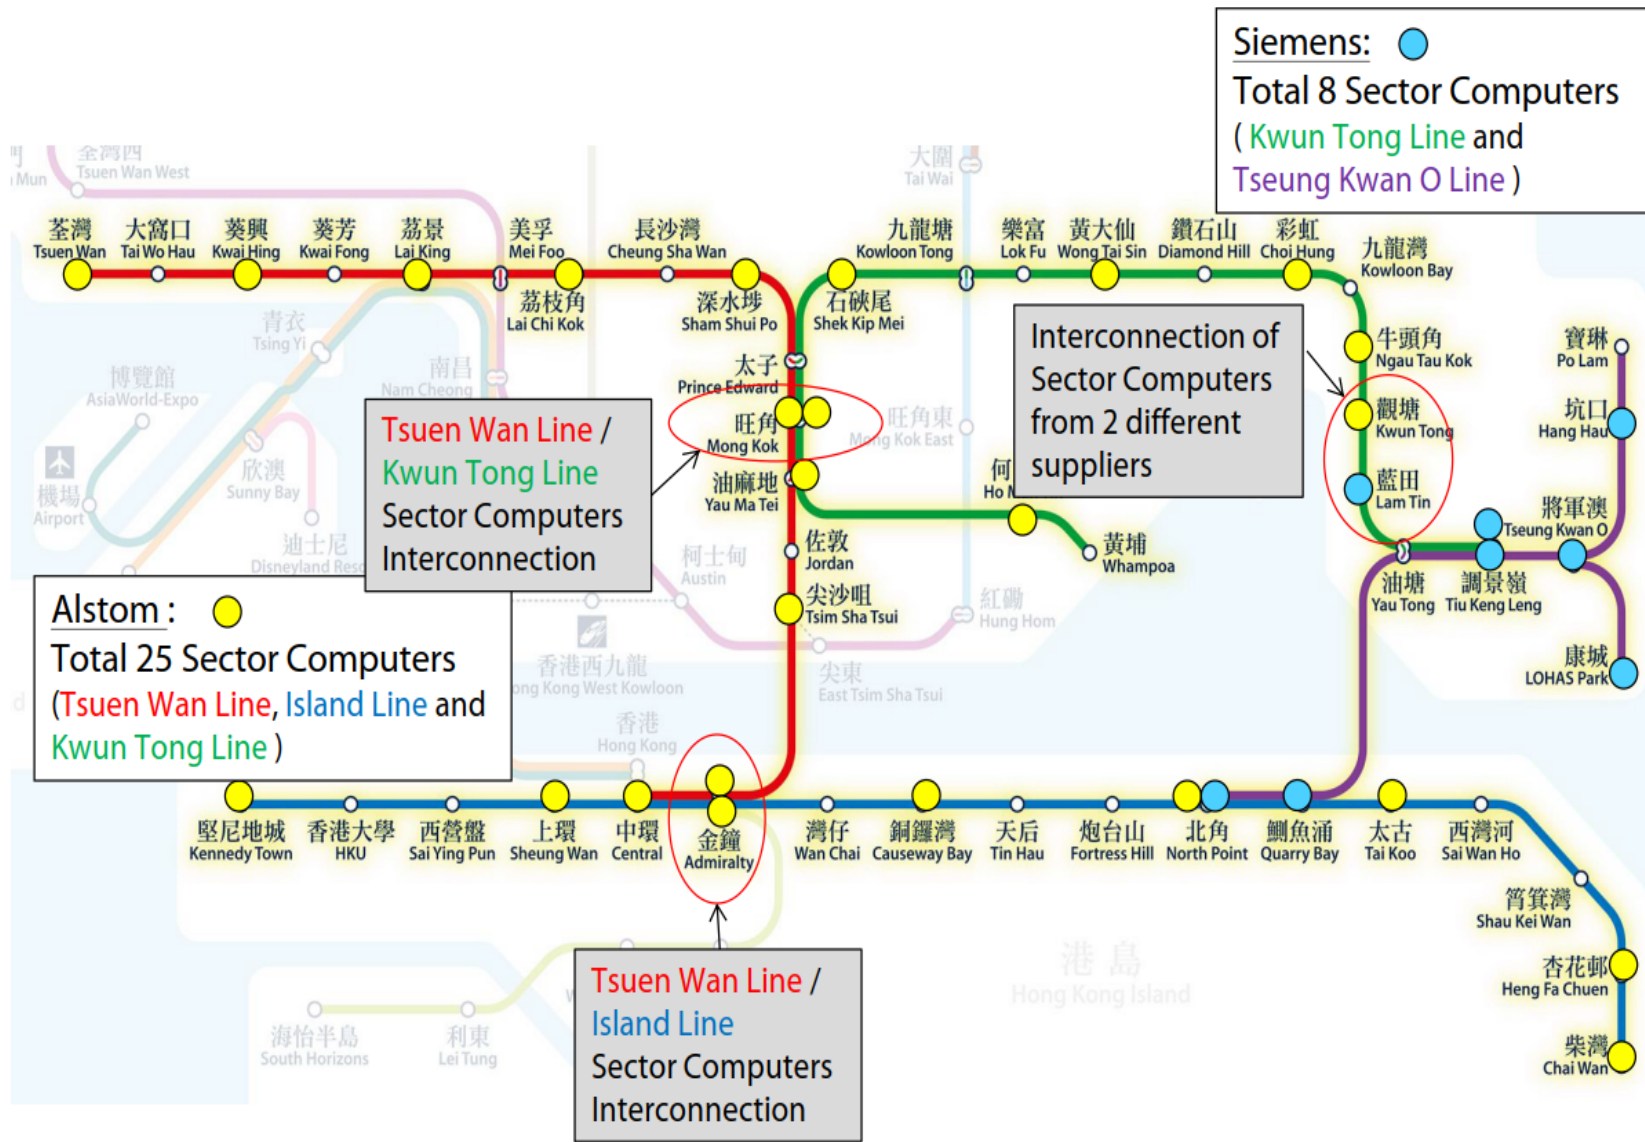
Figure 1 - Configuration and Interconnection of Sector Computers

- 5.1 Signal System Overview and the Root Cause
 - 5.1.1 All the four incident lines use the SACEM signalling system with the equipment on the TWL, ISL and most of KTL (from Whampoa (WHA) to Kwun Tong (KWT) stations) designed and supplied by Alstom and that for TKL and the rest of KTL (from Lam Tin (LAT) to Tiu Keng Leng (TIK) stations) by Siemens. Whilst the equipment provided by the two suppliers differs in detail, it is

- 5.1.5 When all the Siemens software counters reached the ceiling figure at around 10:22 hours, some 5 hours after the Alstom sector computers had passed their automatic re-initialization triggering point, the 8 Siemens sector computers halted as designed. Moreover, trains on the TKL had already encountered trainborne signalling failure earlier at 10:02 hours due to the around 20 minutes counter look ahead validity requirements.

the subsequent signalling system testing and simulations conducted, in-depth analysis by the two signalling system suppliers and external experts, the Panel concluded that the root cause of the incident was the inconsistent software counter re-initialization arrangements of the signalling equipment provided by the two different suppliers. As all the incident lines were interconnected, the synchronization between sector computers led to propagation of a resulting instability to Alstom-equipped areas, i.e. the ISL, TWL, and most of KTL. A lack of provision for counter re-initialization wholly for all lines then affected Siemens-equipped areas, i.e. the TKL and the rest of KTL.

5.2.1 As a short-term measure, the interconnection of the sector computers of the TWL, ISL and KTL has been temporarily segregated, while the interlink between the sector computers at KWT and LAT, and between KTL and TKL continue to be interconnected due to system operational needs. With the conclusion of the root cause and recommended by the Panel,

- 5.2.2 As recommended by the Panel, regular checking of software counter operation for all SACEM equipped lines has been implemented to ensure the counter value is normal. For even better risk control and mitigation, all the sector computers of the Airport Express and Tung Chung Line were effectively re-initialized manually on 25 November 2018. The signalling systems of other lines have also been checked and clarifications have been made with the relevant suppliers. There are software counters in some other lines that also require re-initialization that can be done manually or automatically depending on the signalling system design of the particular line. However, these systems are not at any risk of an uncoordinated software counter re-initialization problem as occurred in this incident.
