Legislative Council Panel on Security

Supplementary Information on New Territories South Regional Police Headquarters and Operational Base at Tsuen Wan

Security Bureau March 2002

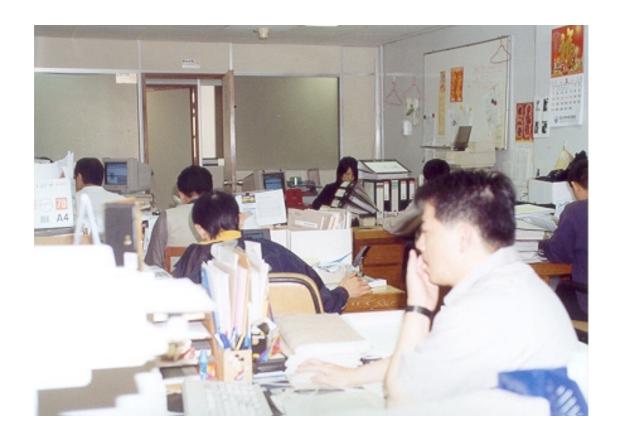
- ➤ A typical Regional Crime Unit office at Ma On Shan Police Station. Measuring 36 m², shared by 12 officers, hence a shortfall of 14.6 m² (-28.8%).
- > Due to shortage of interview facilities in the present complex, members of the public including victims and witnesses are interviewed, to give statements and assist crime investigations in overcrowded offices.
- The proposed Regional Headquarters and Operational Base will not only improve the working environment for staff but also provide better interview facilities and police public interface area for the general public.
- ▶ 一間典型的總區重案組辦公室,位於馬鞍山警署,面積36平方米,由12名警務人員共用,較標準面積少14.6平方米(-28.8%)。
- 由於現時缺乏足夠的會面設施,有關人員須在擠迫的辦公室 內接見包括錄取口供及協助調查的市民。
- 建議中的總區總部及行動基地不單改善員工的工作環境,也 能提供較佳的會面設施及警方接待市民的地方。

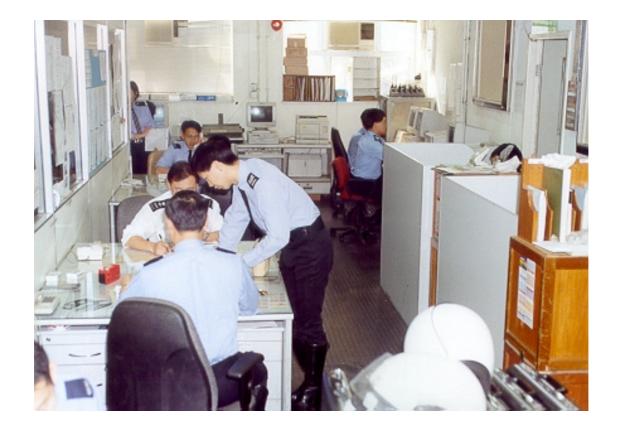
- ➤ The Traffic Accident Investigation Duty Room at NTS Operational Base, Tsuen Wan. Measuring 44 m², shared by 19 officers, hence a shortfall of 33.9 m² (-43.5%). Victims, witnesses and traffic offenders are interviewed therein.
- > The new complex would considerably enhance the working environment and benefit both traffic officers and members of the public attending the offices of the Division.
- 交通意外調查組的當值室,位於荃灣新界南行動基地,面積 44 平方米,由 19 位警務人員共用,較標準面積少 33.9 平方 米(-43.5%)。有關人員在此接見交通意外的受害者、證人及交 通違例人士。
- 新大樓將大大改善有關工作環境,對員工及市民均帶來好處。

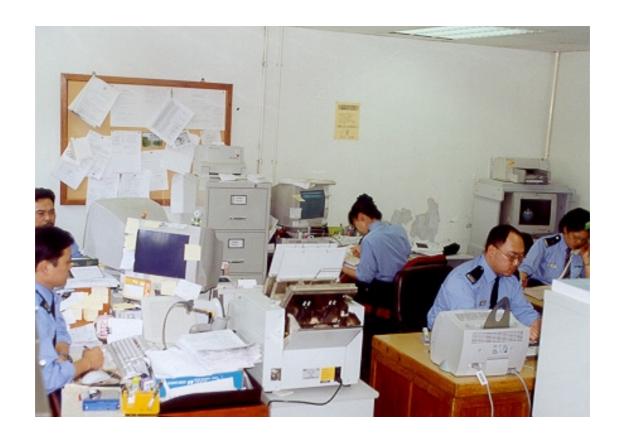
- ➤ The miscellaneous Traffic investigation team office in NTS Operational Base, deals with traffic-related complaints made by members of the public and other traffic offences such as speeding, etc. Measuring 28 m², shared by 10 officers, hence a shortfall of 13 m² (-31.7%). Interviews with complainants, witnesses and traffic offenders are undertaken therein.
- > The new complex would considerably enhance the working environment and benefit both traffic officers and members of the public attending the offices of the Division.
- 雜項交通調查隊之辦公室,位於新界南行動基地,處理市民作出與交通有關的投訴,及其他交通違例事項如超速等。面積28平方米,由10名警務人員共用,較標準面積少13平方米(-31.7%)。有關人員在此接見投訴人、證人及交通違例人士。
- 新大樓將大大改善有關工作環境,對員工及市民均帶來好處。

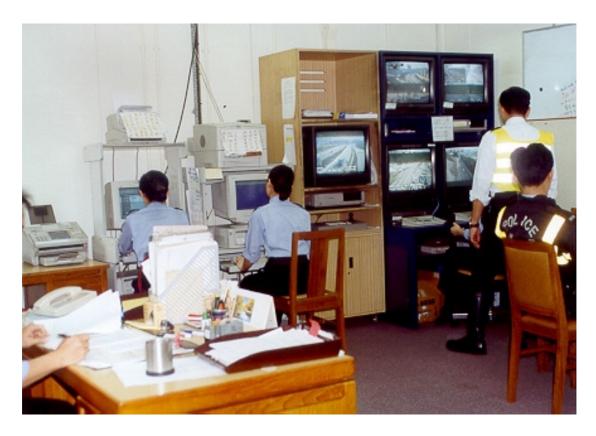
- ➤ The Traffic Operations Room in NTS Operational Base, is used by about 14 officers to monitor traffic conditions during major incidents and in the events of serious traffic congestion.

- > Due to the shortfall of accommodation, the Operations Room is used daily by traffic officers on a sharing-basis for administrative and support duties. This arrangement is unsatisfactory and not conducive to operational effectiveness.

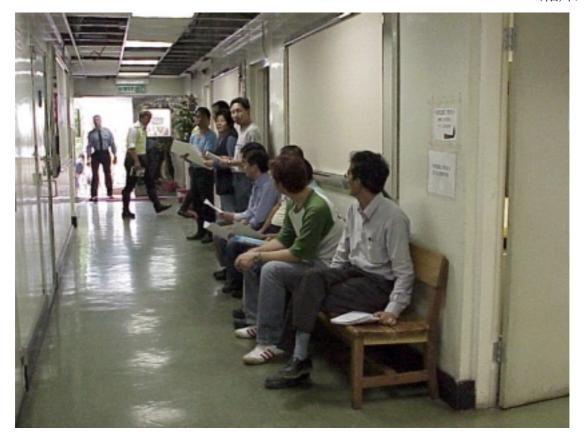
- Members of the public waiting in the corridor outside the Traffic offices. The proposed Regional Headquarters and Operational Base will provide enhanced reception and waiting facilities for the public.
- 公眾人士在交通單位辦公地方外的走廊中等候的情況。建議中的總區總部及行動基地大樓將會提供較佳的接見及等候設施。

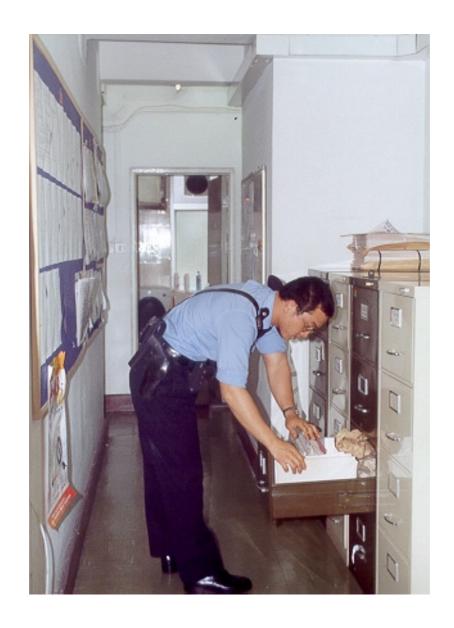
- A corridor outside the Emergency Unit offices in NTS Operational Base. Due to insufficient storage space, file cabinets are placed along the corridor. This arrangement is unsatisfactory and does not meet current occupational safety standards.
- 新界南行動基地內衝鋒隊辦公地方的走廊。由於缺乏貯存地方,部分文件櫃放於走廊之內。現時之安排並不理想,也不合乎現今職業安全標準。

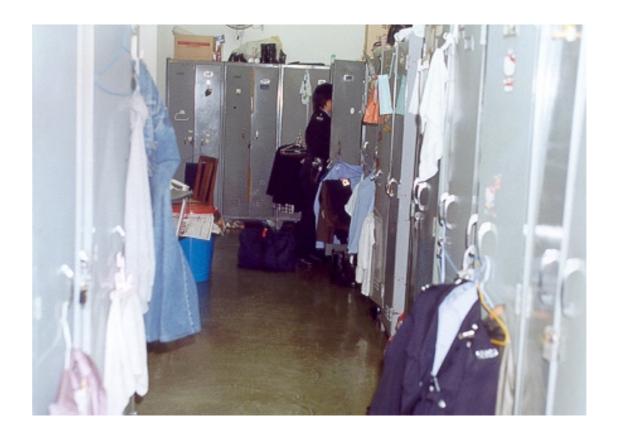
- ➤ The female changing room of the Emergency Unit in NTS Operational Base. Measuring 21 m², shared by 18 officers, hence a shortfall of 6 m² (-22.2%).
- > The facilities do not meet current Force standards in terms of fitting out requirements.
- 新界南行動基地內衝鋒隊之女警更衣室,面積21平方米,由 18名女警共用,較標準面積少6平方米(-22.2%)。
- 更衣室內之設施並不合乎現時警隊的標準。

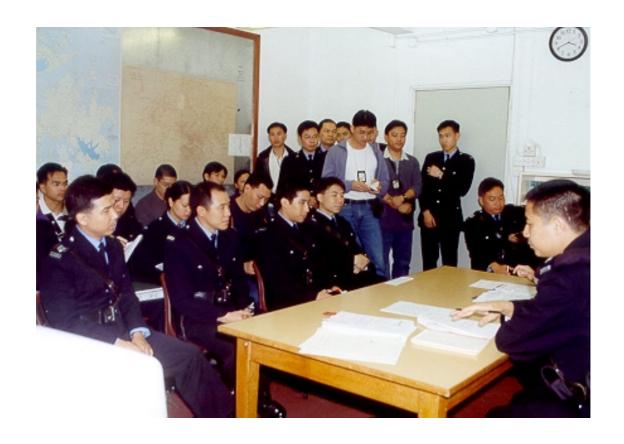
- ➤ The briefing room of the Emergency Unit in NTS Operational Base. Measuring 26 m², shared by a platoon of 60 officers per shift, hence a shortfall of 34 m² (-56.7%)
- > This is an important facility for the front-line officers to be briefed about daily crime trends, crime black spots, suspects and wanted persons, etc.
- 新界南行動基地內衝鋒隊之訓示室,面積26平方米,每更由小隊中的60名警務人員共用,較標準面積少34平方米(-56.7%)。
- 這是一項重要設施,讓前線警務人員掌握每天的罪案趨勢、 罪案黑點、疑犯及通緝人士的資料等。
