咸水樓拉力橫樑  
鋼筋漲爆石屎

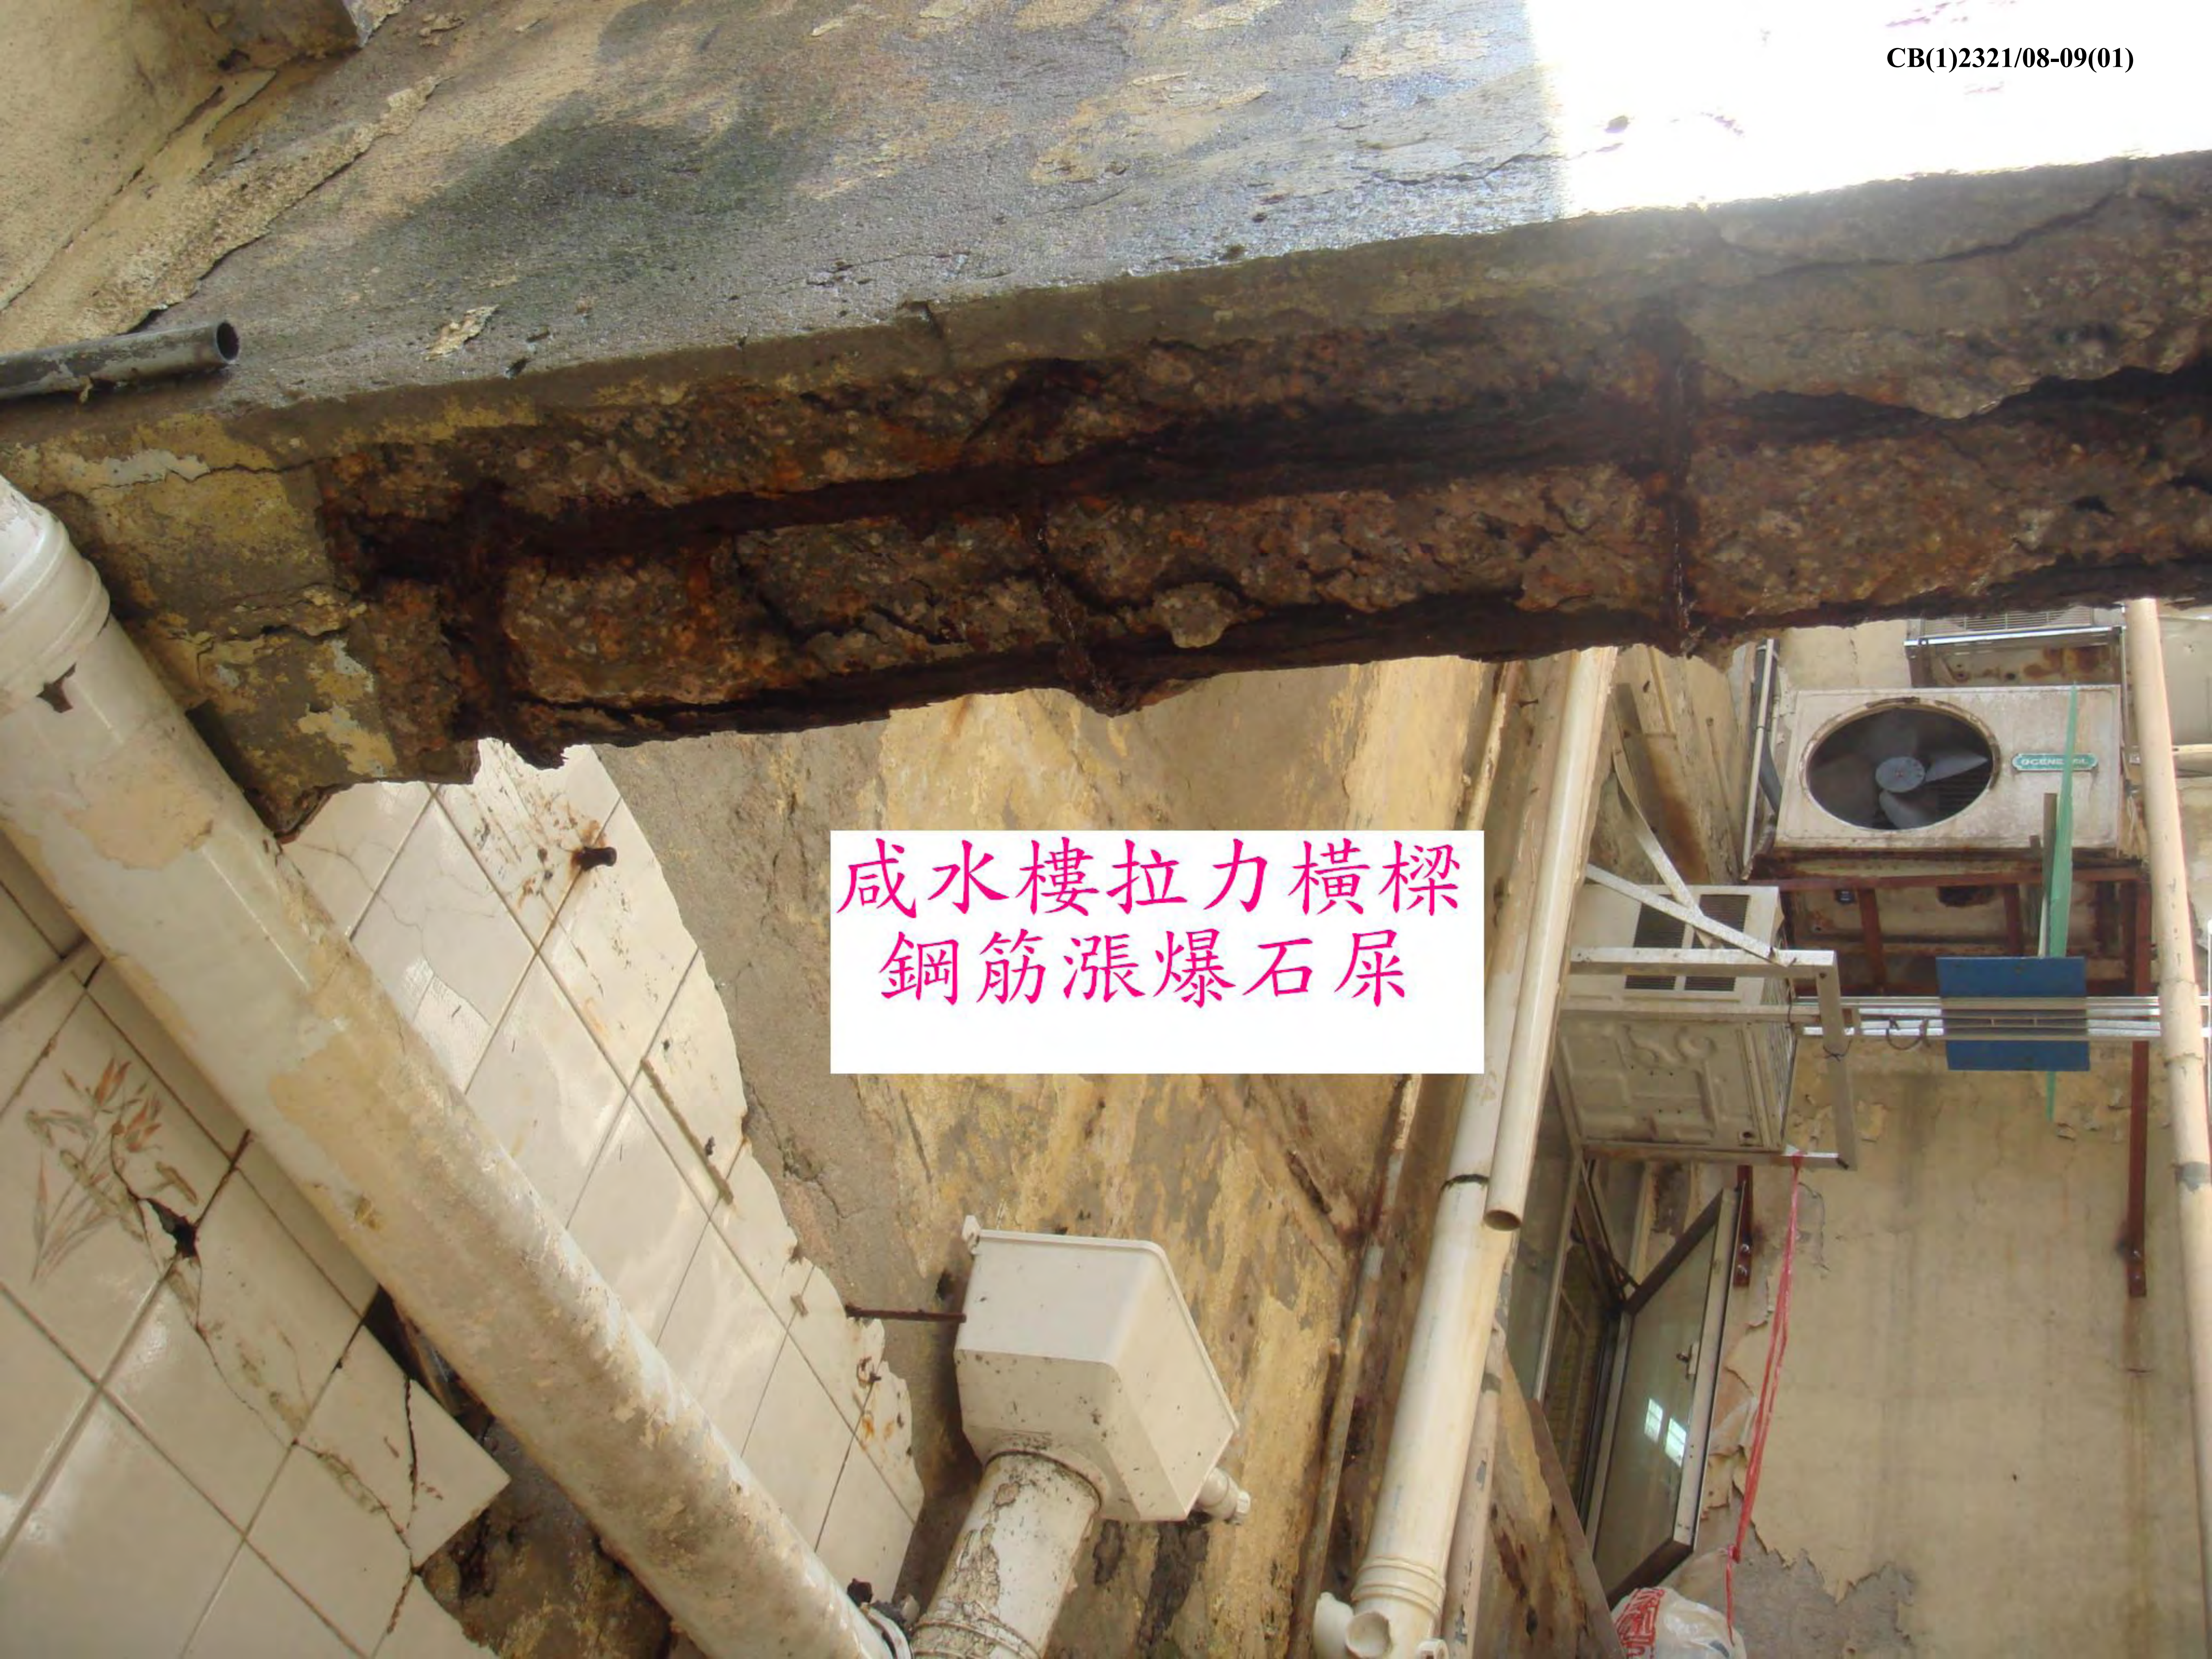
樓宇結構鋼筋漲爆石屎

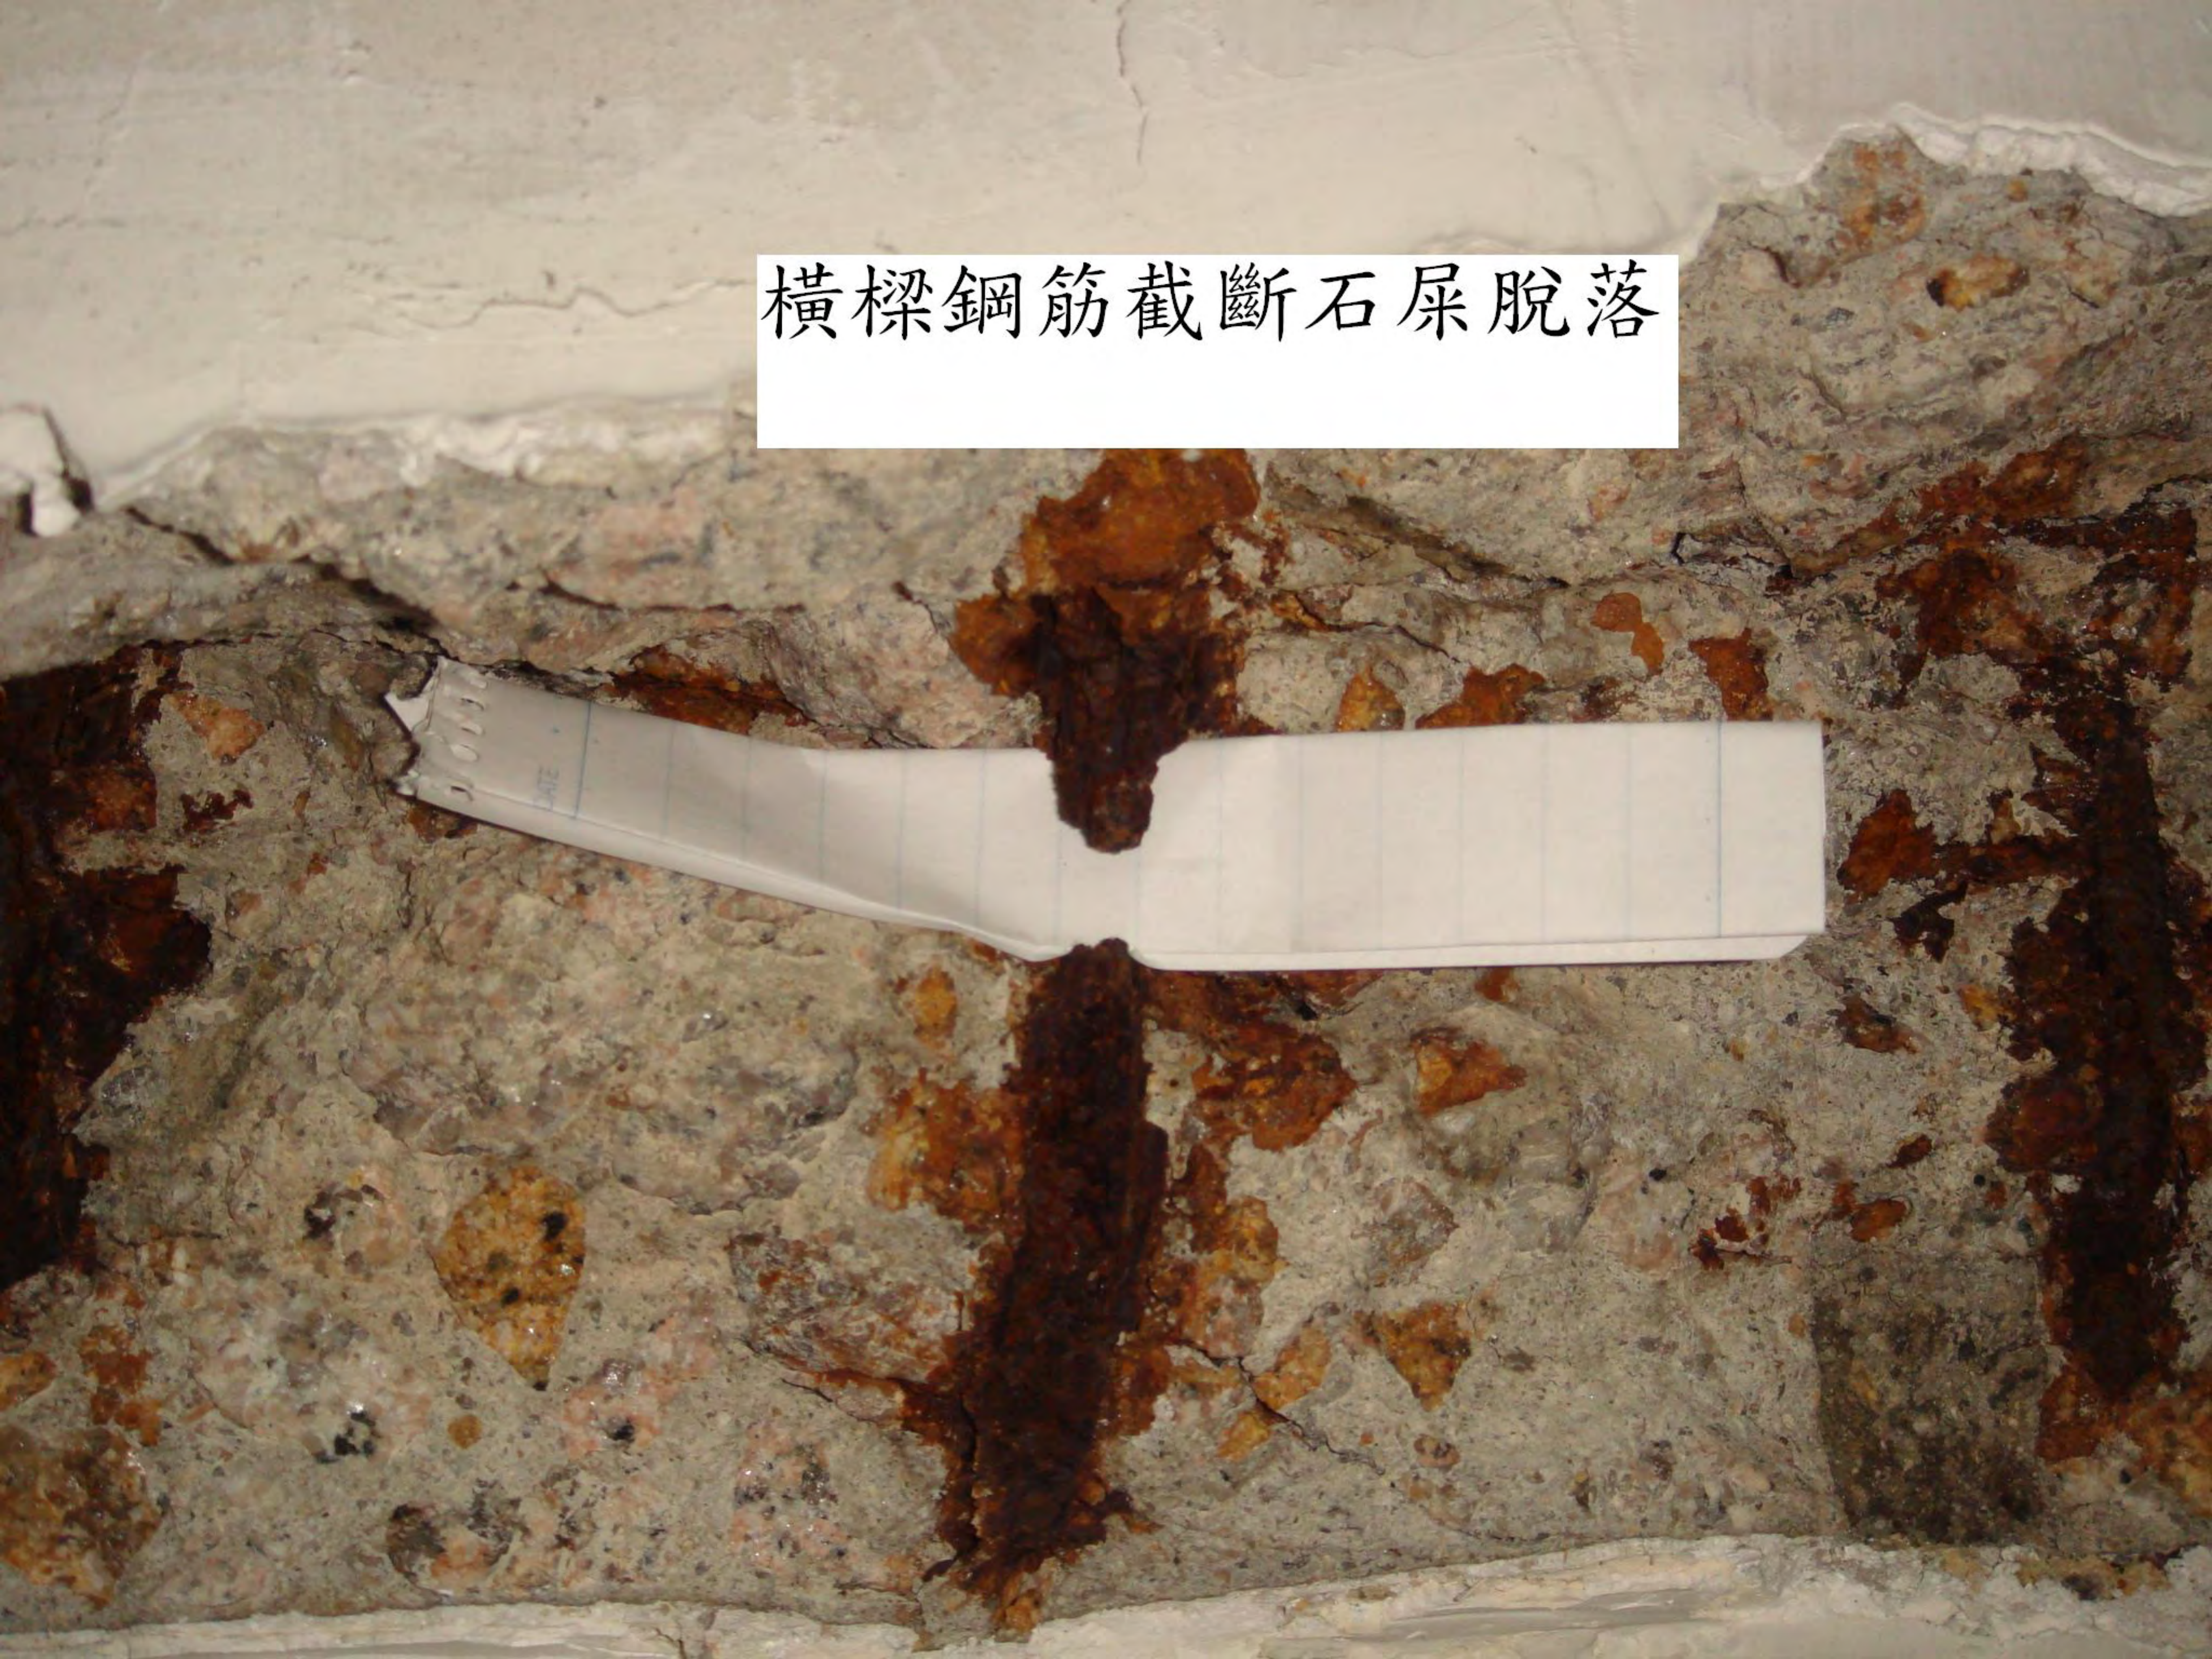
橫樑鋼筋截斷石屎脫落

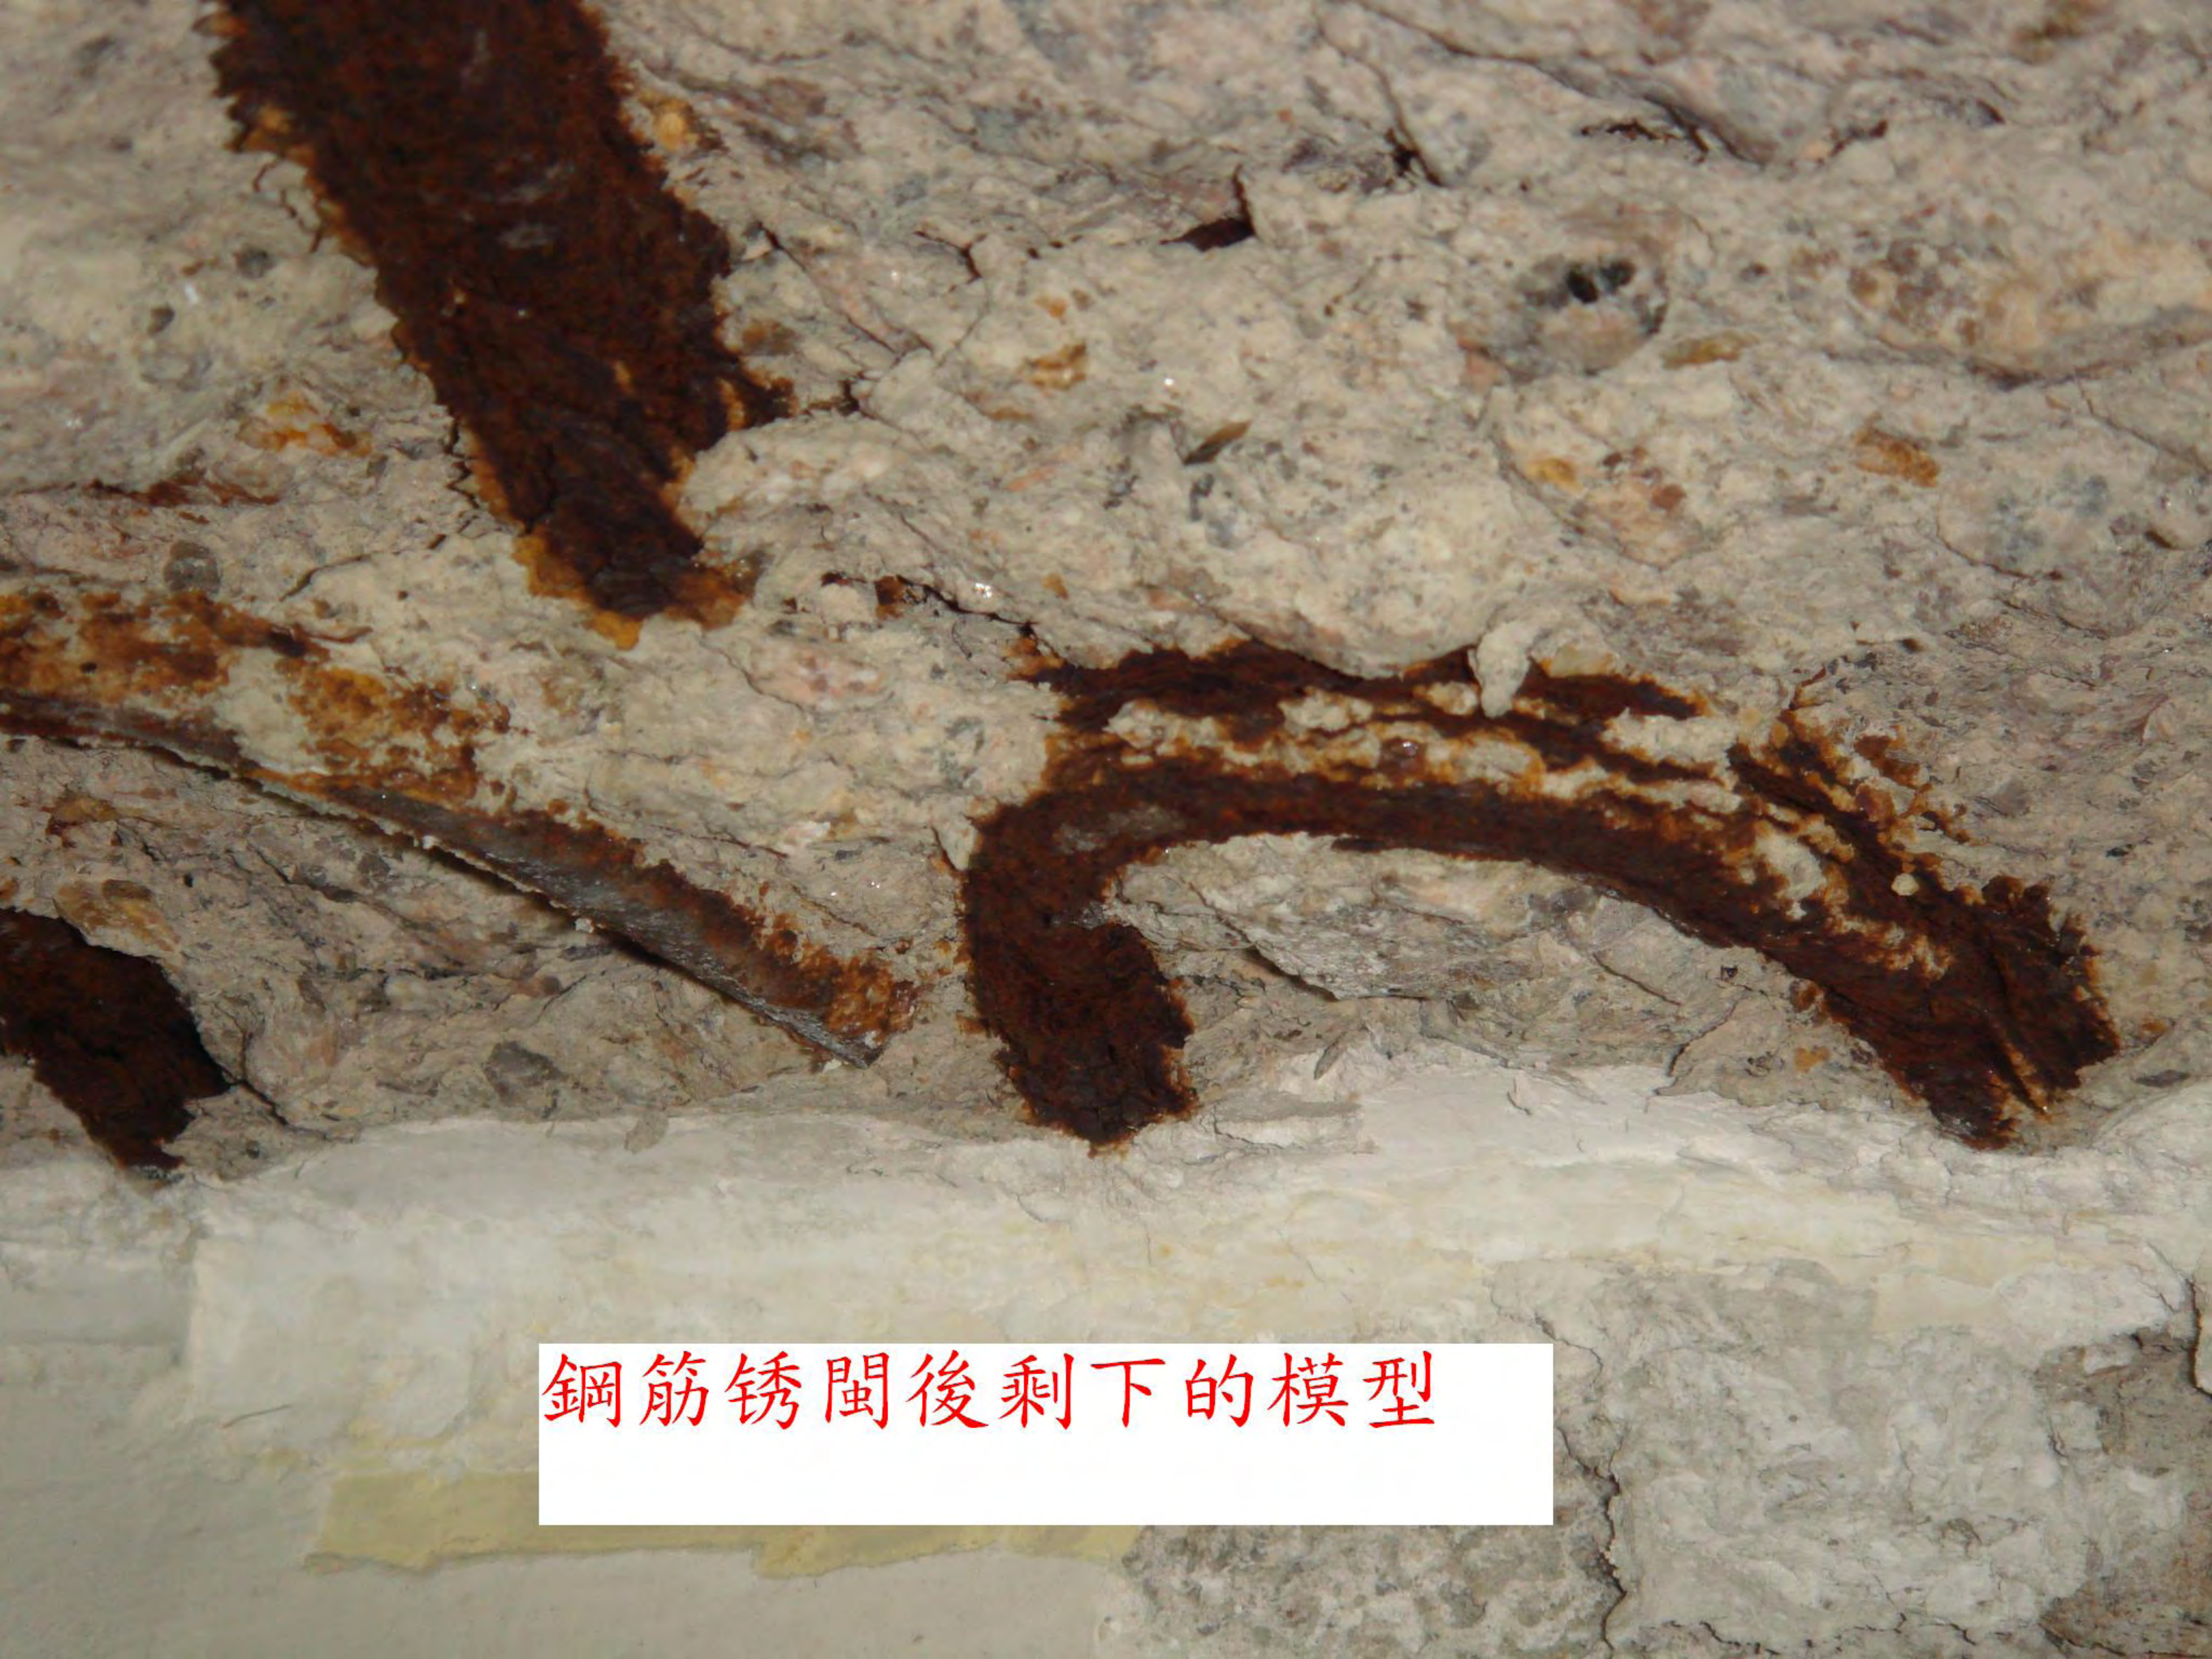
鋼筋銹蝕後剩下的模型

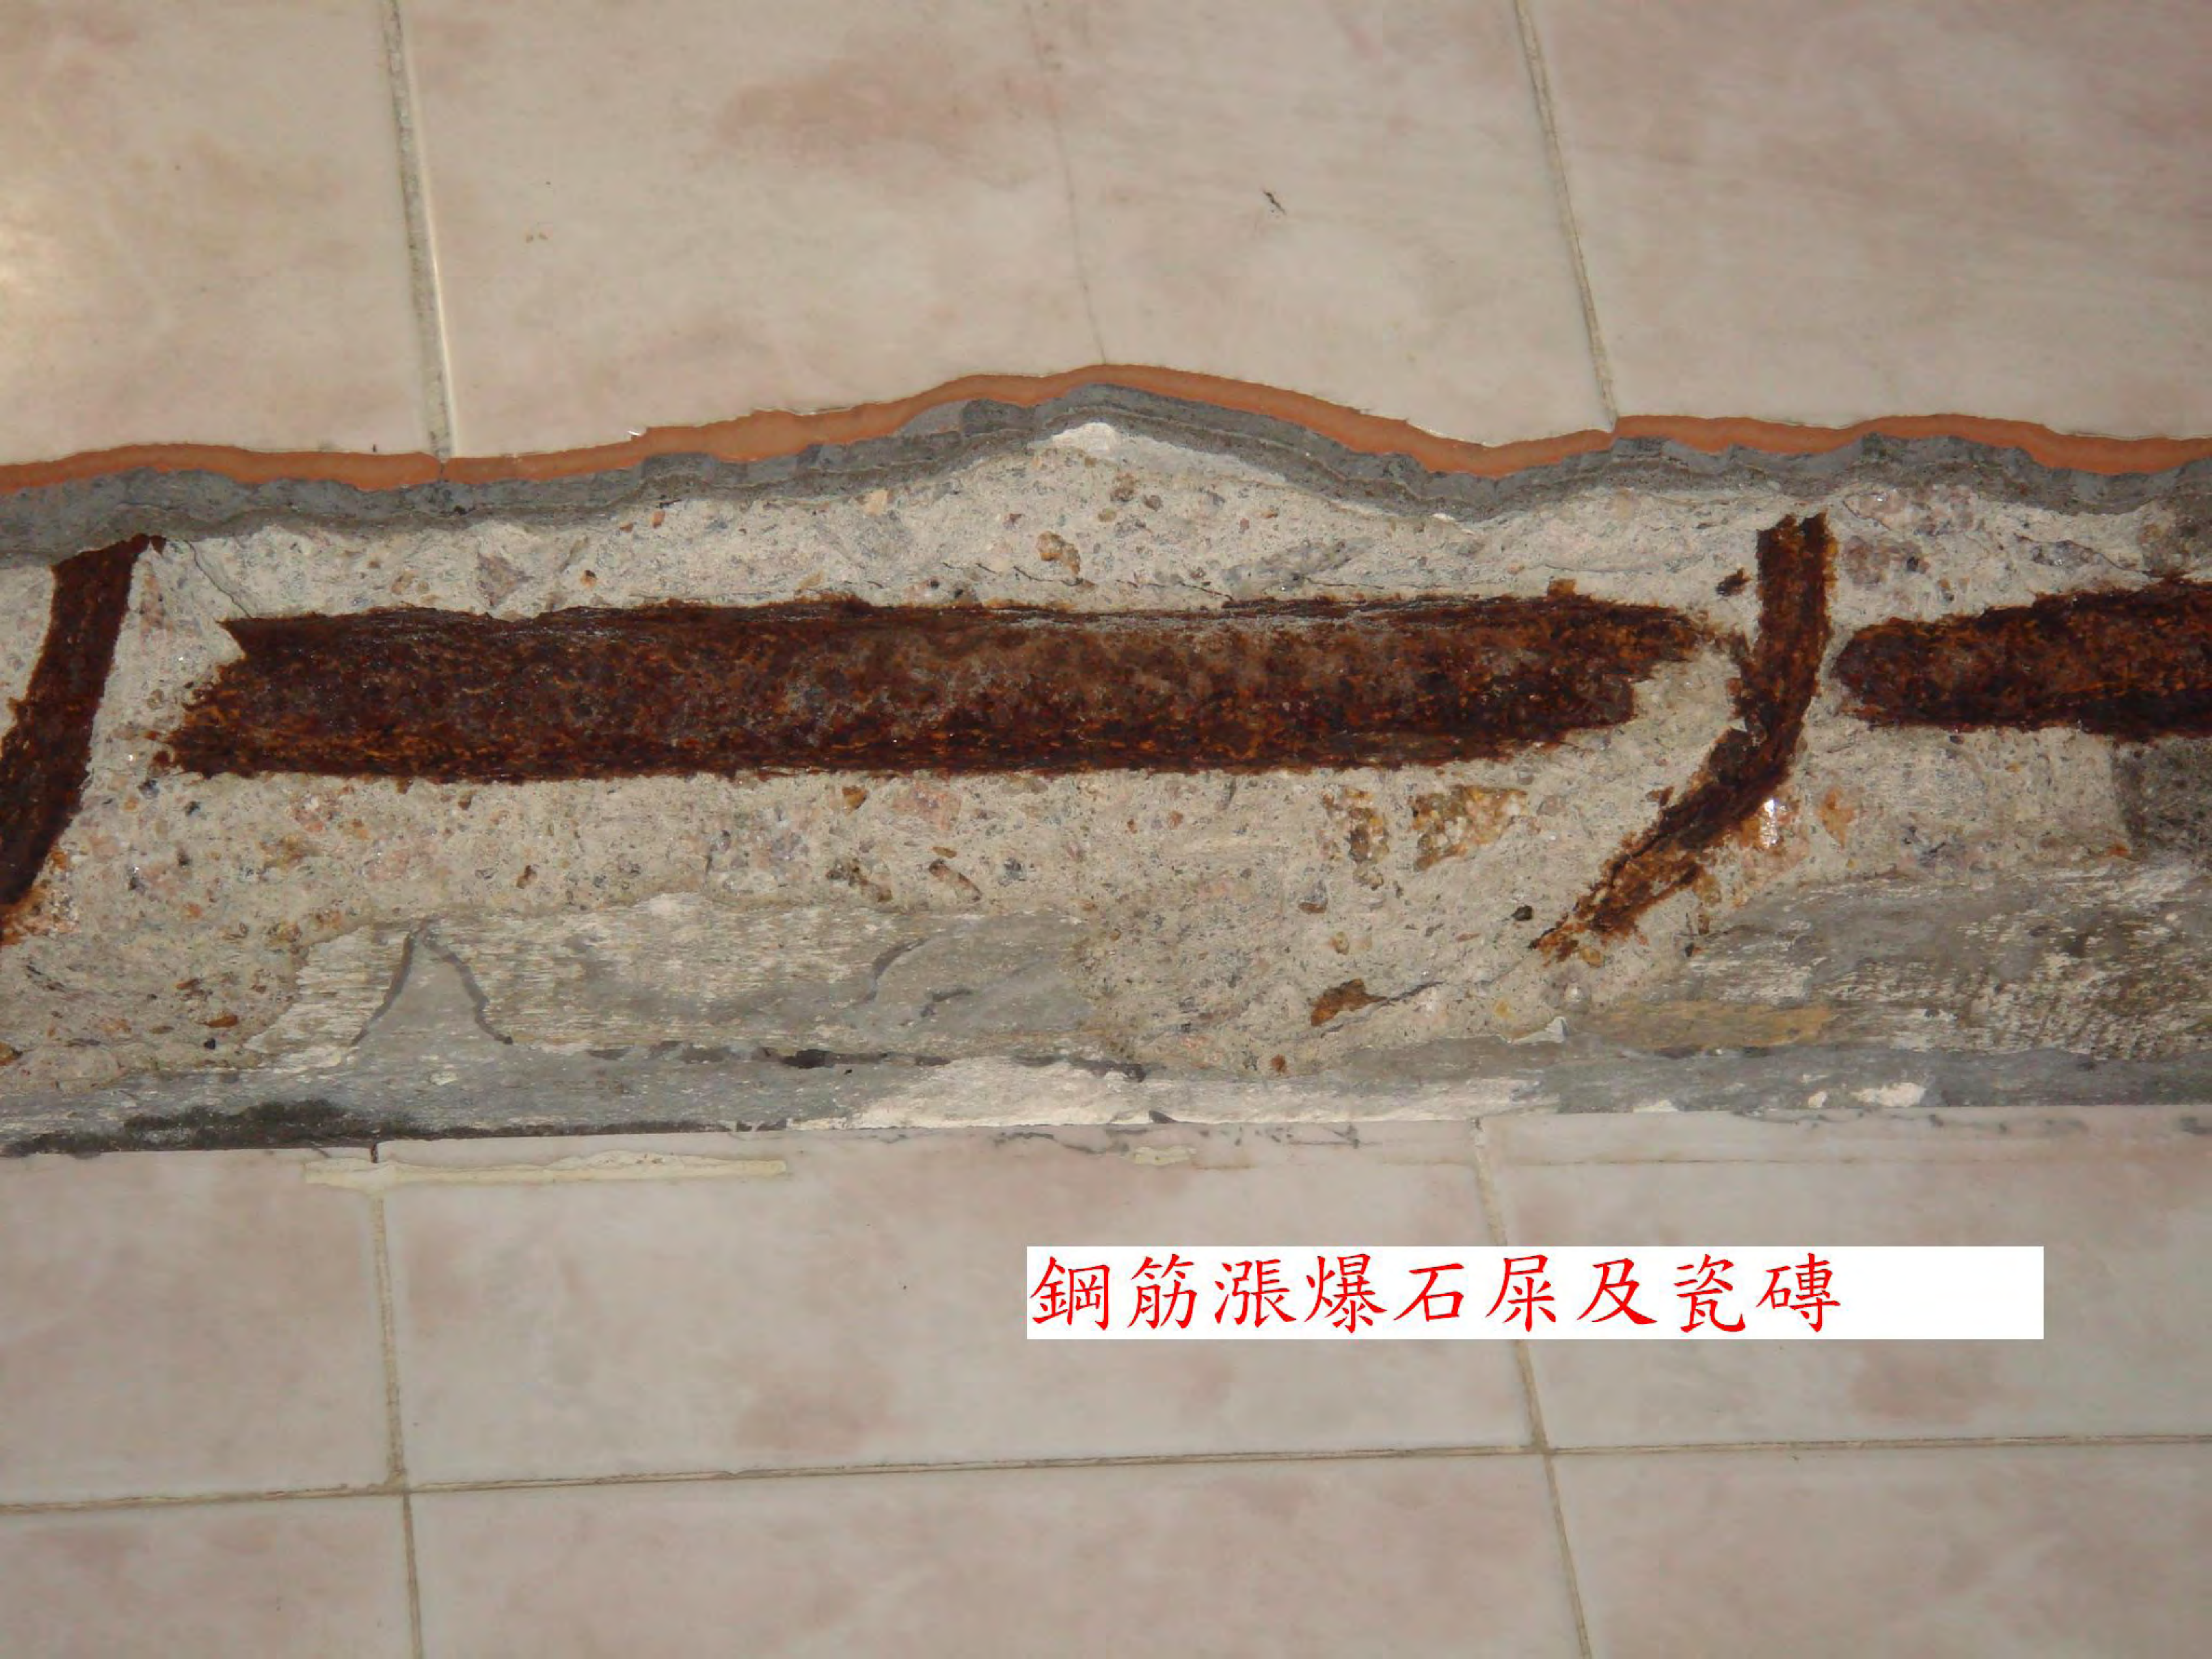
鋼筋漲爆石屎及瓷磚

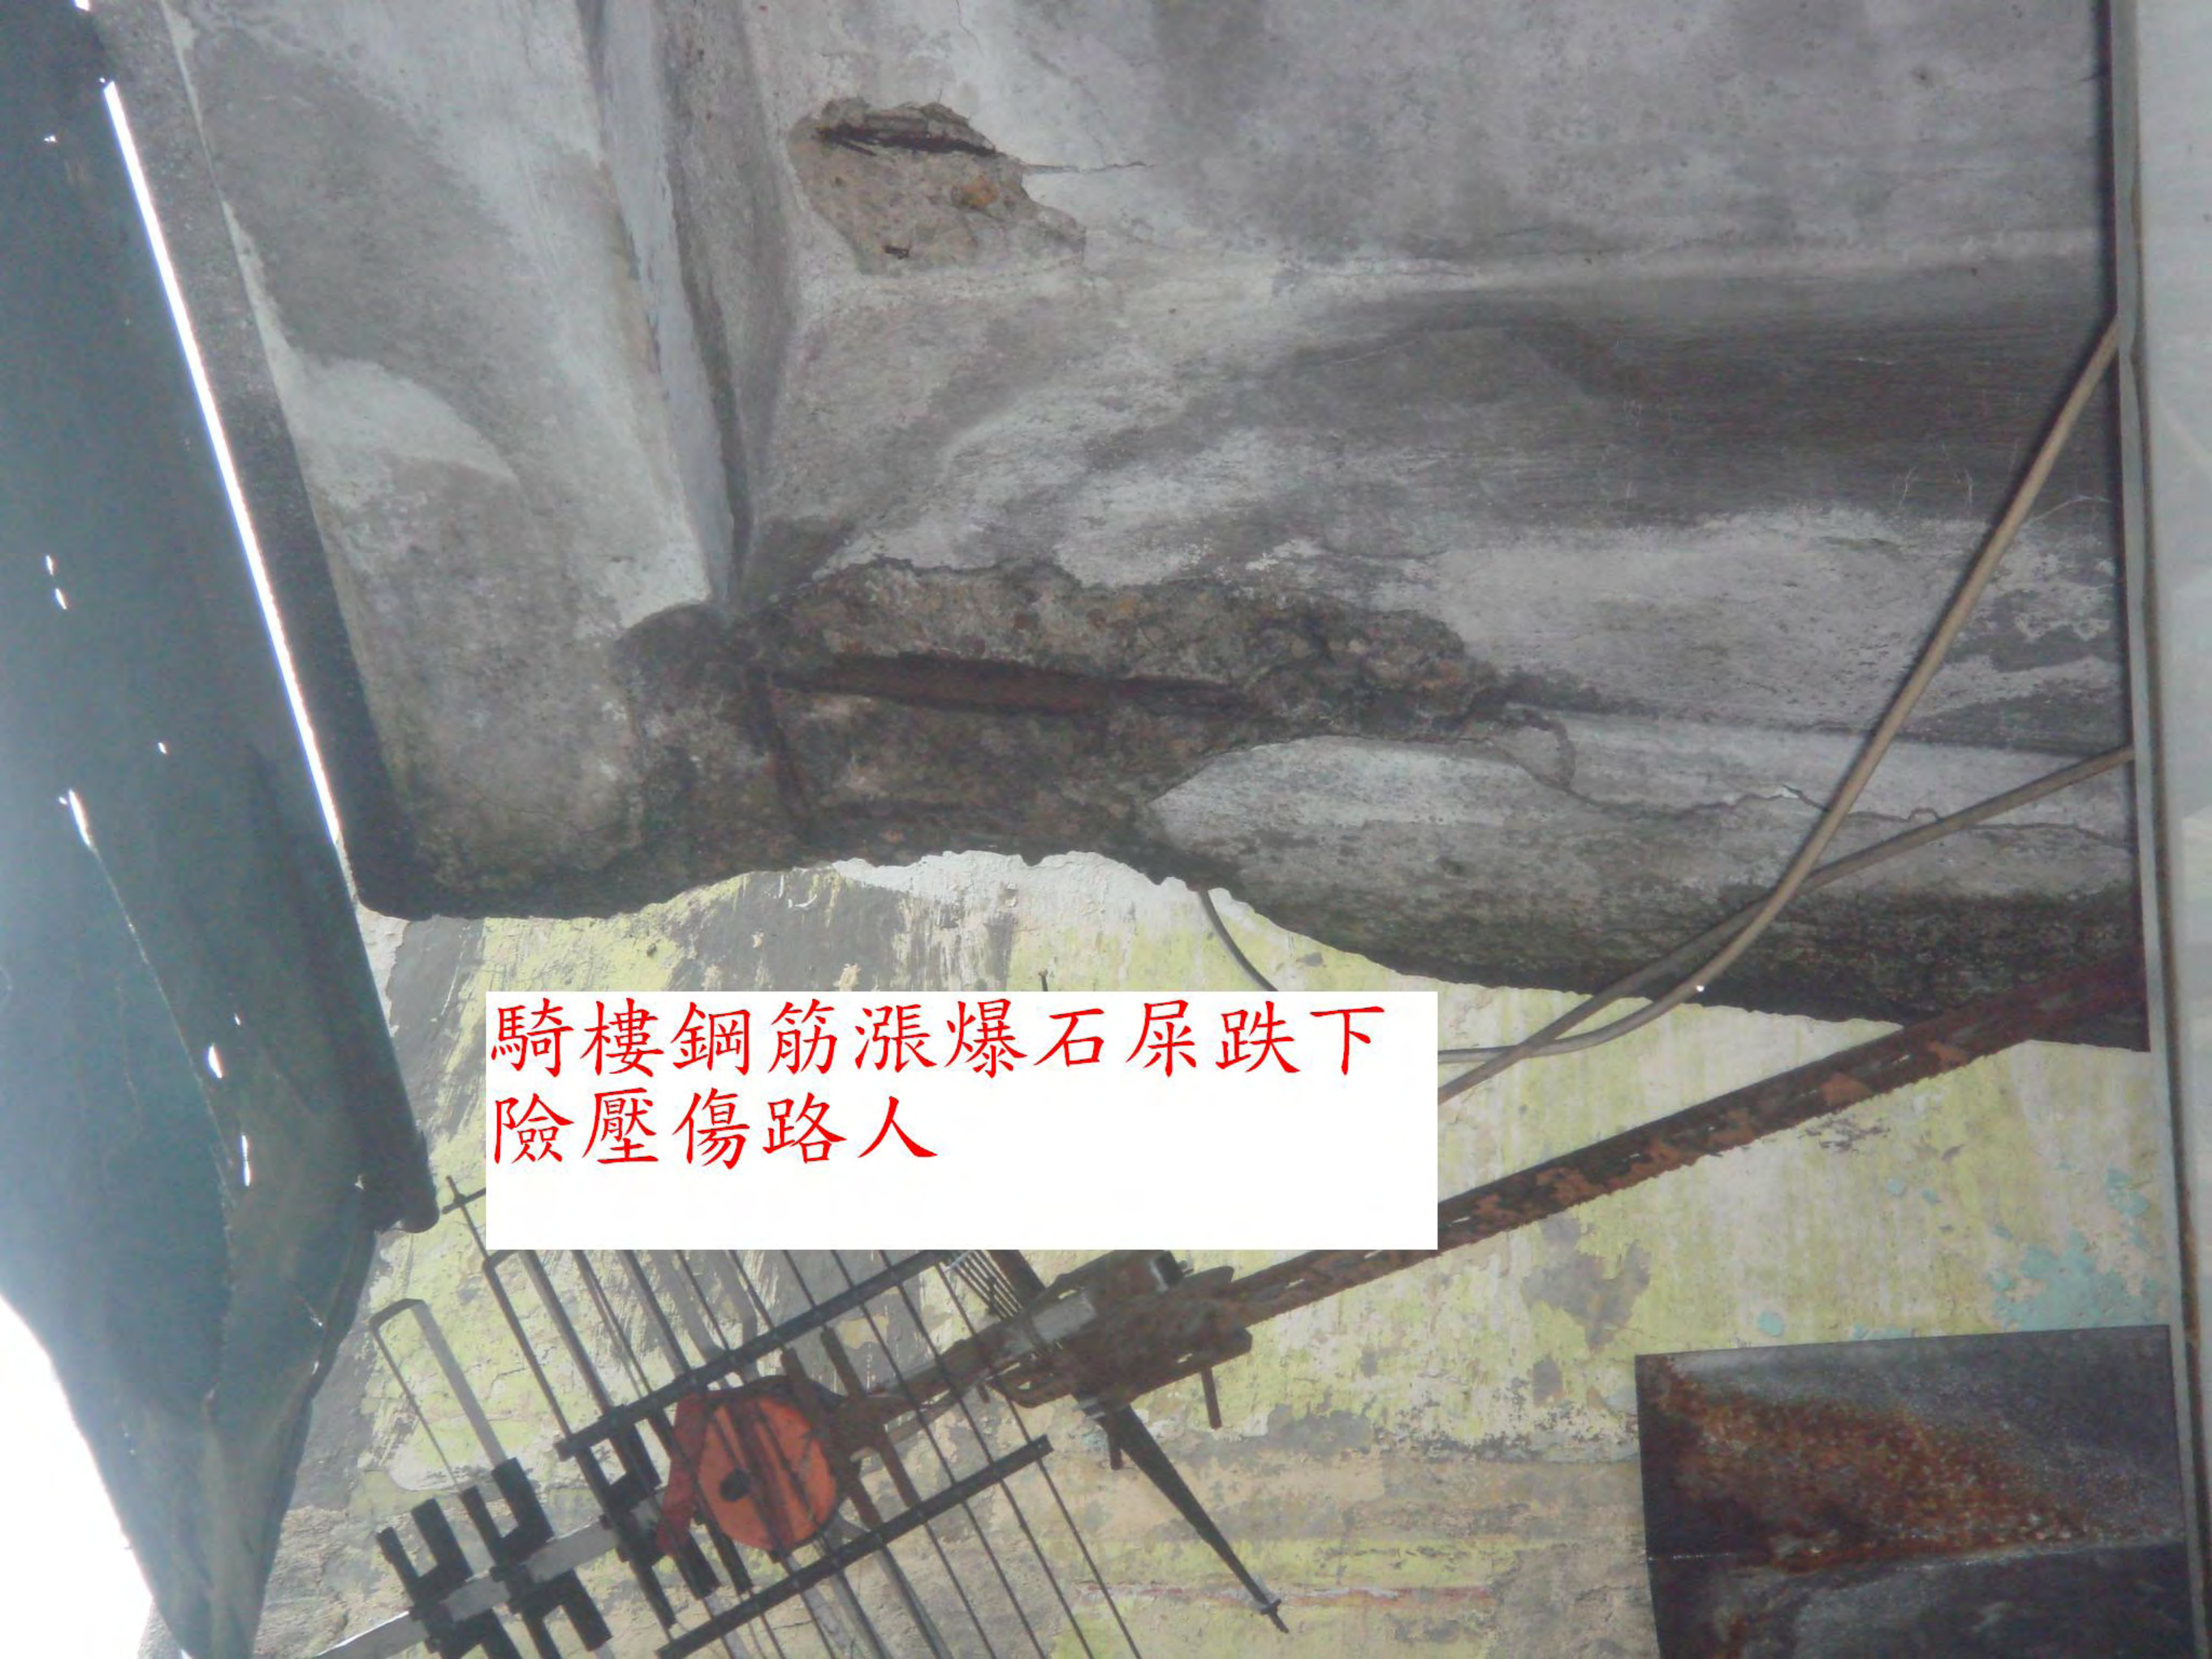
鋼筋漲爆石屎情況嚴重

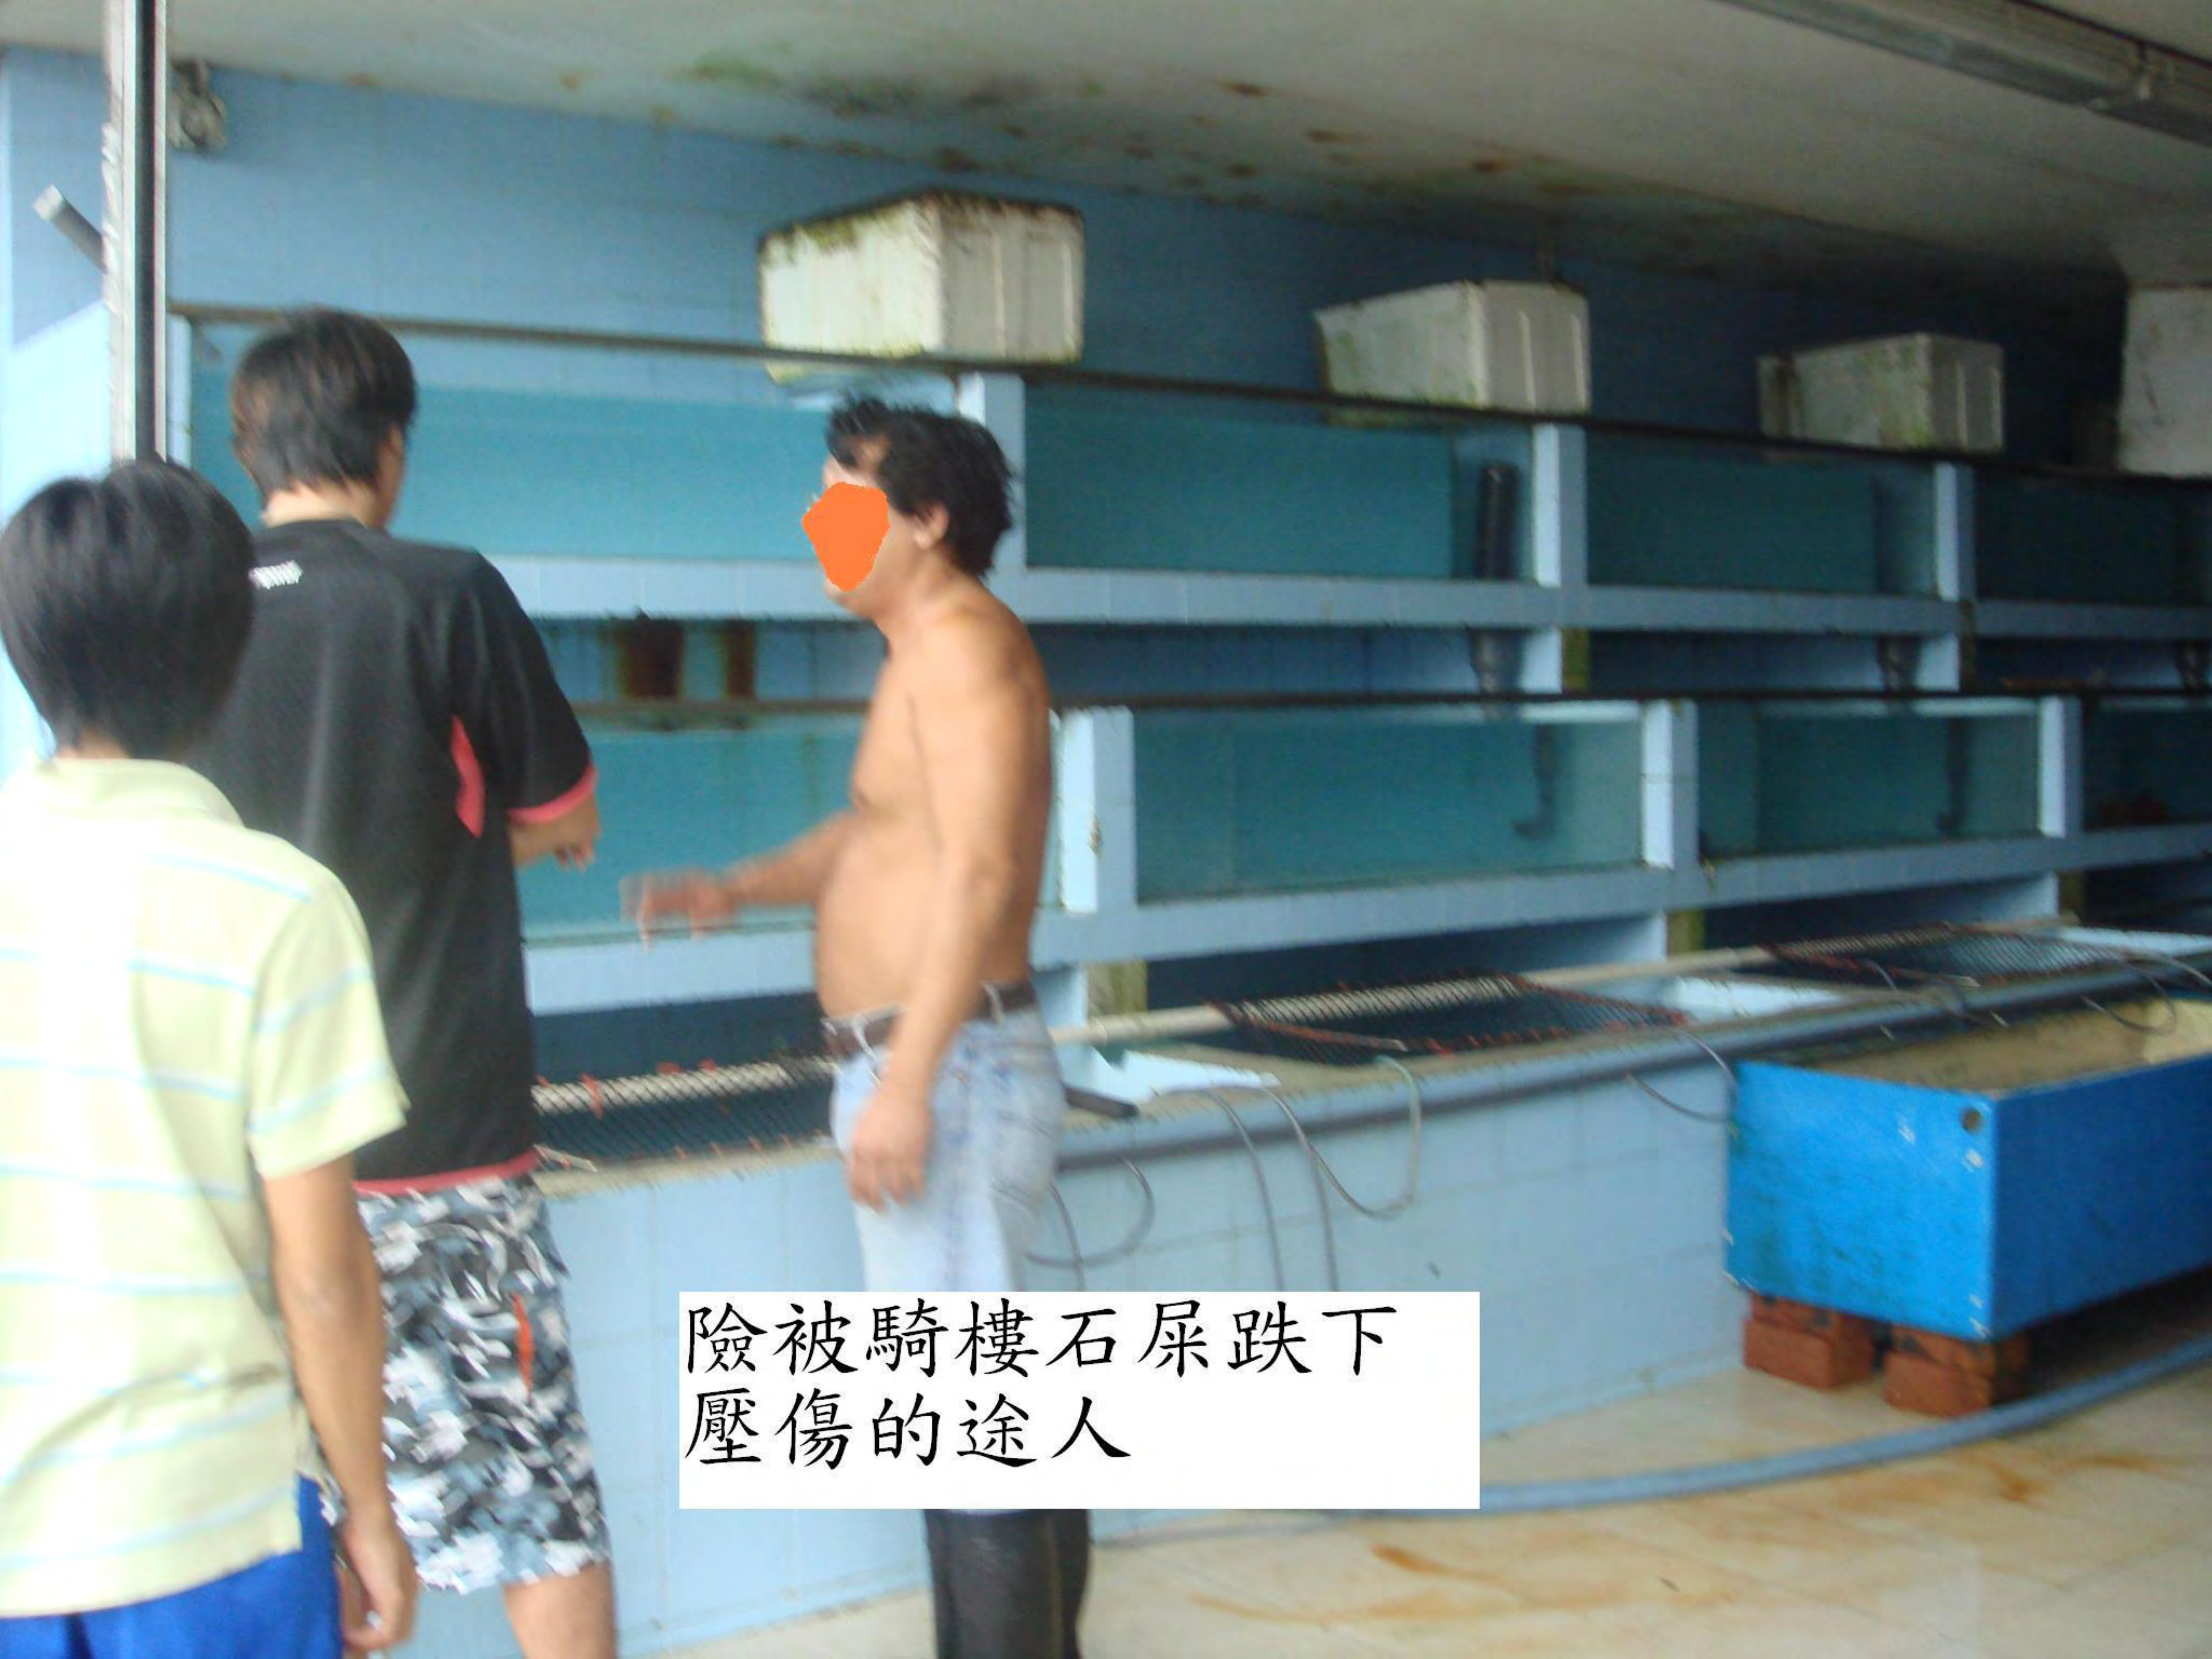
下  
跌  
屎  
石  
爆  
漲  
筋  
鋼  
樓  
騎  
人  
路  
傷  
壓  
險
