咸水樓拉力橫樑  
鋼筋漲爆石屎

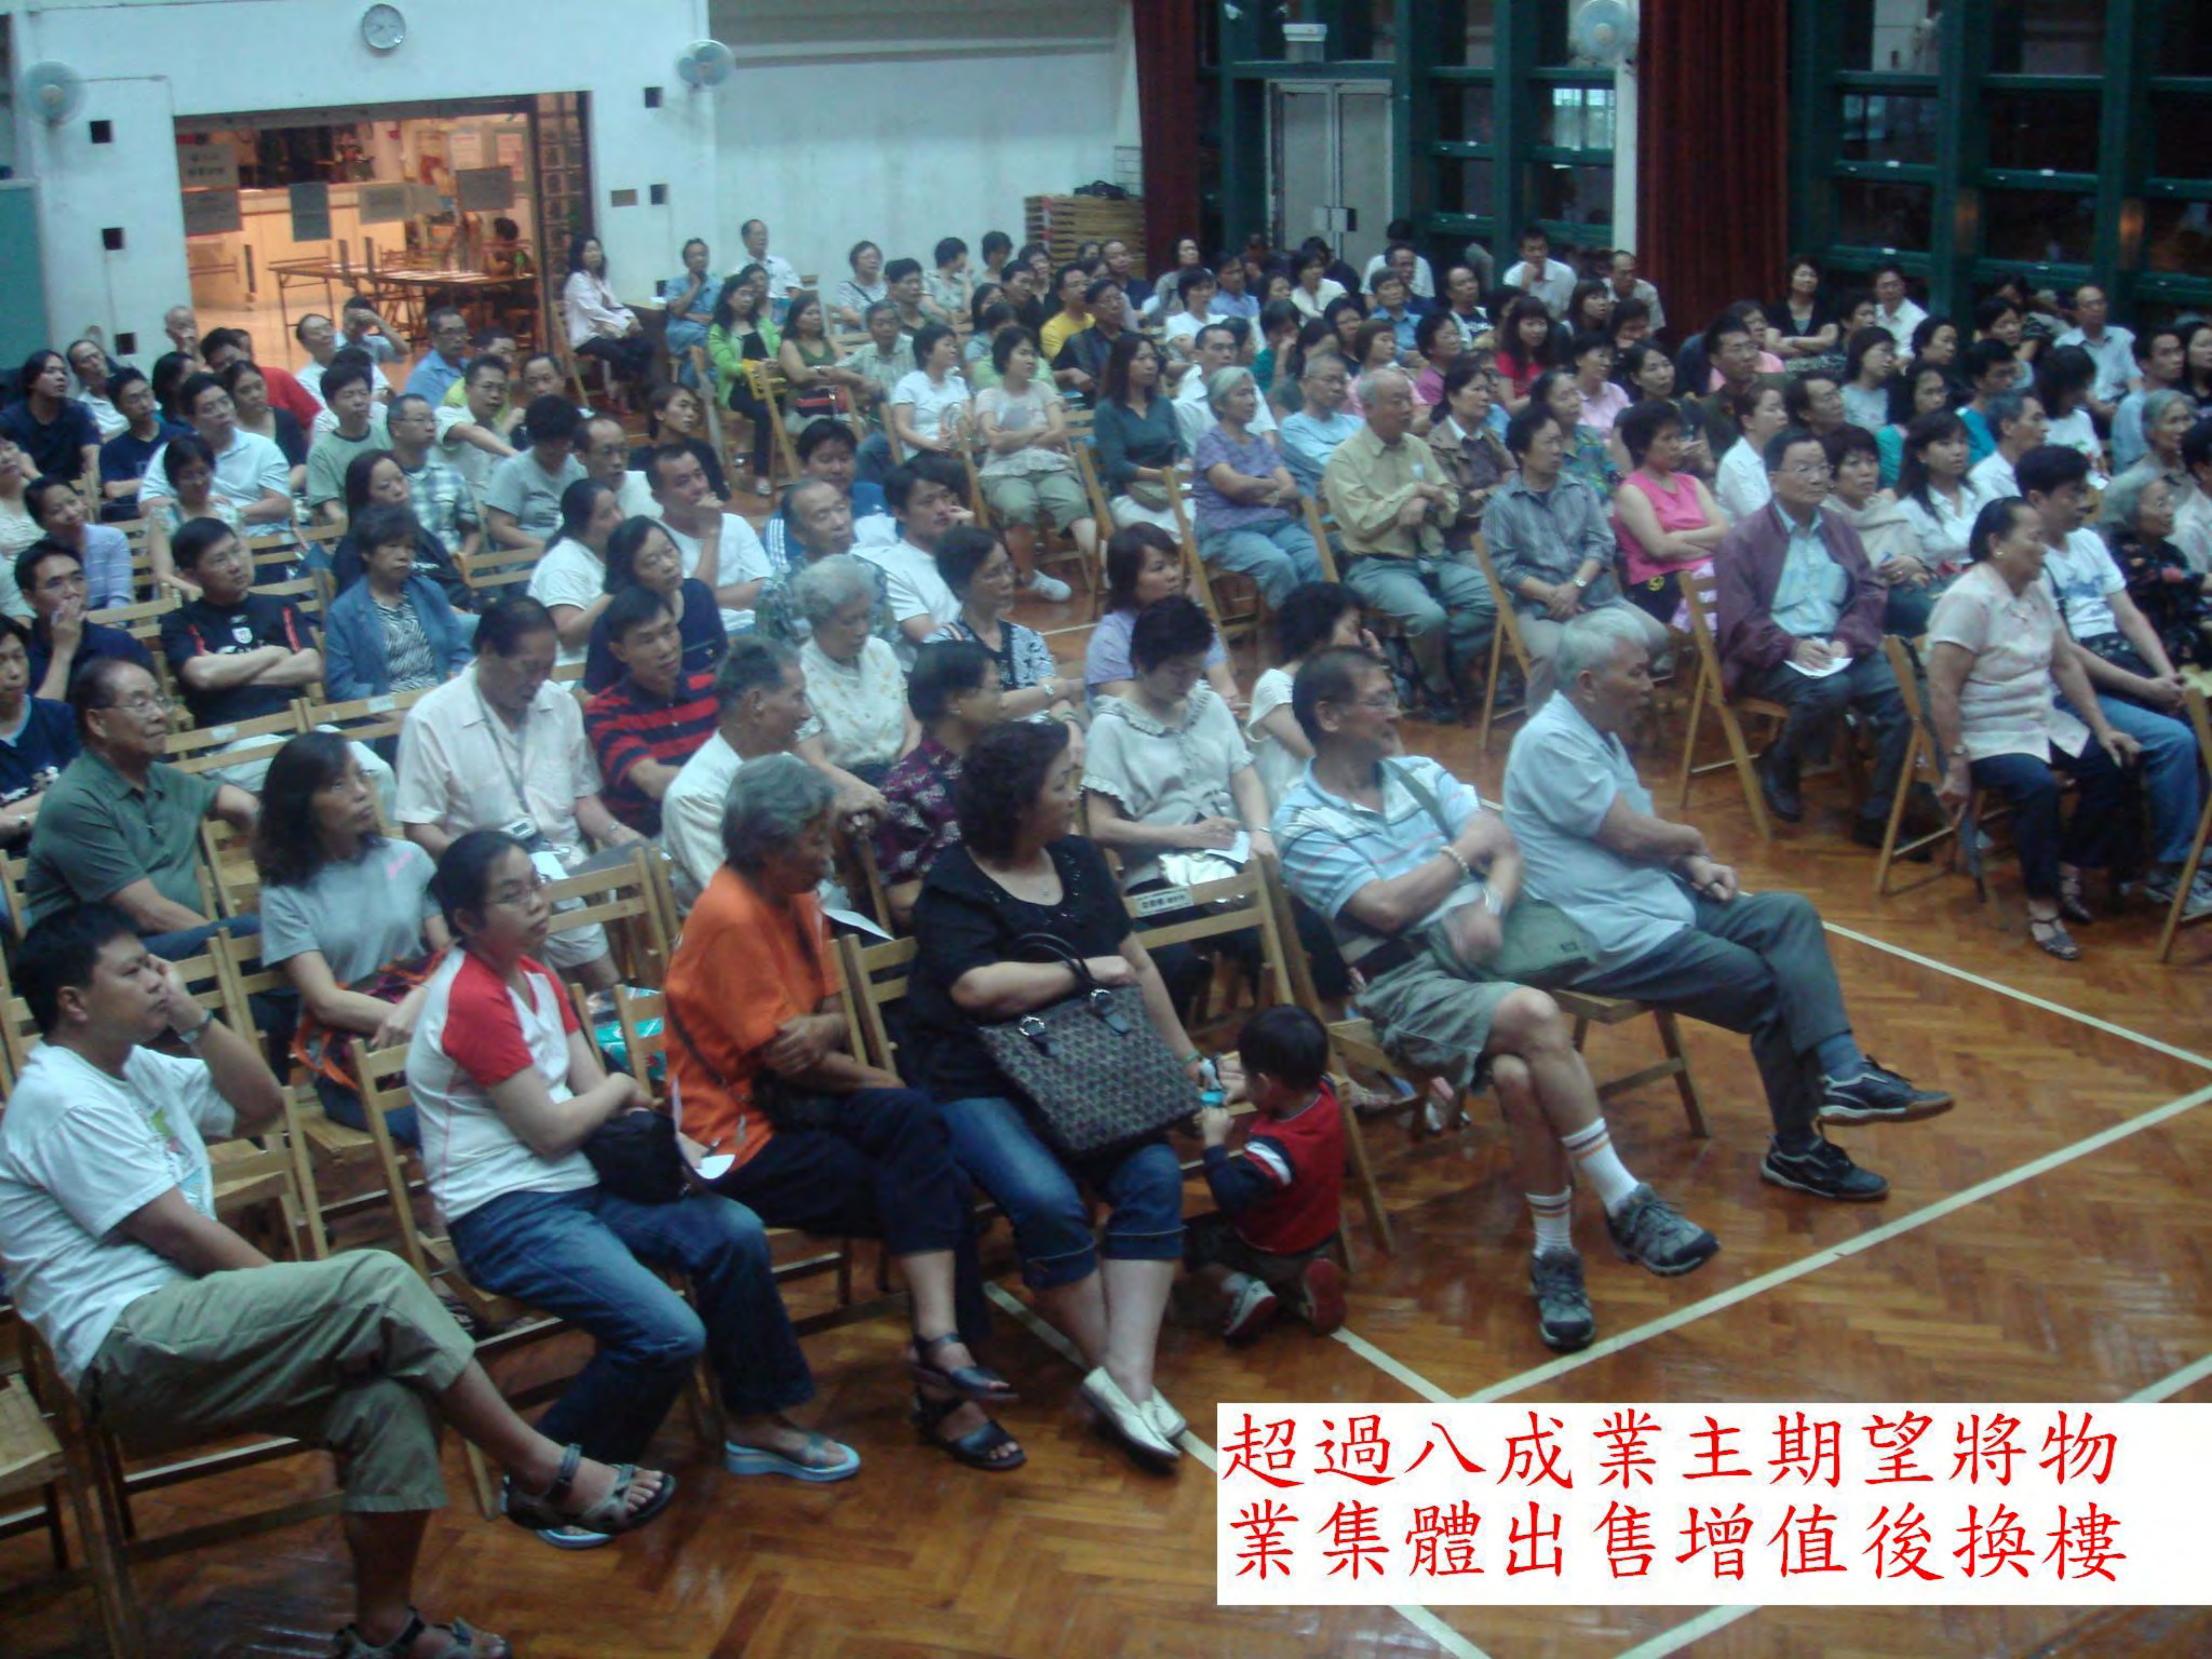
險被騎樓石屎跌下  
壓傷的途人
