## **CKR – Kai Tak**

Central Kowloon Route -  
Design and Construction

Tree Assessment Schedule - Kai Tak Area (Trees under AFCD to Provide Expert Advice)

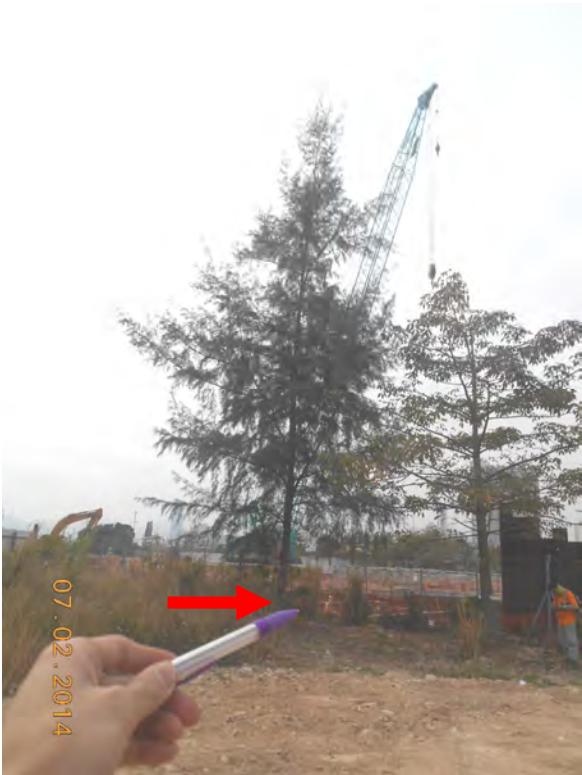
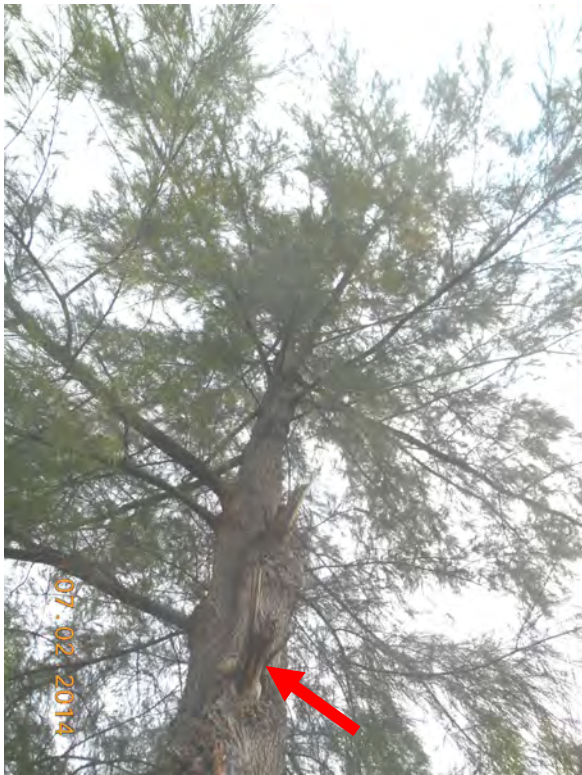
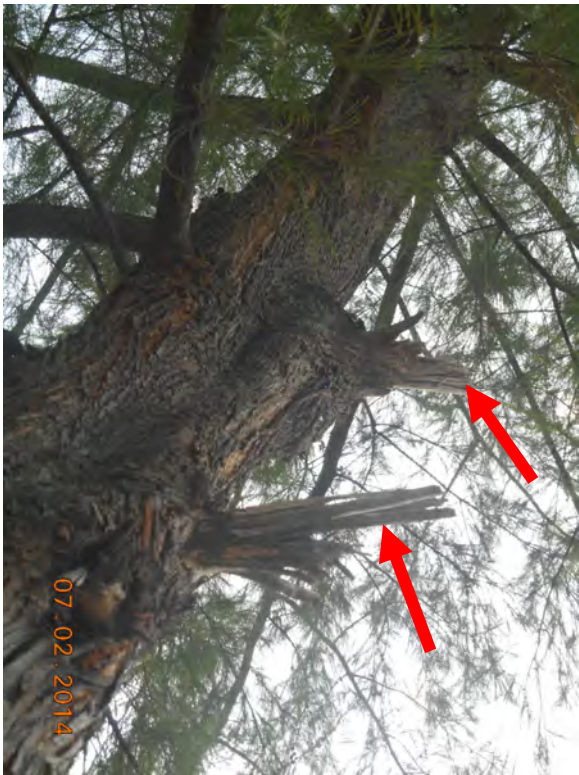
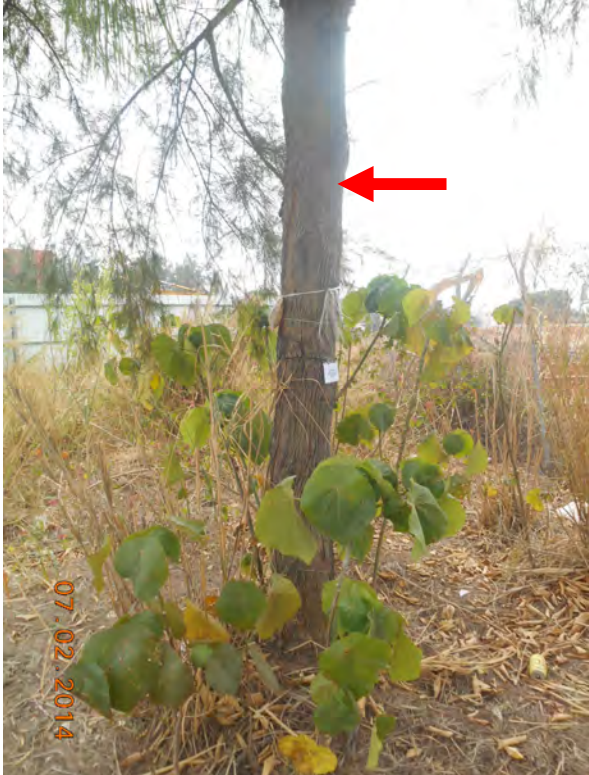
KT/T472_1 (Fell) Scientific Name: <i>Bombax ceiba</i>	KT/T472_2	KT/T472_3

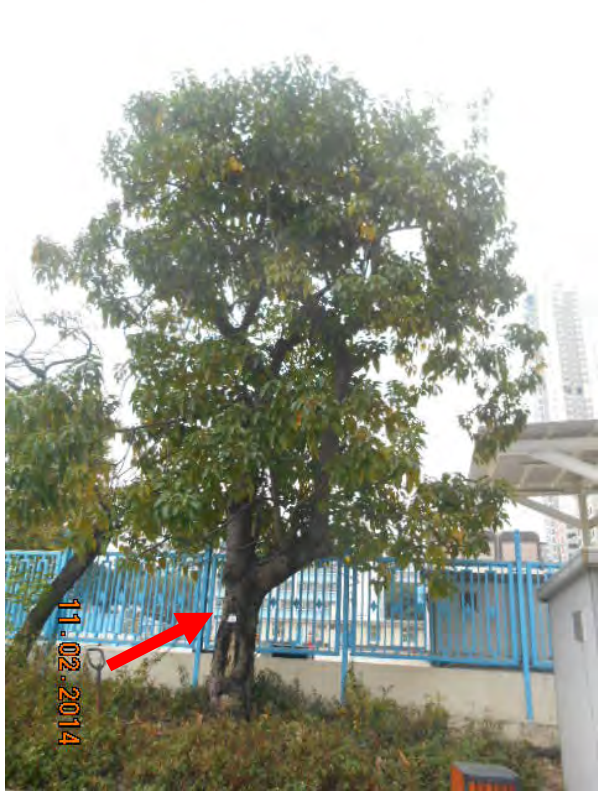
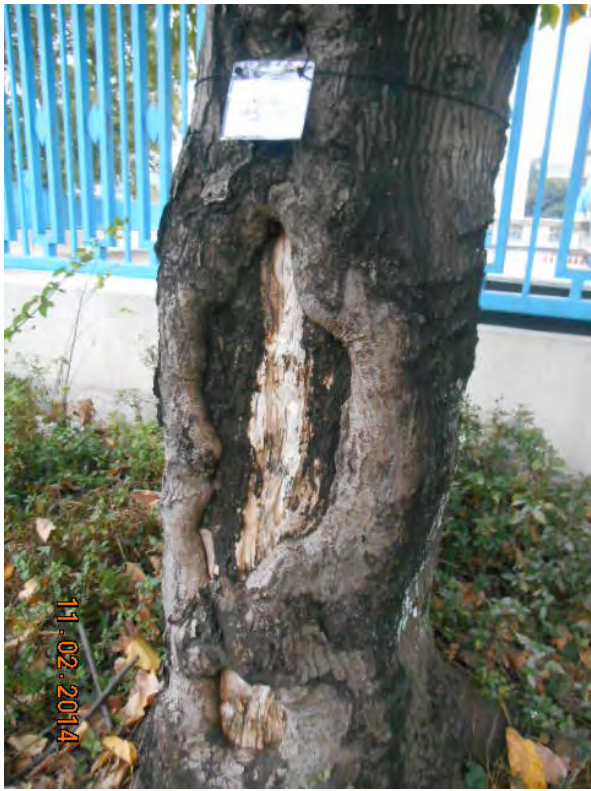
KT/T480_1 (Retain) Dead tree	KT/T480_2 bark crack	KT/T480_3 Leaning to N at 5°	KT/T480_4 No foliage

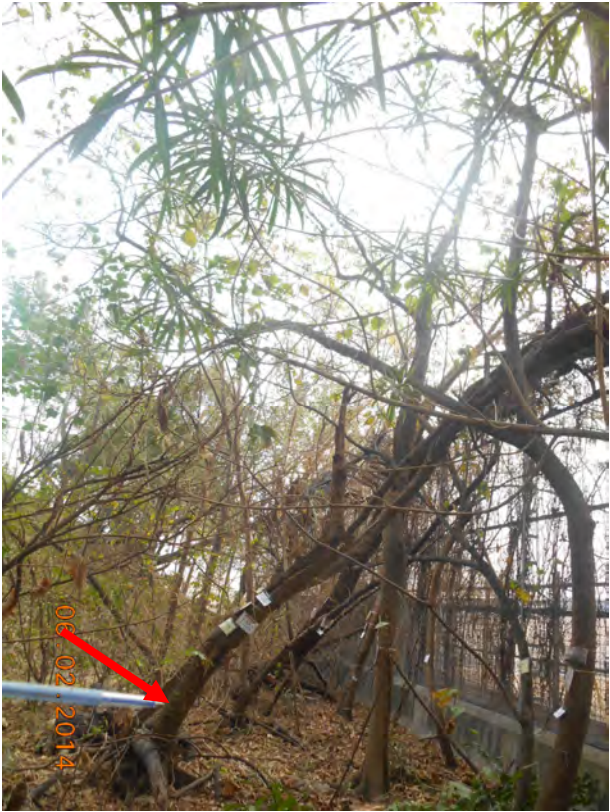
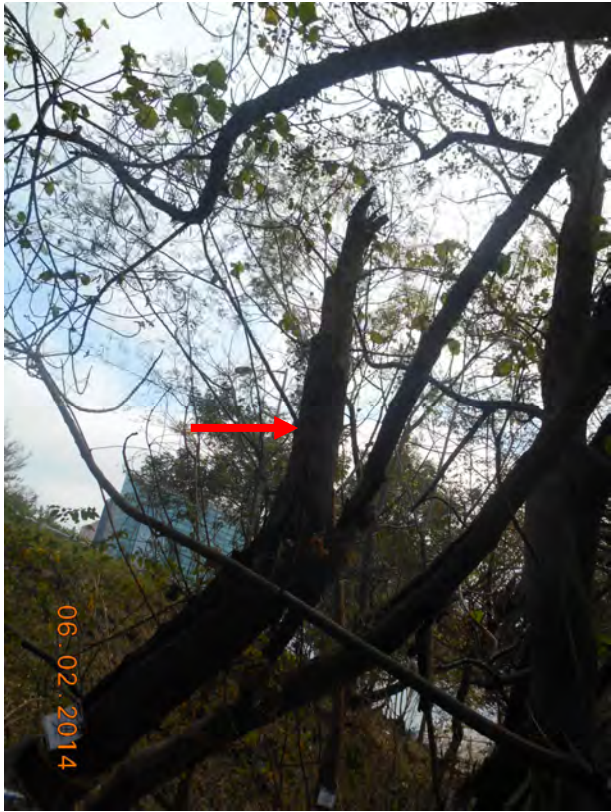
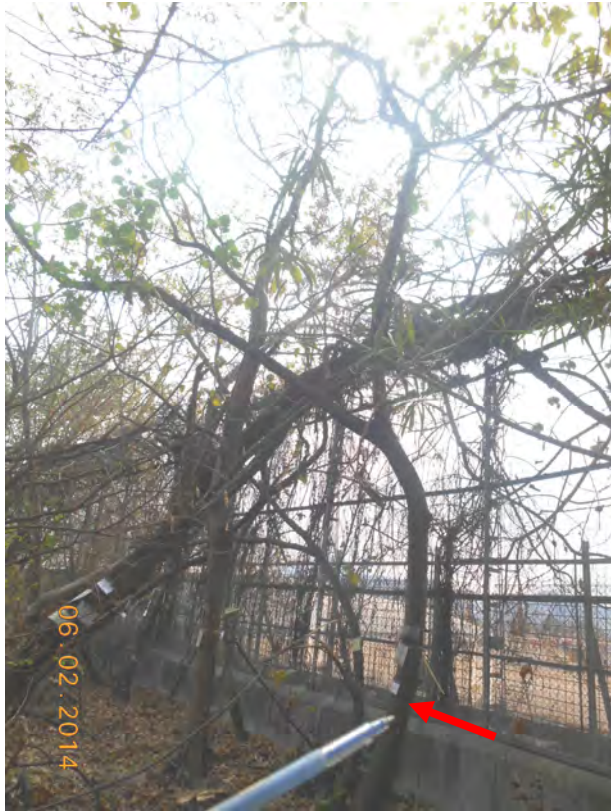
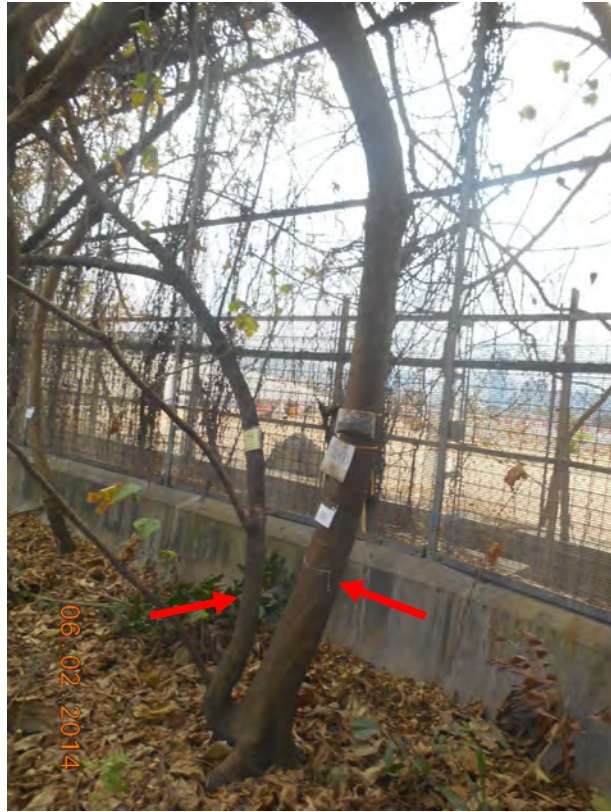
KT/T182_1 (Fell) Scientific Name: <i>Celtis sinensis</i>	KT/T182_2 Exposed roots	KT/T182_3 Crooked trunk; Low live crown ratio	KT/T182_4 Trunk crossed with nearby tree

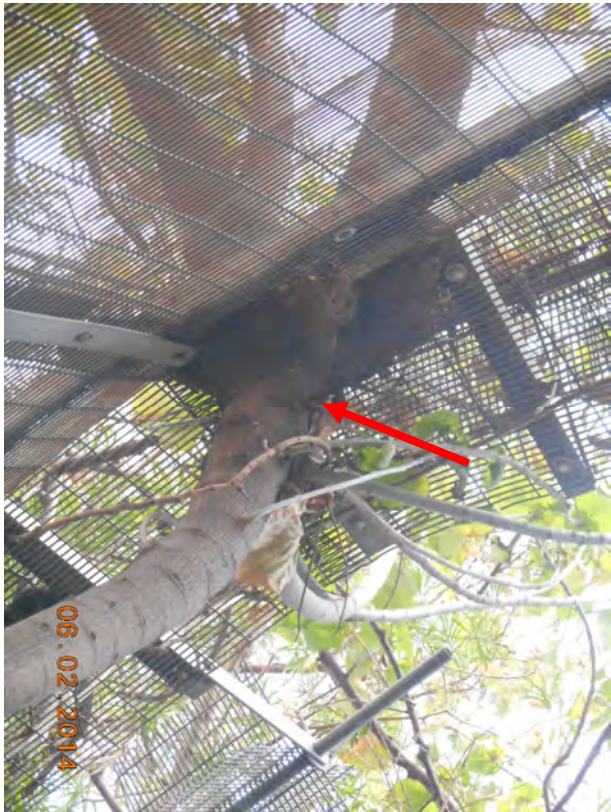
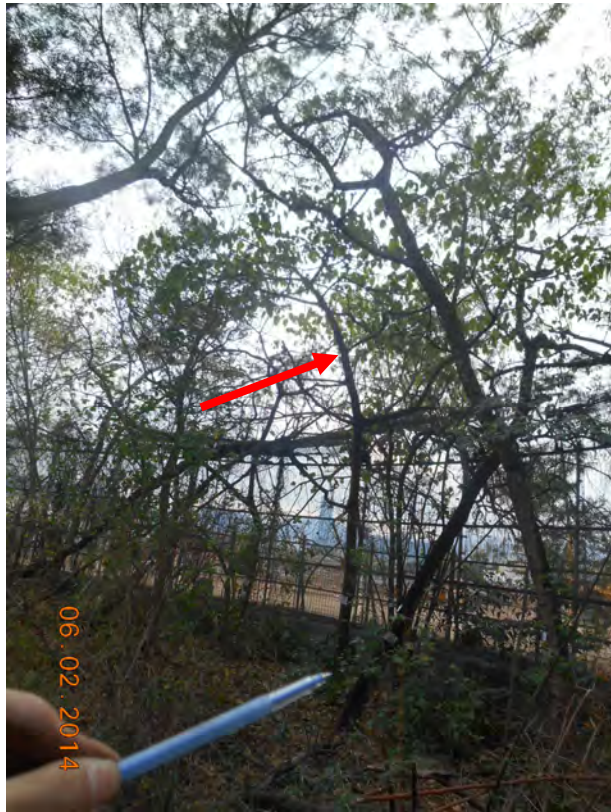
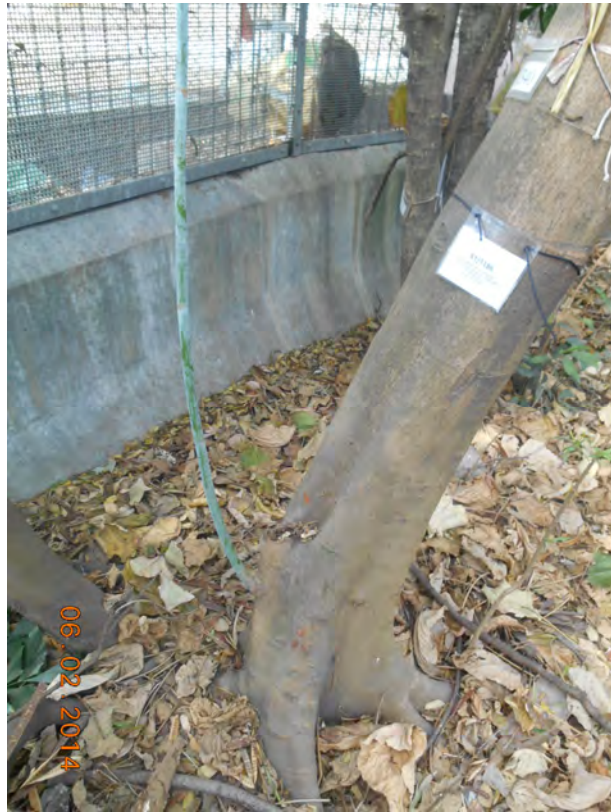
KT/T183_1 (Fell) <i>Dead tree</i>	KT/T183_2 <i>Broken trunk</i>	KT/T184_1_(Fell) <i>Macaranga tanarius var. tomentosa</i>	KT/T184_2 <i>Twin stems; Heavily bent trunk</i>

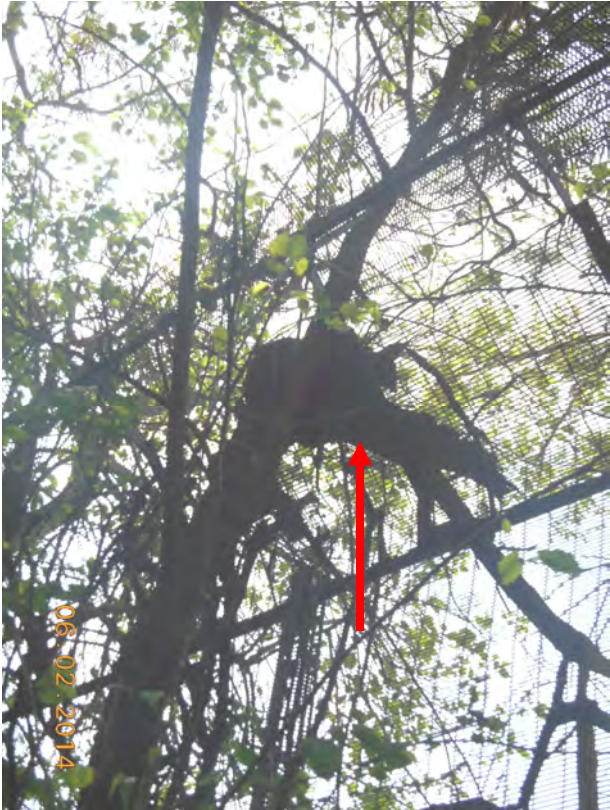
<p>06.02.2014</p>
KT/T193_2	KT/T194_1 (Fell) Scientific Name: <i>Morus alba</i>	KT/T194_2 Multi-trunk	KT/T194_3 Decay at trunk base

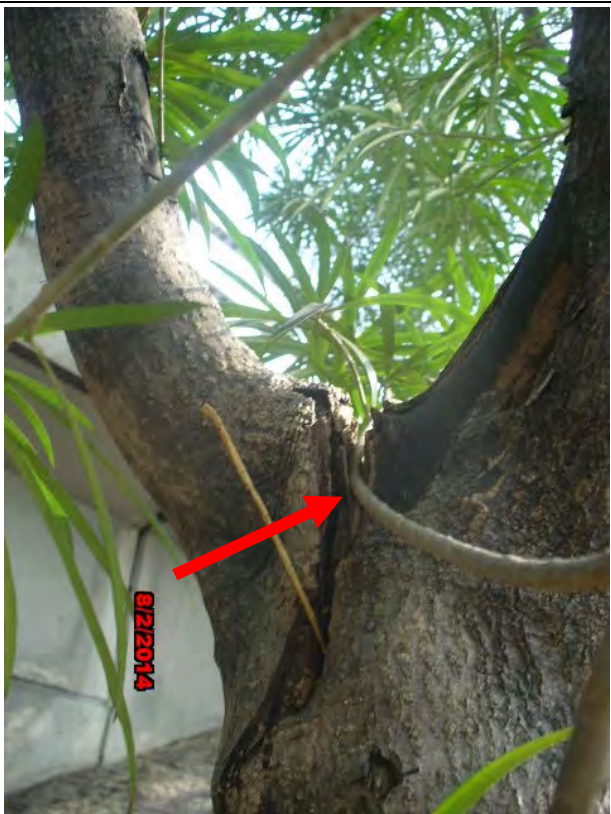
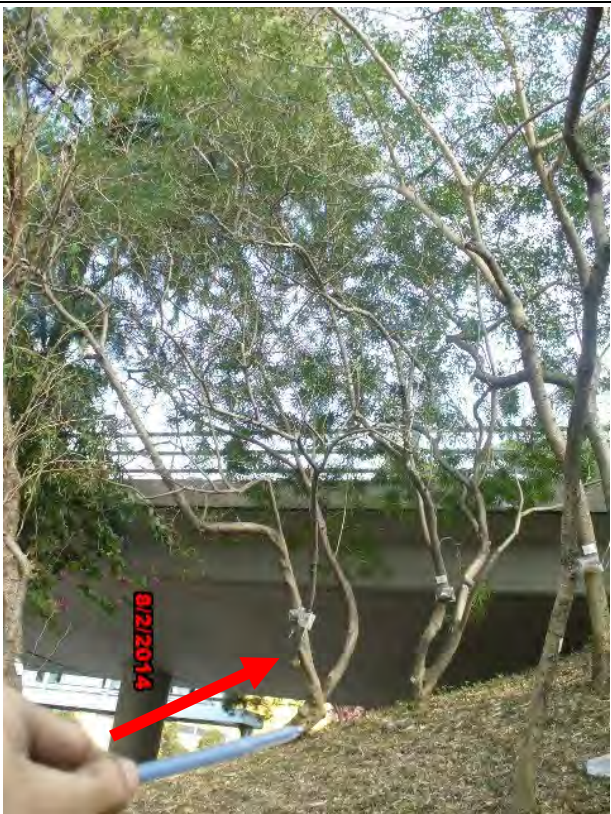
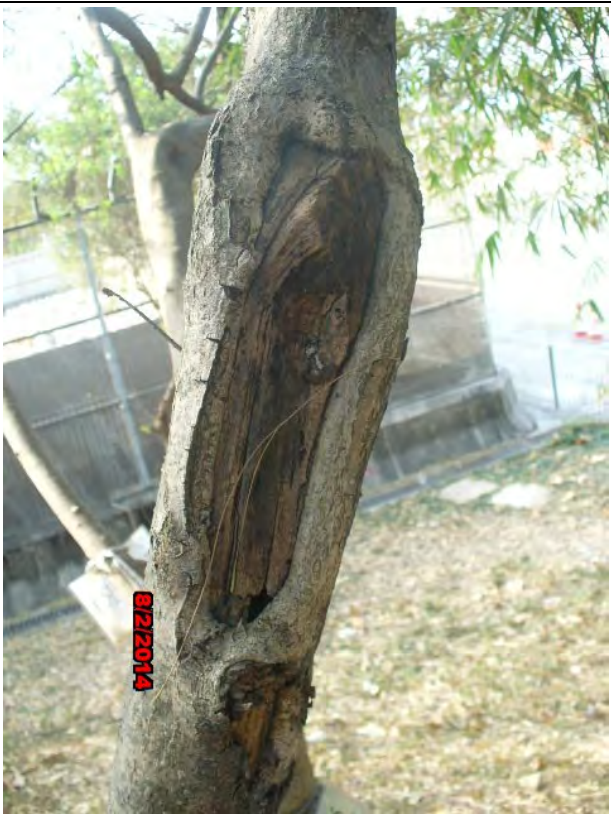
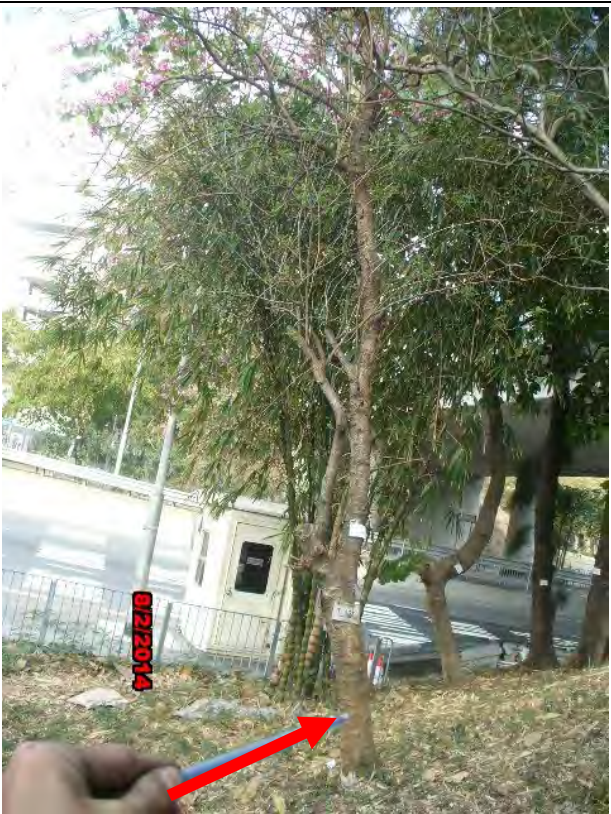
KT/T230_2 Twin stems	KT/T231_1 (Fell) Scientific Name: <i>Thevetia peruviana</i>	KT/T231_2 Multi-trunk	KT/T232_1 (Fell) Scientific Name: <i>Thevetia peruviana</i>

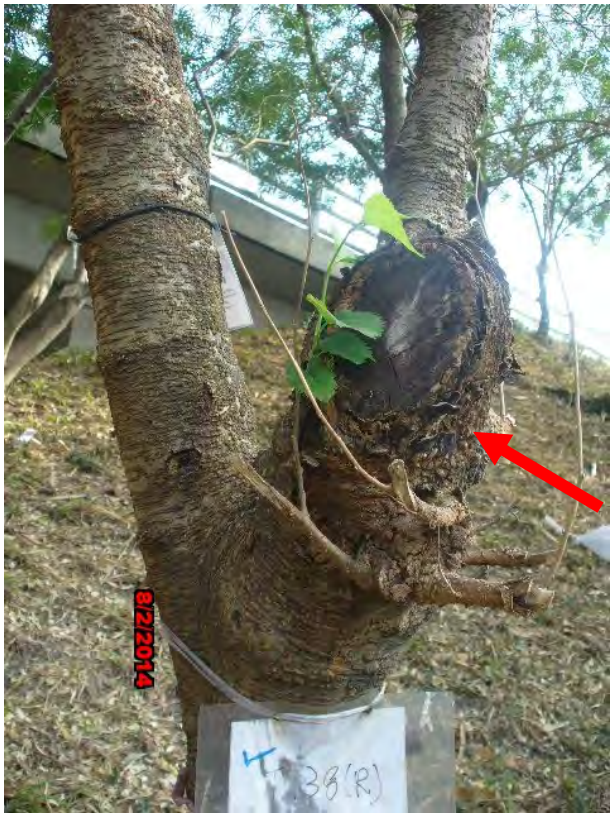
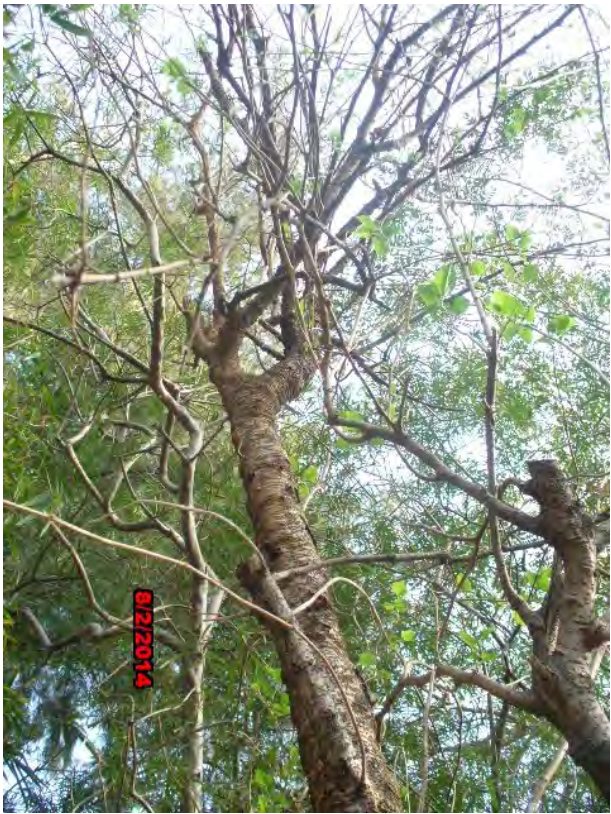
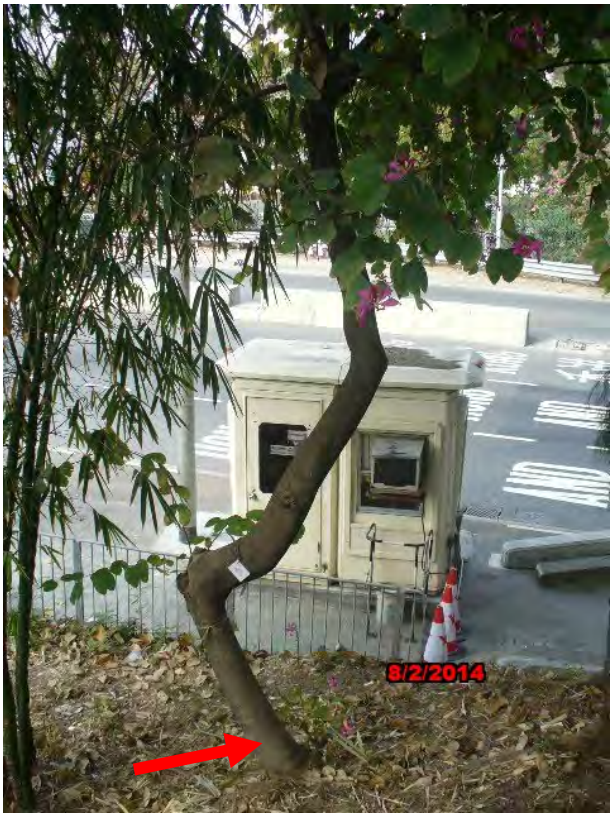
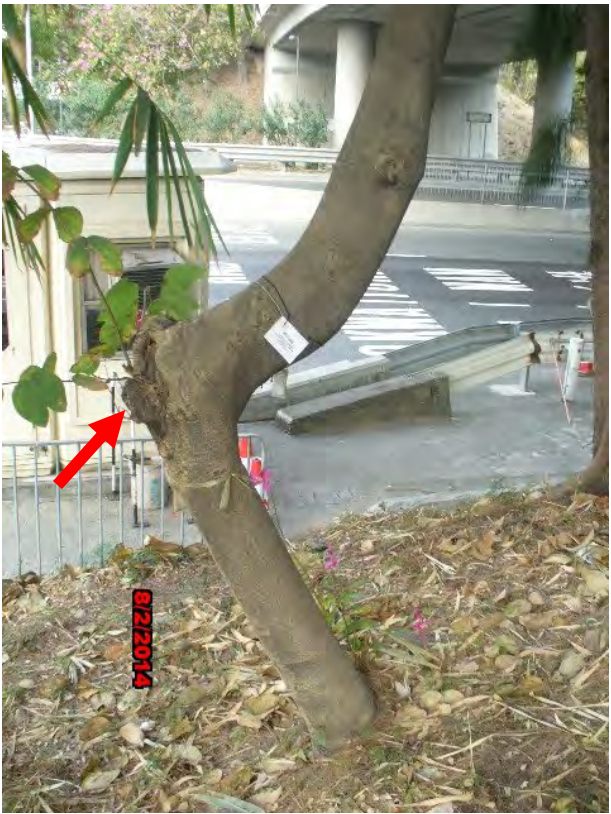
KT/T232_2 Cracked branch union	KT/T233_1 (Fell) Scientific Name: <i>Thevetia peruviana</i>	KT/T233_2 Large wound on trunk	KT/T234_1 (Fell) Scientific Name: <i>Morus alba</i>

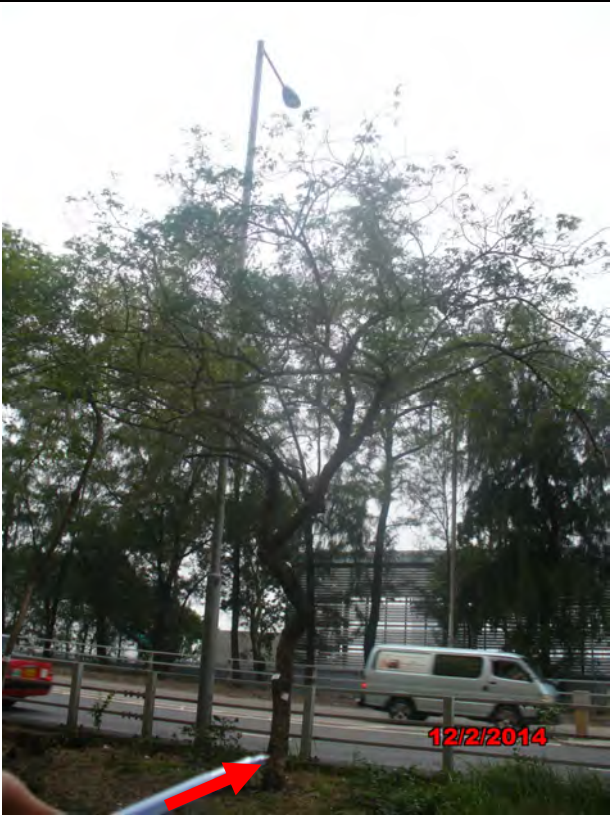
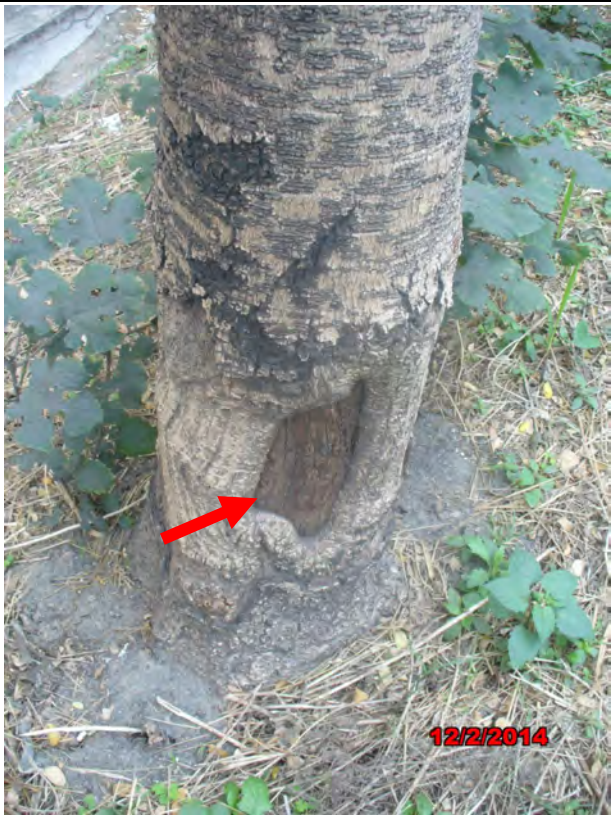
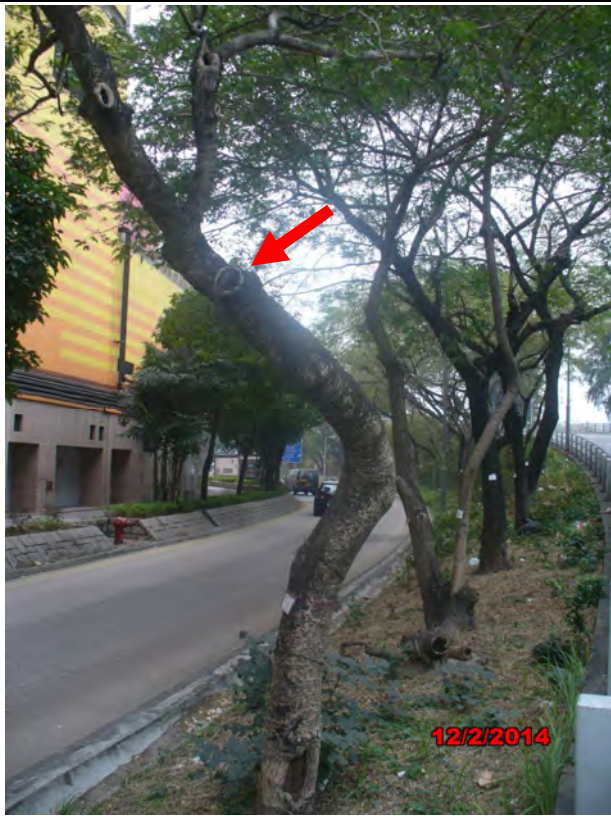
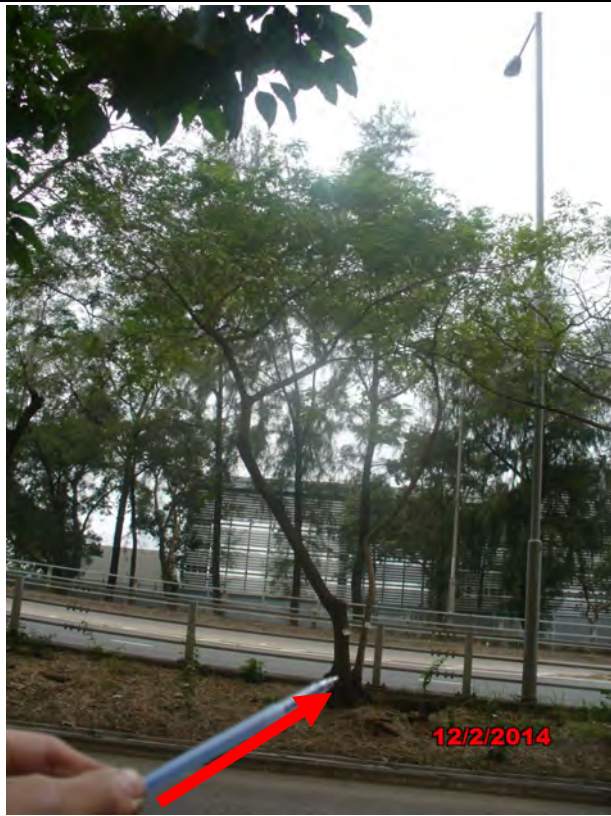
NOT USED	NOT USED	NOT USED	NOT USED
NOT USED	 	 	 
	KT/T263_1 (Fell) Scientific Name: <i>Albizia lebbbeck</i>	KT/T263_2	KT/T263_3 Broken leader

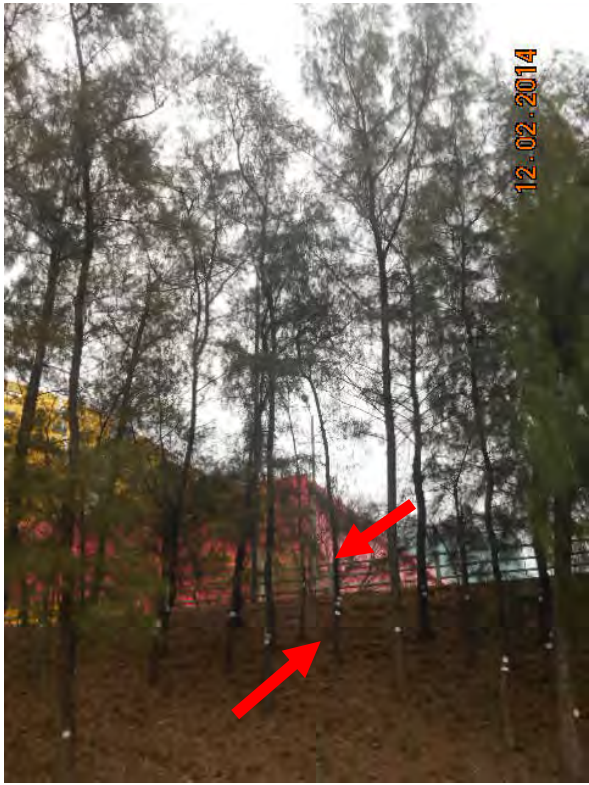
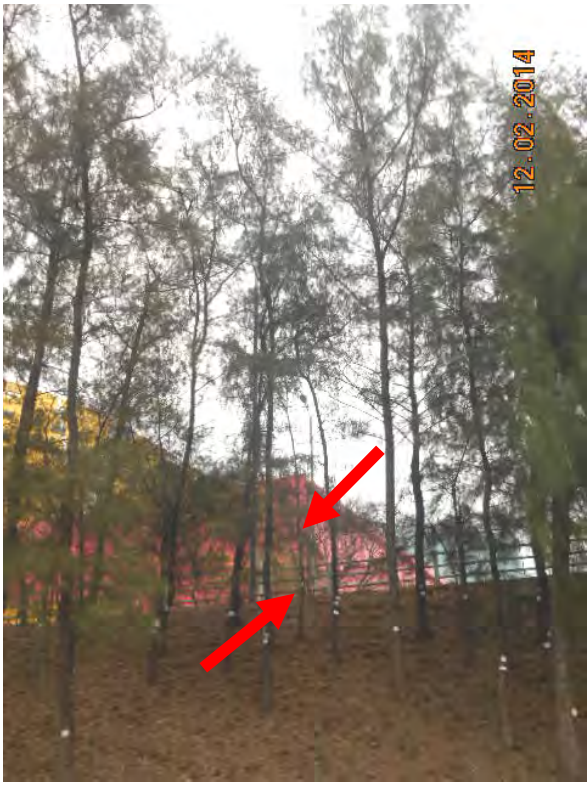
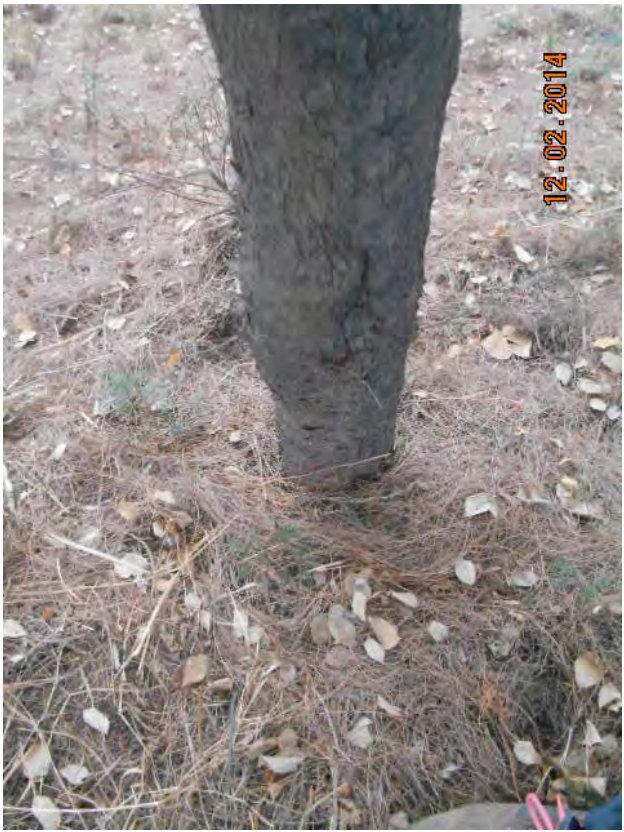
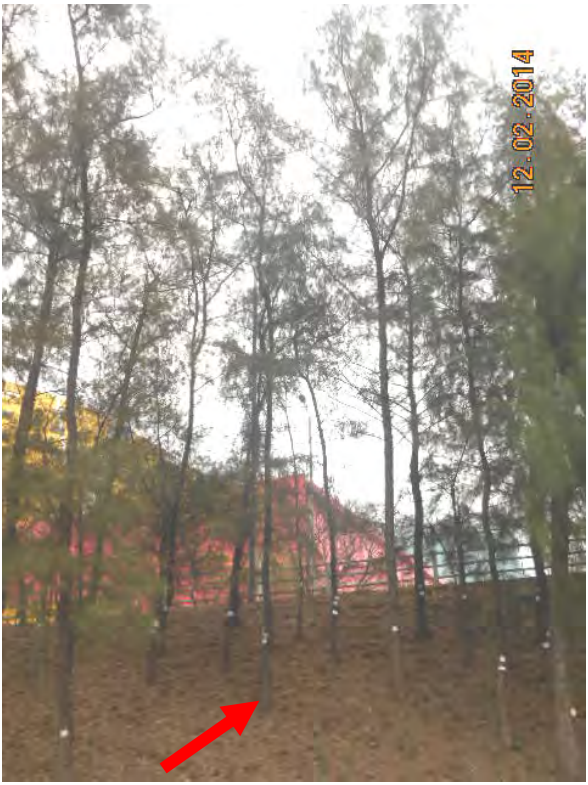
KT/T339_2 Broken leader	KT/T339_3 Split trunk	KT/T340_1 (Fell) Scientific Name: <i>Casuarina equisetifolia</i>	HMT/T340_2

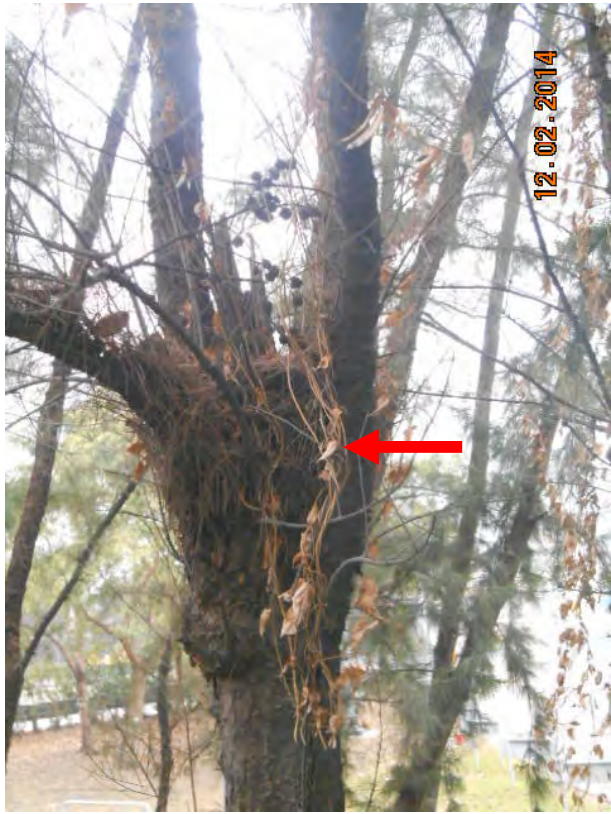
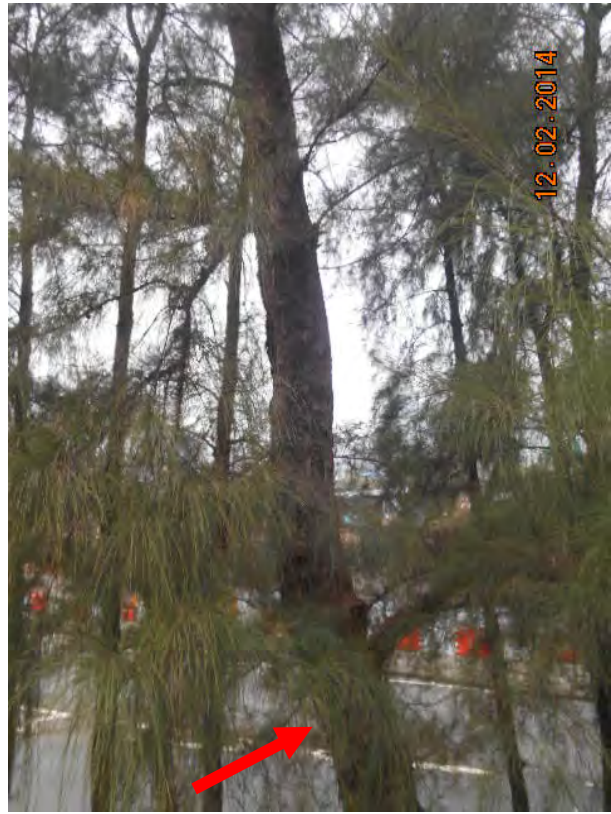
KT/T366_1 (Fell) Scientific Name: <i>Casuarina equisetifolia</i>	KT/T366_2 Broken main trunk	KT/T366_3	KT/T367_1 (Fell) Scientific Name: <i>Casuarina equisetifolia</i>

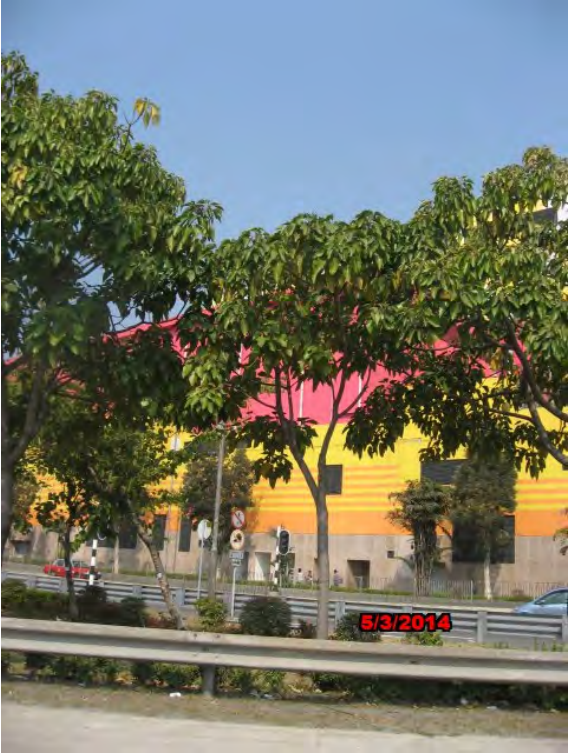
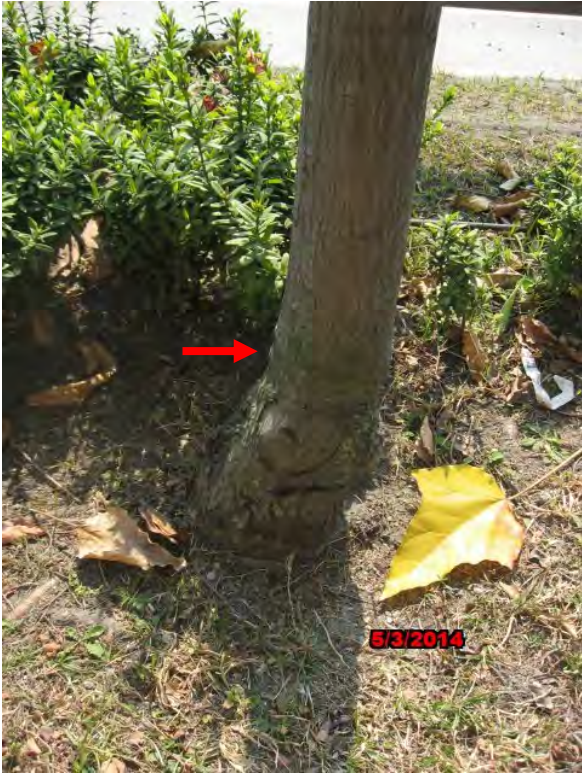
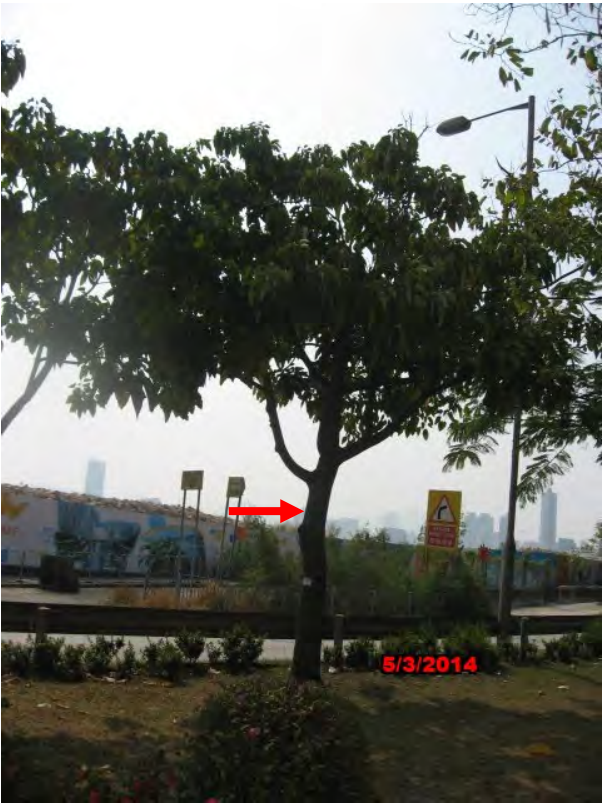
KT/T82_1 (Fell) Scientific Name: <i>Leucaena leucocephala</i>	KT/T82_5 Mingled with chain link fence	KT/T83_1 (Fell) Scientific Name: <i>Aleurites moluccana</i>	KT/T83_2 Close to utilities box

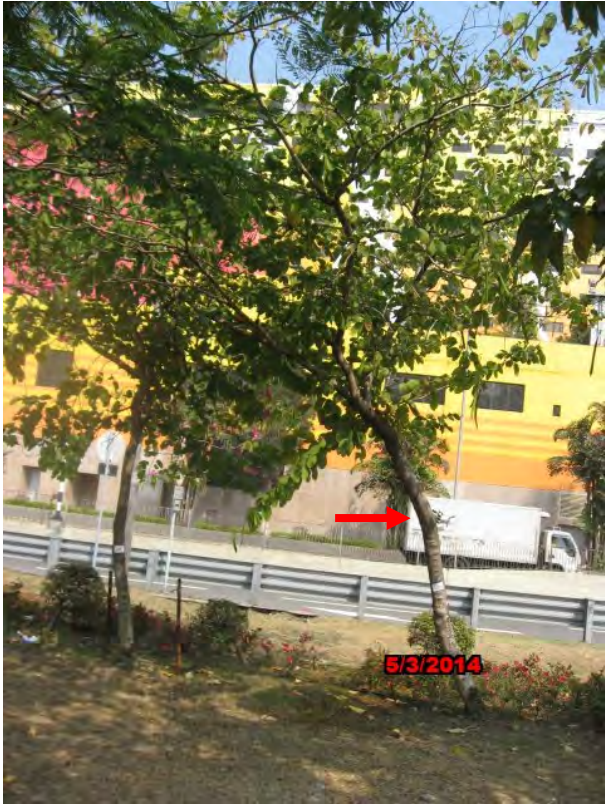
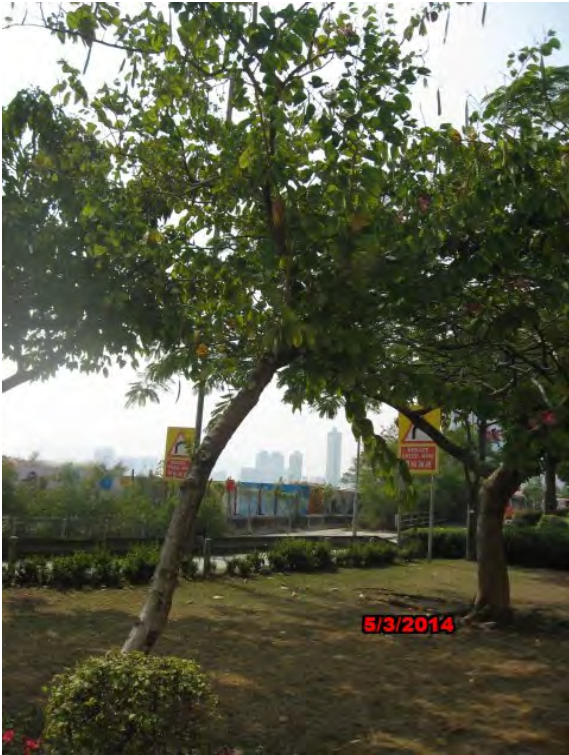
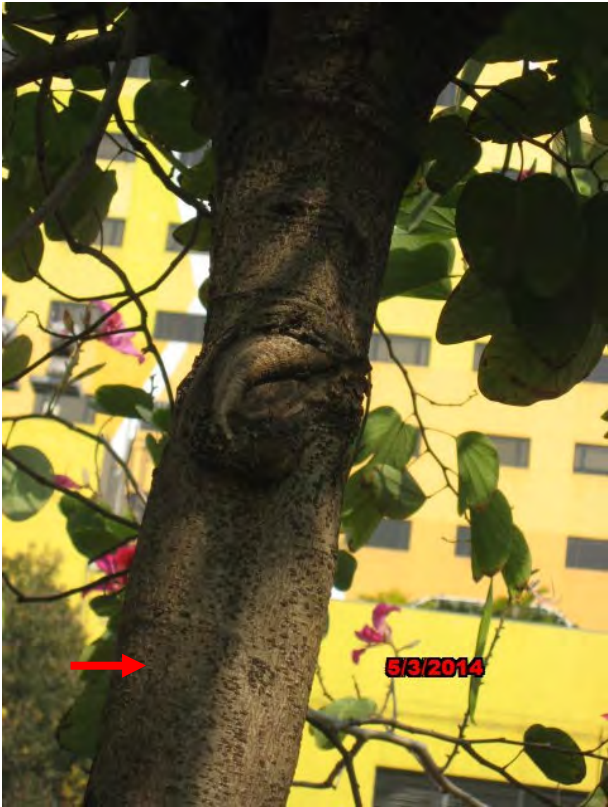
KT/T84_1 Transplant Scientific Name: <i>Aleurites moluccana</i>	KT/T84_2	KT/T85_1 Transplant Scientific Name: <i>Aleurites moluccana</i>	KT/T85_2 Broken branches

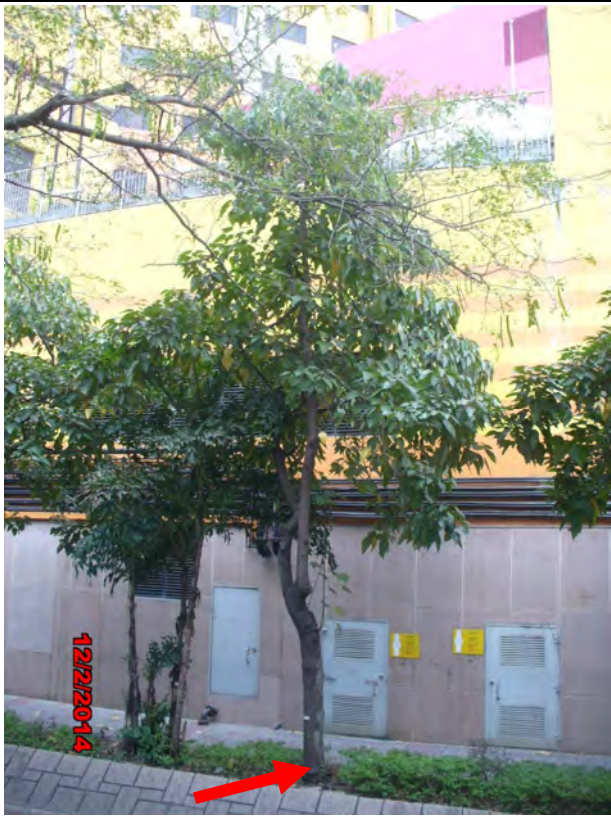
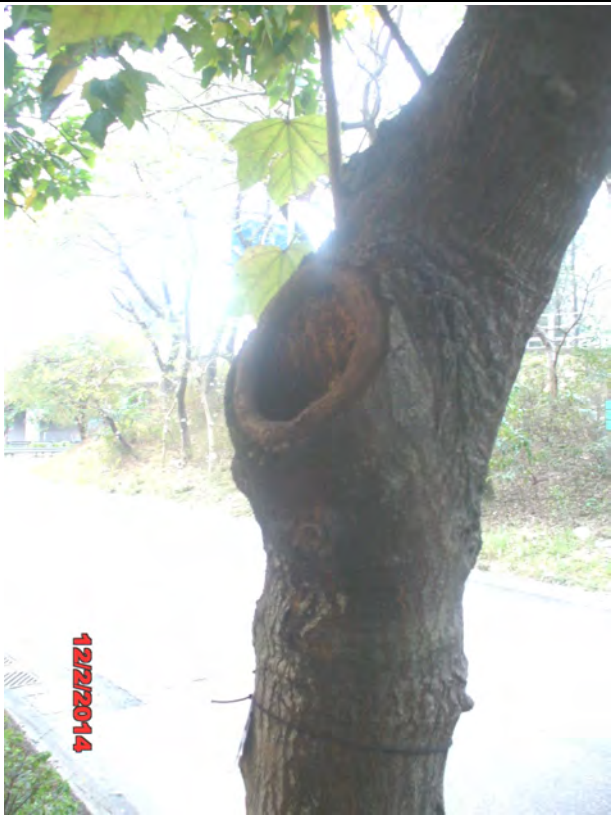
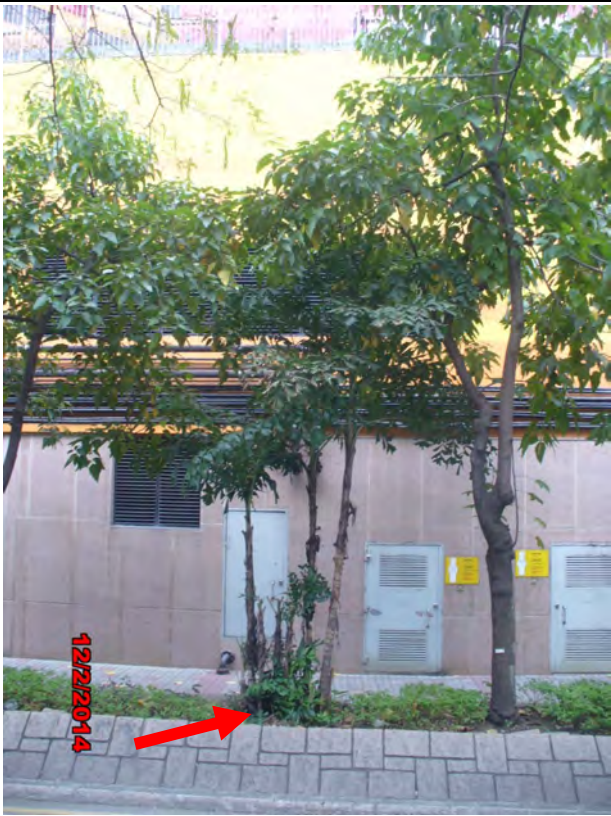
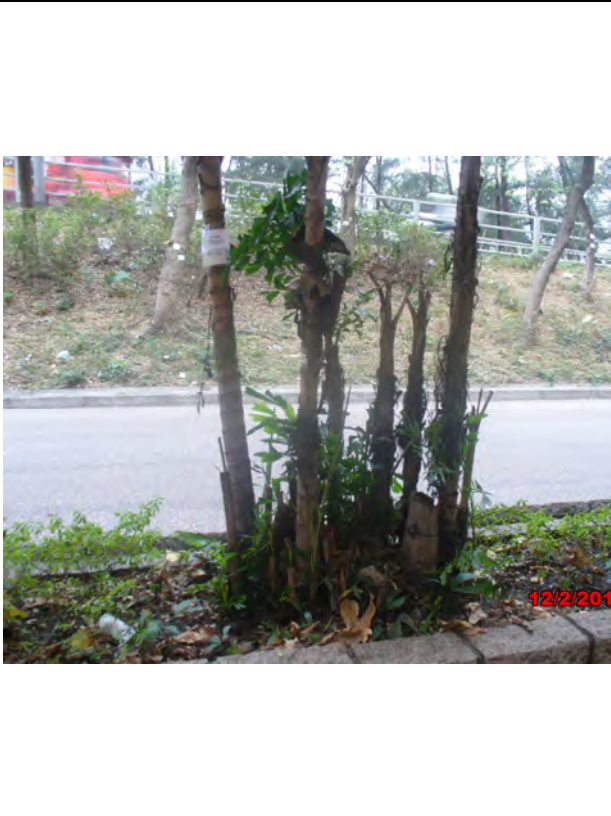
KT/T266_1 (Retain) Scientific Name: <i>Aleurites moluccana</i>	KT/T266_2 Wound on trunk	KT/T267_1 (Retain) Scientific Name: <i>Aleurites moluccana</i>	KT/T267_2 Girdling roots

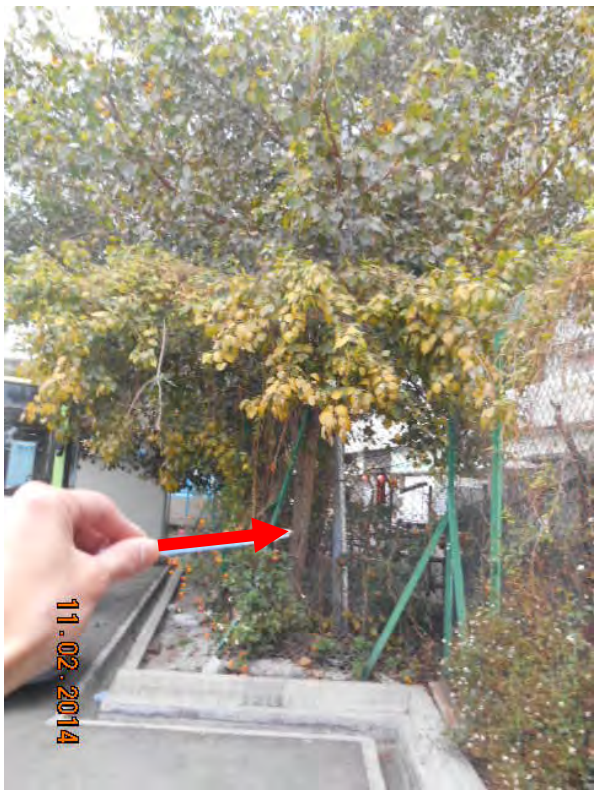
KT/T484_1 (Fell) Scientific Name: <i>Ficus religiosa</i>	KT/T484_2 Co-dominant trunks
