**Legislative Council Panel on Home Affairs  
Subcommittee on Heritage Conservation**

**Preservation of King Yin Lei at 45 Stubbs Road, Hong Kong**

**Summary of the Report on Site Investigation and Restoration Options  
King Yin Lei at 45 Stubbs Road, Hong Kong**

**Heritage Assessment of King Yin Lei at 45 Stubbs Road, Hong Kong  
by the Antiquities and Monuments Office**

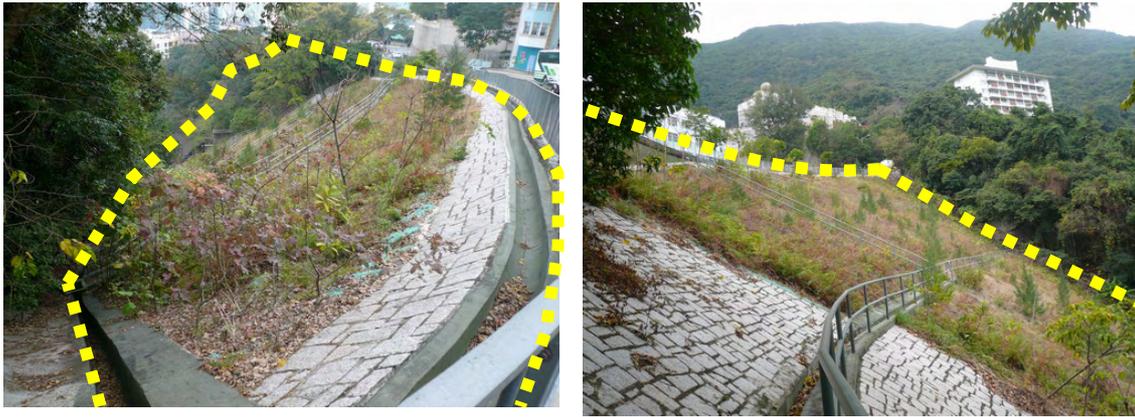
**View on the man-made slope as at January 2008**

7. The site we are considering granting is a man-made slope with slope stabilisation works undertaken in 2002 to the west of King Yin Lei. Although it is currently zoned as “Green Belt” under the Peak Area Outline Zoning Plan, it is a man-made slope with little vegetation. For details, please see the layout plan and relevant photos at **Annex C**.

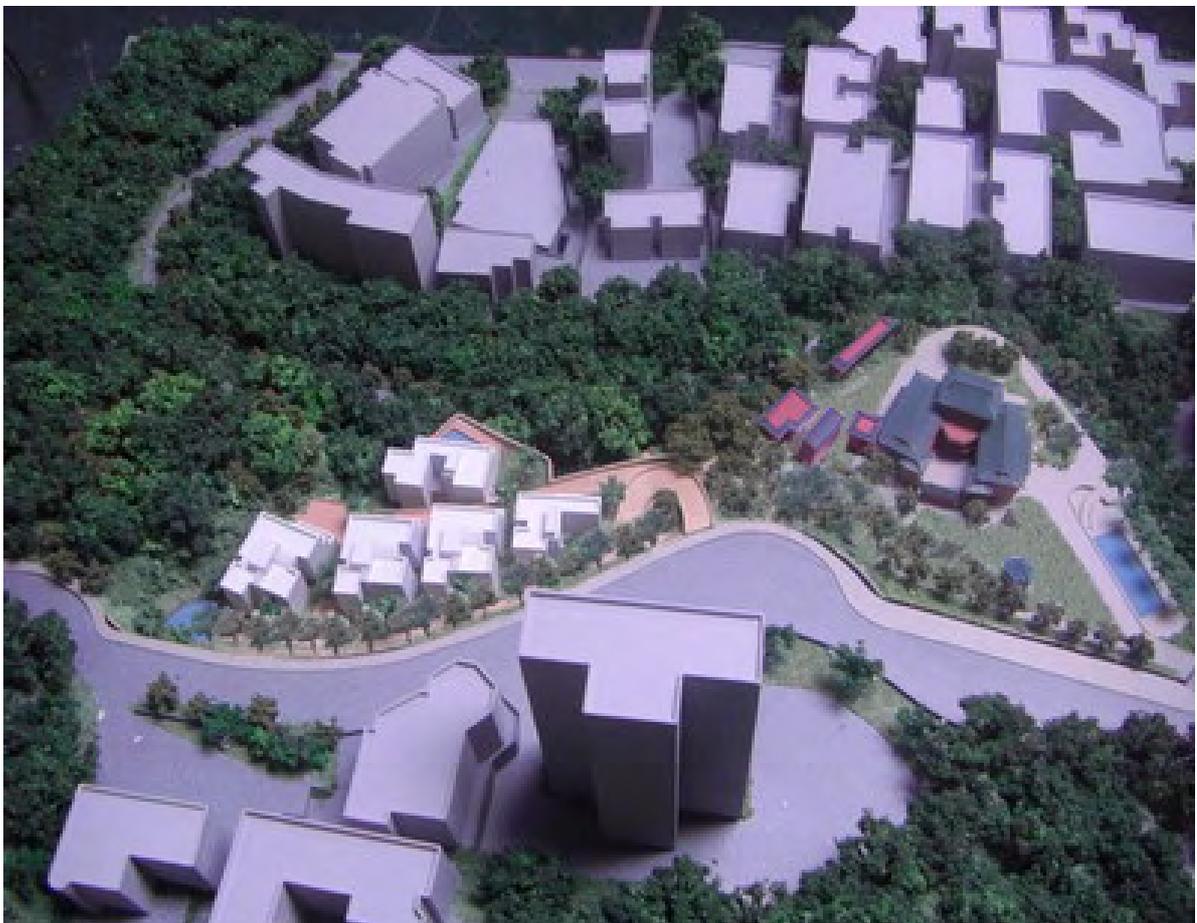
**Layout of proposed development**

8. The owner plans to construct five residential houses on the new site within the permissible plot ratio. The proposed development will not adversely affect the density, traffic load, landscape and greenery of the area or the vista of the neighbourhood. As the proposed development involves rezoning the new site from “Green Belt” to “Residential (Group C) 1”, approval from the Town Planning Board will be required. It is also subject to agreement by the concerned departments in accordance with the established procedures. We will seek approval of the Chief Executive in Council for the proposed non-in-situ land exchange in due course.

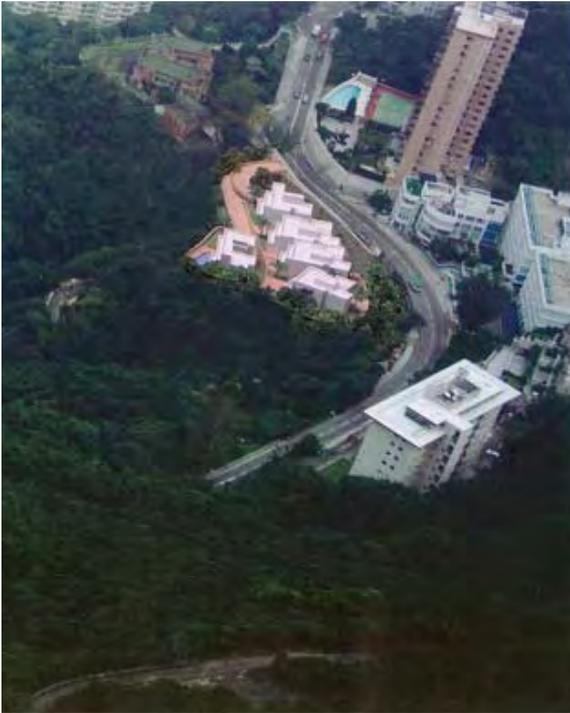
**Aerial view showing new houses covering up the man-made slope without affecting view of residential and institutional buildings**

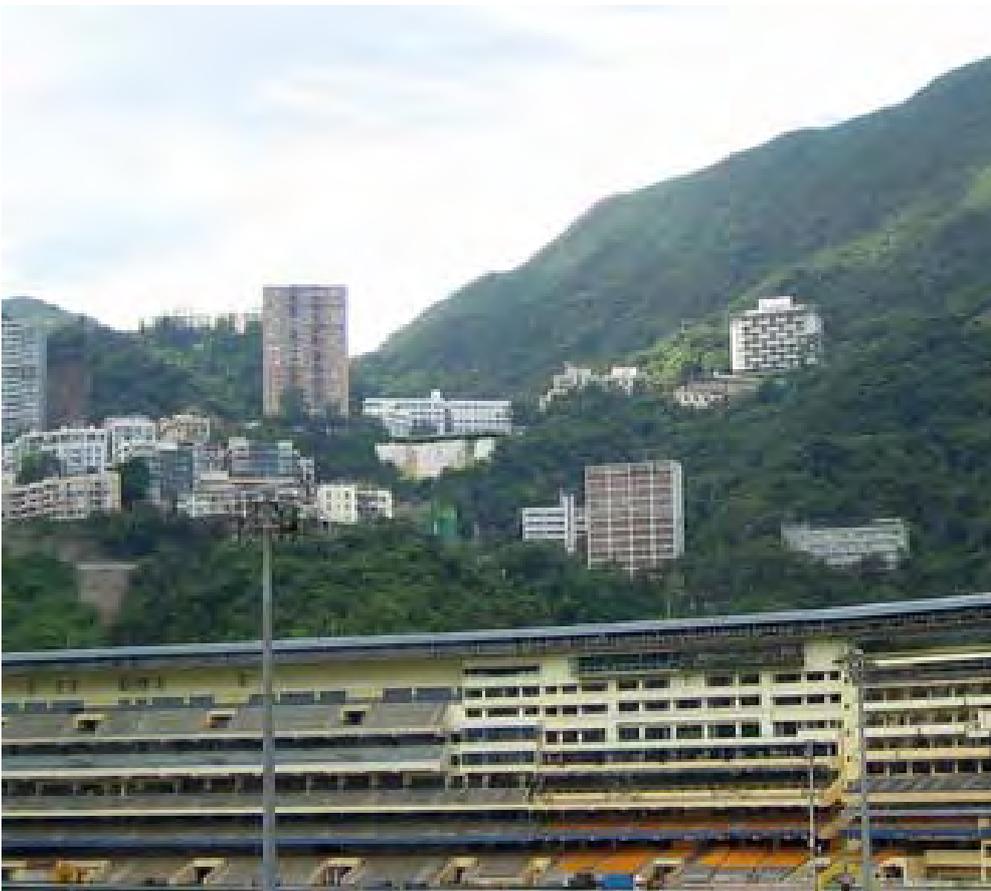
**New houses helping to cover up man-made slope and enhance cityscape**
