Legislative Council Panel on Development

**Policy and Matters Relating to Preservation of
Historical Remains Discovered at Works Sites**

**Photos of the Remains Discovered at the Works Site
at Harcourt Garden in Admiralty by the MTRCL**

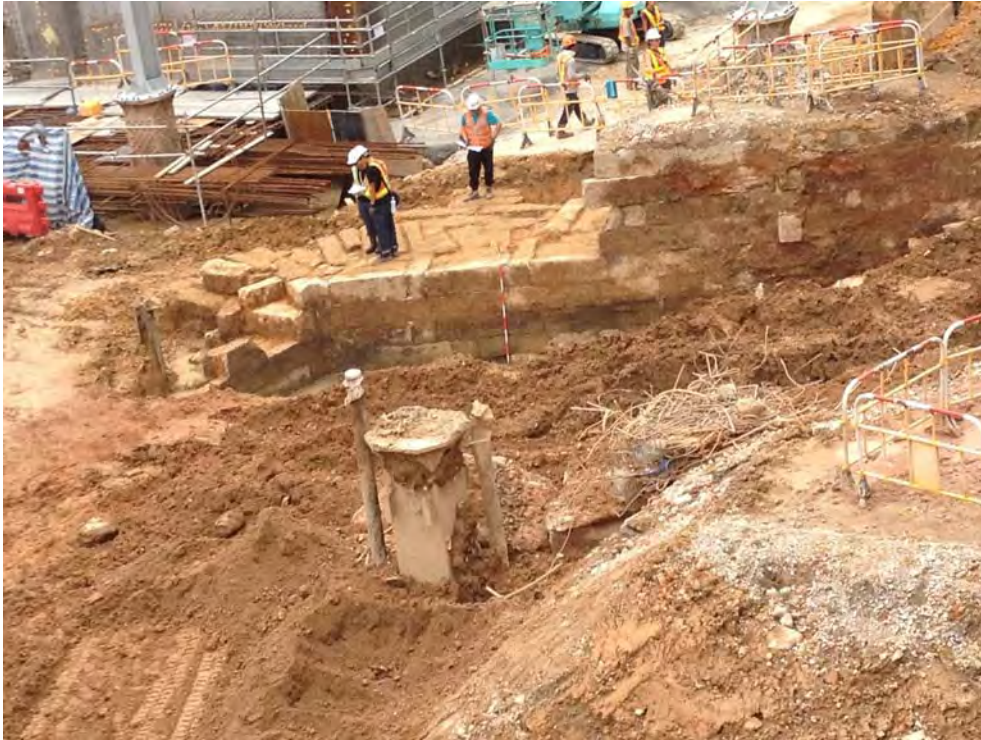
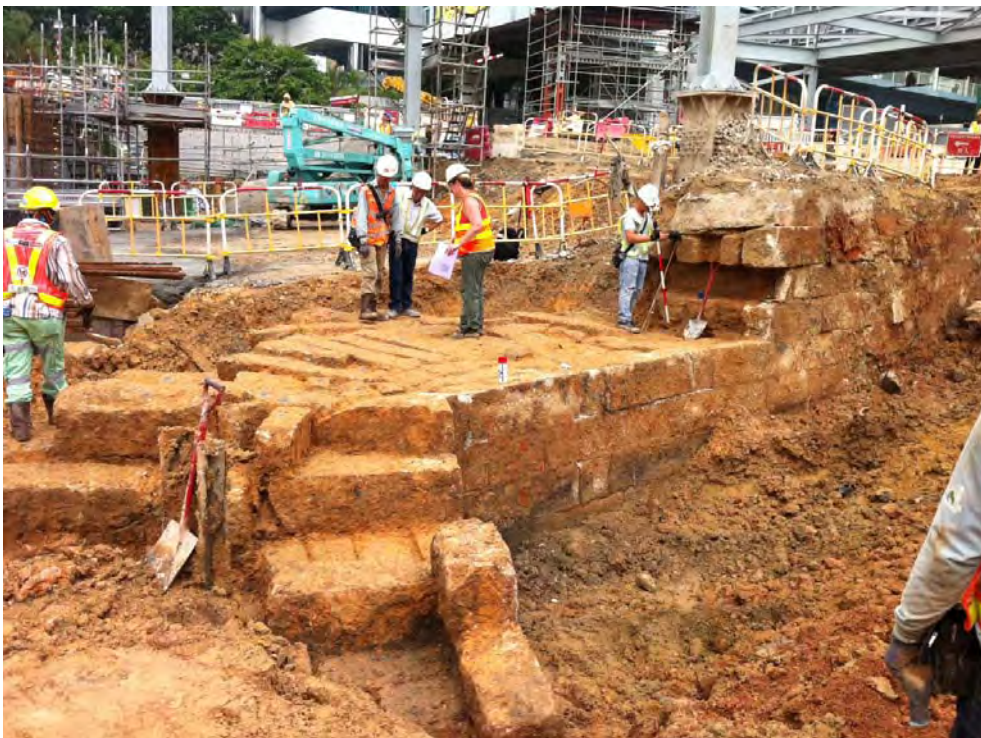
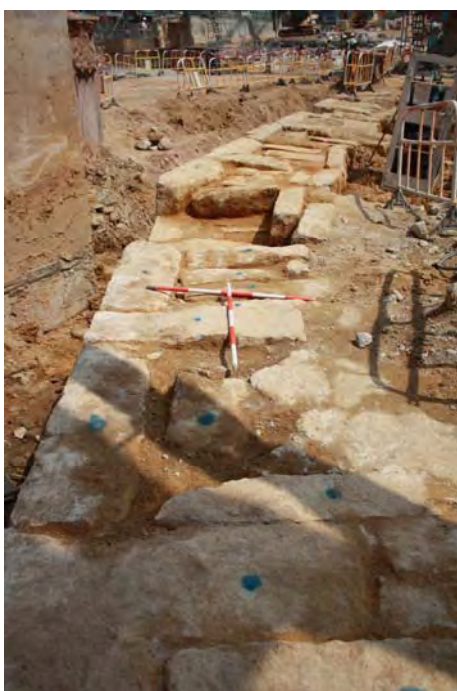
26 September 2012	AMO's staff of the curator grade who have received professional archaeological training ("professionals of the AMO") conducted a site visit and discussed with the archaeologist commissioned by the MTRCL. Both sides agreed that the structural remains were not part of the Wellington Battery, but a fragment of the seawall of the mid-19th century, which has been damaged by various works in the early years.

Time	Events
First Half of October 2012	The archaeologist commissioned by the MTRCL considered that since the remains discovered were remains of a seawall which have been damaged by various projects in the early years, the heritage value of the remains discovered is relatively low, and since the location of the remains discovered is critical for the extension of Admiralty Station, it is not appropriate to preserve the remains discovered in-situ. The archaeologist recommended that a detailed recording such as by photography, drawing and written description be conducted. This suggestion was made in accordance with the relevant condition in the licence for the archaeological works (i.e. the archaeological watching brief should be conducted in accordance with the information submitted by the applicant when applying for the licence; and the information concerned stipulated that the applicant should consult and obtain the agreement with the AMO on the follow-up works for the materials discovered). After consideration, the AMO agreed with the above-mentioned arrangement, and suggested that some of the blocks of the seawall be salvaged for reuse and appropriate interpretation in the future. The MTRCL accepted the suggestion of the AMO, and has stored those blocks in good condition properly.

research team, as well as Dr. Kwong Chi-man, who is the Research Assistant Professor of the History Department of the Hong Kong Baptist University and has been studying military history, to the works site, and the remains were further confirmed as remains of a damaged seawall but not those of a battery.
