# 沙田至中環綫項目 紅磡站擴建工程 全面評估策略建議

Holistic Proposal for the verification and assurance of  
Hung Hom Station Extension  
under Shatin to Central Link Project

# 評估目的 – 確定車站結構安全及完整性

Purpose of the study – Verifying the structural safety and integrity of extension works

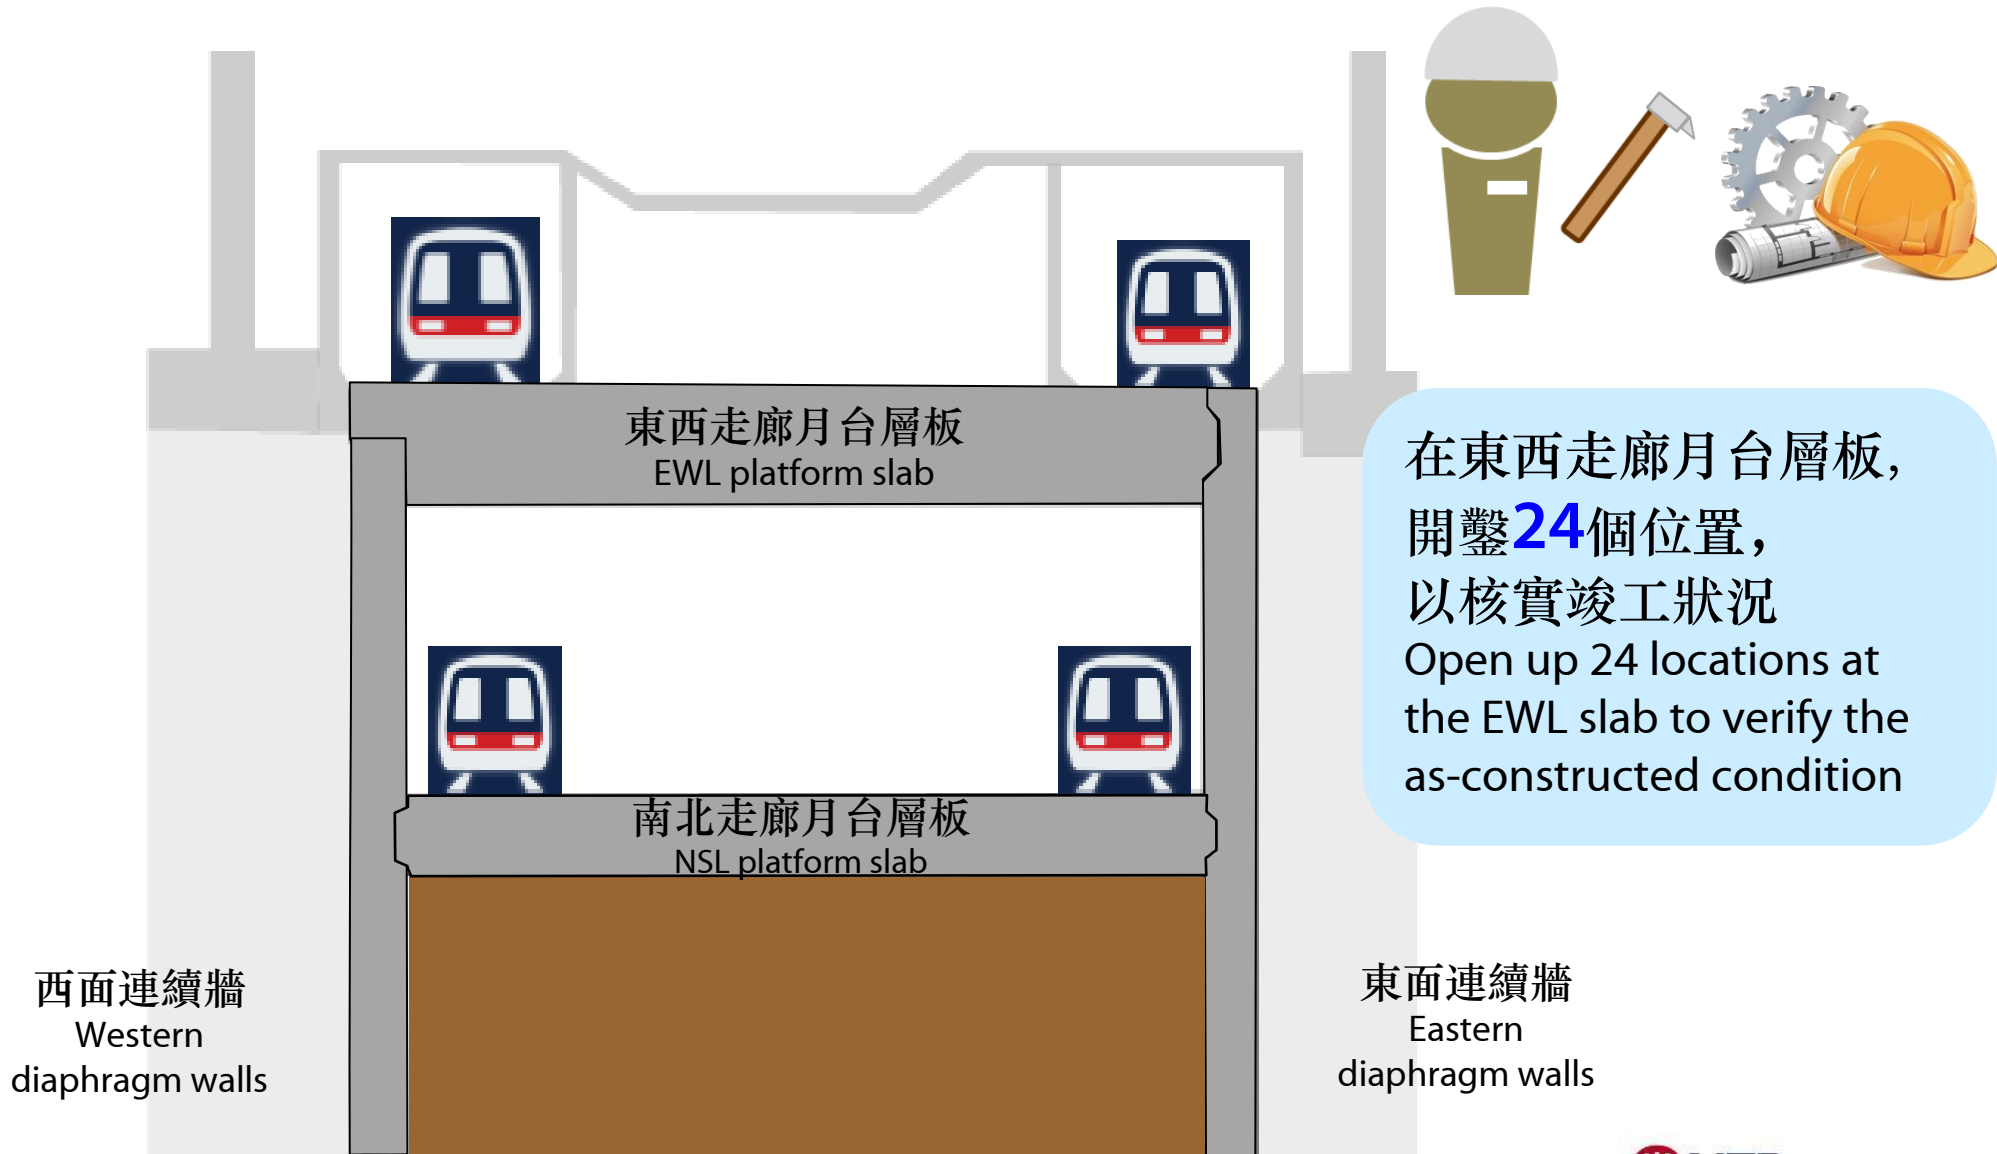
# 第二階段: 實地檢測 - 開鑿以核實竣工狀況

Stage 2: On-site investigation - Opening up to verify as-constructed conditions

1. 確認竣工狀況 – 工程設計曾有改動及資料不完整的地方

Verify as-constructed condition – areas with design change and incomplete information

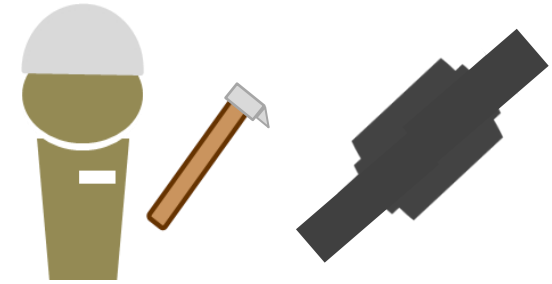
Stage 2: On-site investigation – Opening up to verify the workmanship of coupler connection

兩個月台層板各開鑿**28**個位置  
(即合共**56**個位置)，  
收集最少**168**個隨機螺絲帽樣本  
Open up 28 locations at each of the  
platform slab (total 56 locations) with  
a minimum of 168 steel bar/coupler  
connection random samples

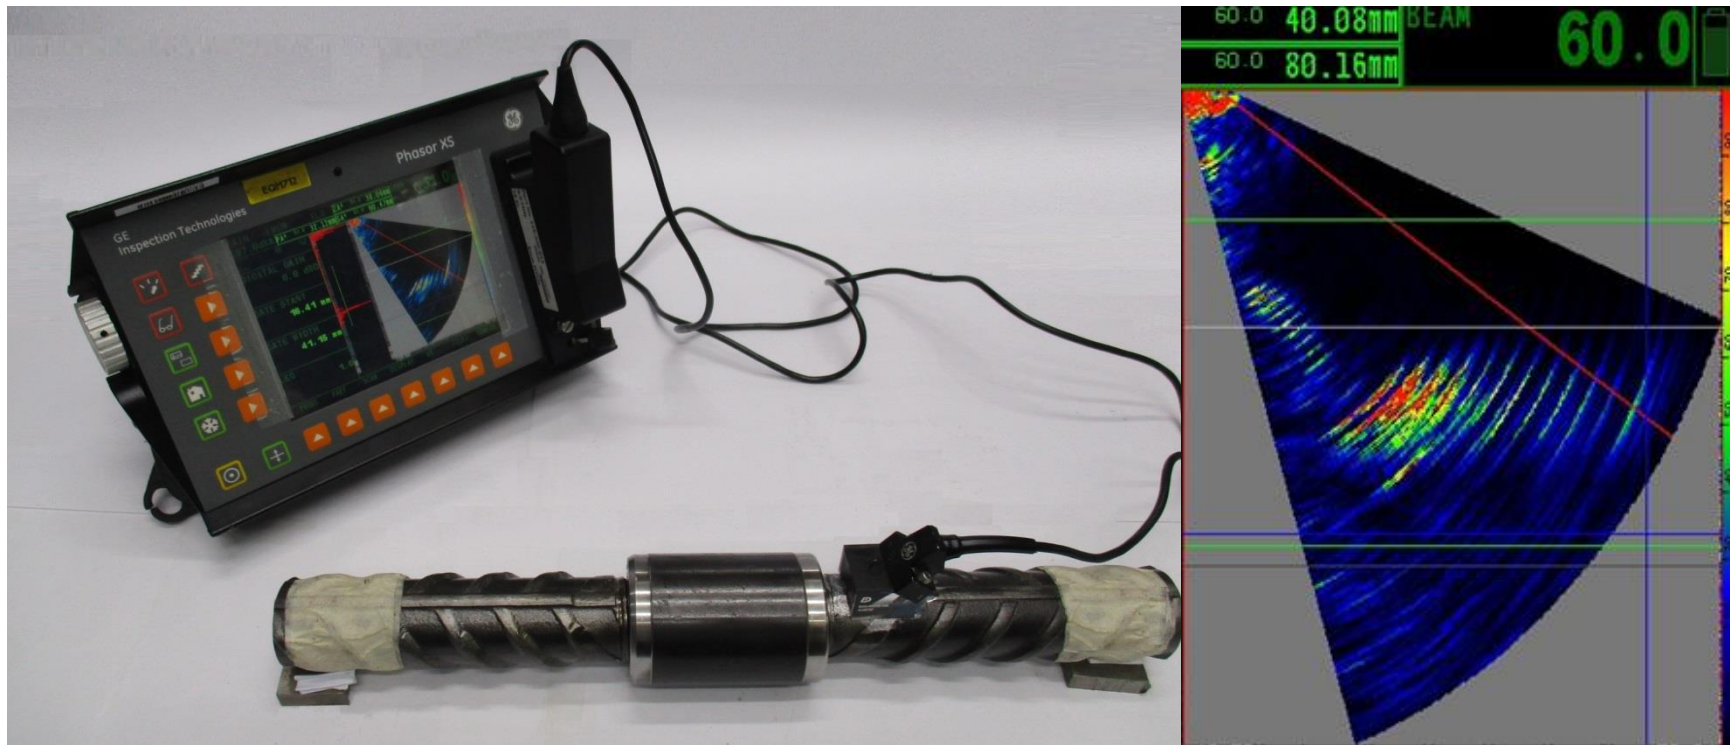
Phased Array Ultrasonic Examination

- 核實螺絲帽的接駁狀況  
Verify the coupler connection

超聲波技術

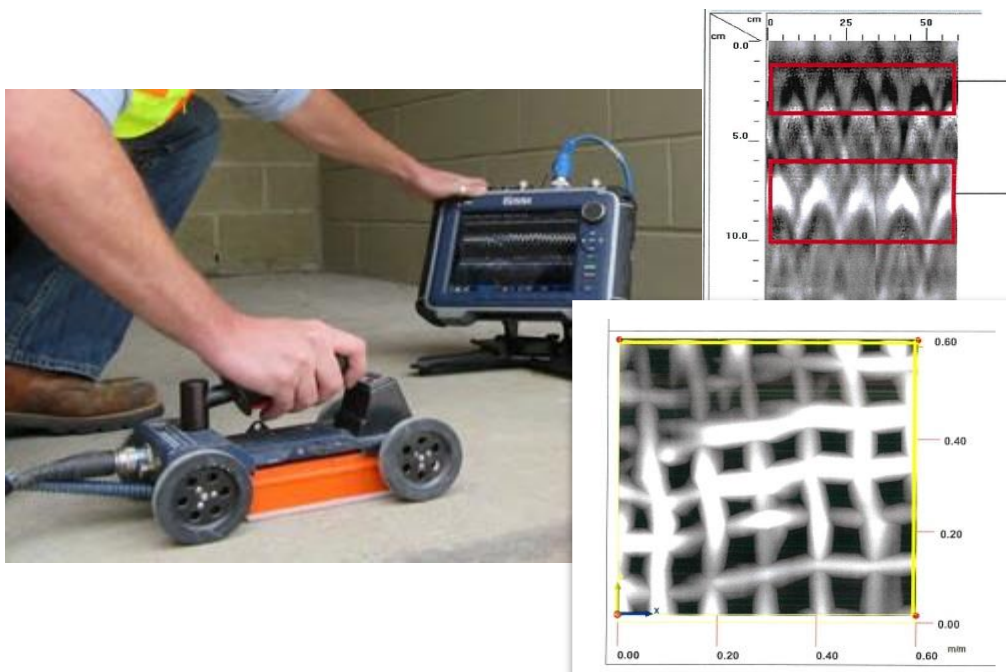
透地雷達儀器  
Ground Penetration Radar

- 核實鋼筋的配置及混凝土質量  
Verify condition of steel bar spacing and quality of concrete

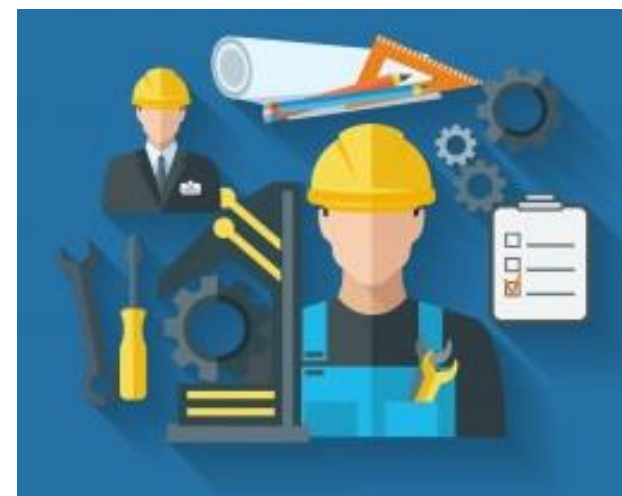
- 根據核實結果，就整個車站擴建工程進行詳細結構評估  
Based on findings, structural assessment will be conducted for the platform slabs and station extension structure
- 如有需要，會制定及實施修復措施  
Remedial works will be designed and implemented wherever necessary

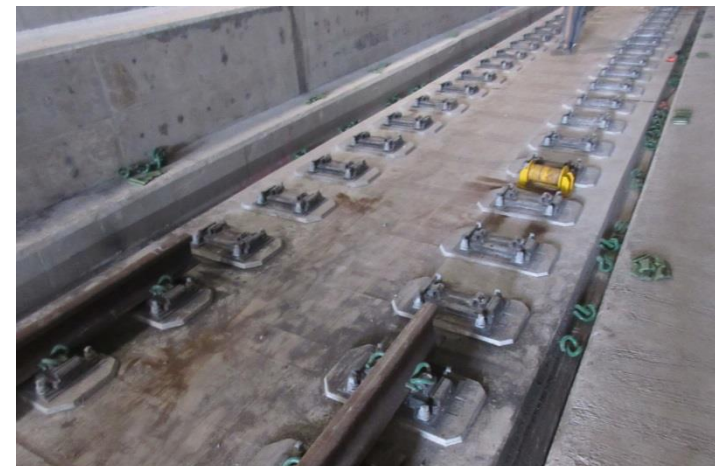
- 已展開移除路軌及鐵路設施等準備工作  
Preparatory works for implementing the verification works including removal of tracks and railway facilities have started

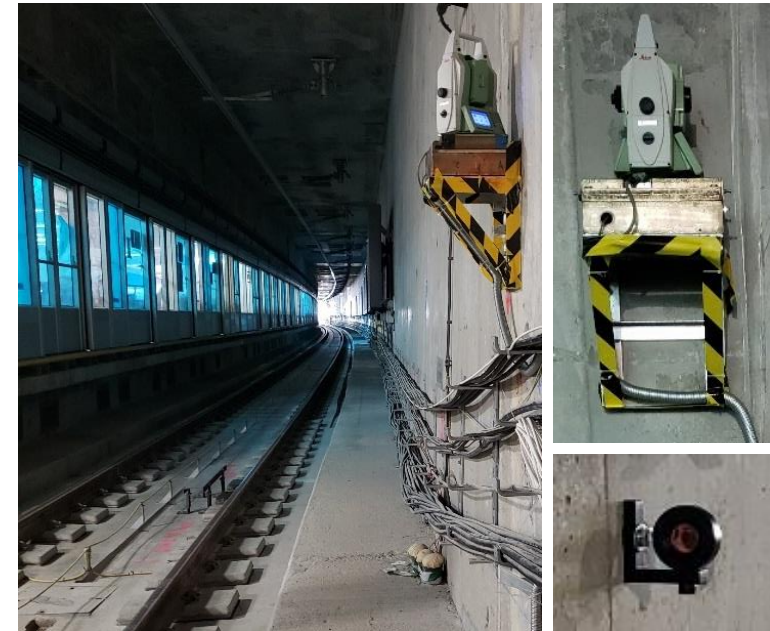
- 東西走廊月台已安裝結構監察系統  
Structural monitoring system has been installed on the EWL platform
- 為進一步確保車站的結構完整性及耐久程度，會因應測試結果，制訂長遠的監測方案  
Long-term monitoring programme will also be formulated after the exercise for further assurance on the long-term performance and durability of the structure
